Visual Paint Assessment Report

For 10 First Street, Unit 9 A, Flagtown Hillsborough Township, NJ
 01/24/2024

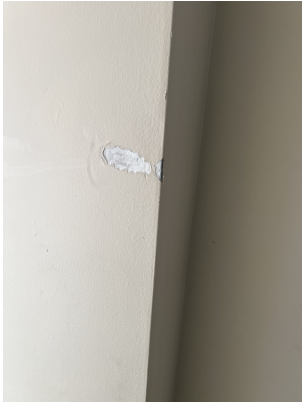
Hazard: Living Room | Wall | Deteriorated Paint Hazard: Living Room | Wall | Deteriorated Paint

Identified hazards shall be remediated using either abatement (permanent) or interim controls (temporary). Abatement shall be performed by a NJ Licensed lead abatement firm using licensed lead abatement supervisors and workers. Interim control work shall be performed by EPA RRP certified firms using an EPA certified RRP Renovator. After completion of interim control work, a lead-based paint post-remediation with dust wipes will be required. After completion of abatement work, a lead-based paint abatement clearance will be required.
