Visual Paint Assessment Report

For: 67 River Rd, Unit 2, Summit, NJ, 07836

LEAD-BASED PAINT EVALUATION REPORT DWELLING UNIT(S) INSPECTION

67 River Rd, Unit 2 & Stairwell (Common Area), Summit, NJ, 07836

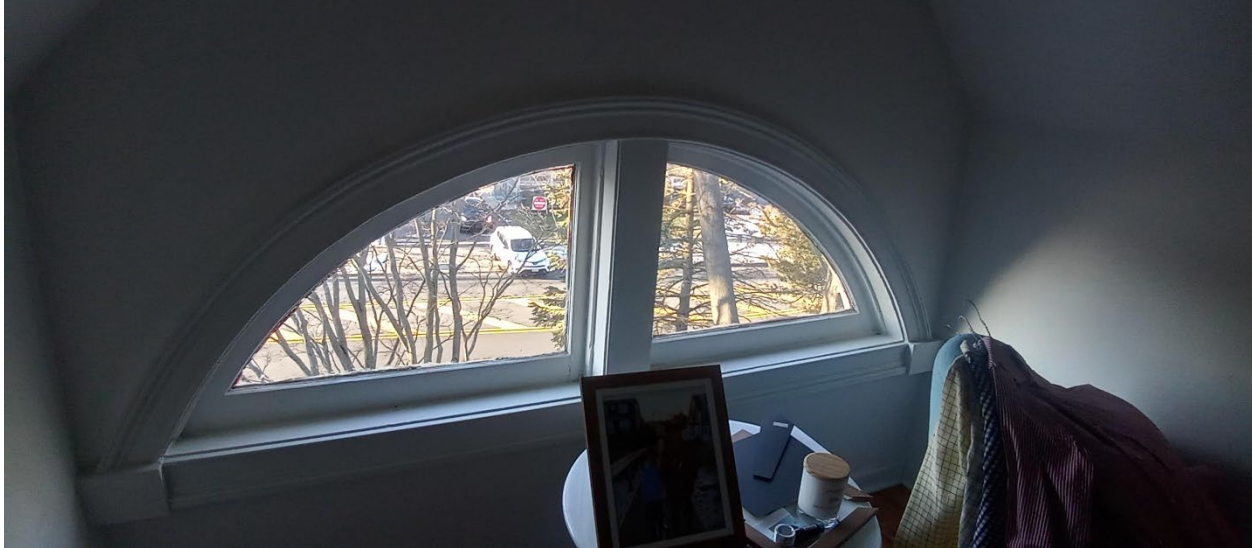
Bedroom 2 Window in Wall A

No deteriorated paint, chips or dust from painting activities or paint residue on floors were observed in the dwelling unit. The property is eligible for a lead-safe certificate per NJAC 5:28A. Certificate enclosed.

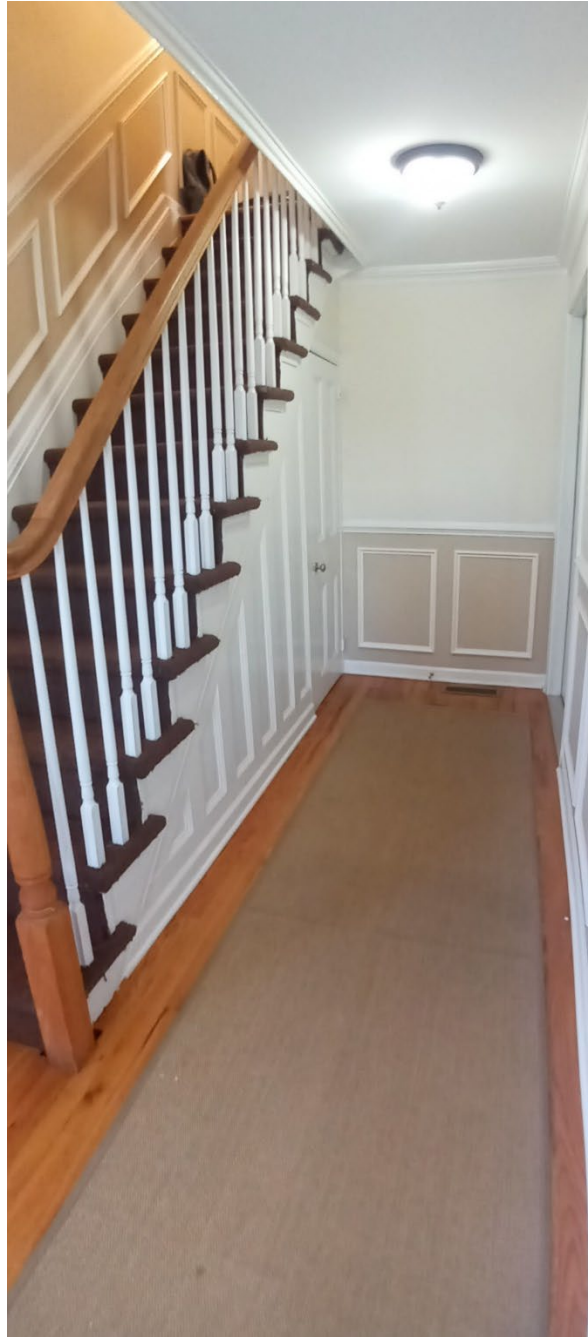
Stairwell: Stair & Door in Wall B2

Room Equivalent	Component		Substrate	Value (mg/cm ²)	Paint Condition	Recommendation
Stairwell	Stair	Stinger Wall B	Wood	31	Intact	Maintain in good condition
Stairwell	Stair	Undersided Wall B2	Wood	33	Intact	Maintain in good condition
Stairwell	Door	Door Wall B	Wood	13.6	Intact	Maintain in good condition
Stairwell	Door	Jamb Wall B	Wood	35	Intact	Maintain in good condition
Stairwell	Door	Casing Wall B	Wood	22.9	Intact	Maintain in good condition
