Visual Paint Assessment Report

For 102 Windsor ct Hillsborough Township, NJ 08844
02/05/2024

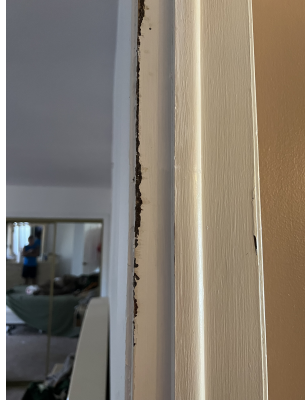
Room	Component	Hazard
Bedroom 1	Door Casing	Deteriorated Paint

Hazard: Bedroom 1 | Door Casing | Deteriorated Paint

Identified hazards shall be remediated using either abatement (permanent) or interim controls (temporary). Abatement is permanent but has a higher cost, as Interim controls are temporary but can be much more affordable. Abatement shall be performed by a NJ Licensed lead abatement firm using licensed lead abatement supervisors and workers. You can find the list of NJ licensed lead abatement contractors at https://www.nj.gov/dca/divisions/codes/publications/pdf_lead/ld_abat_c.pdf. Interim control work shall be performed by EPA RRP certified firms using an EPA certified RRP Renovator. You can find certified EPA RRP contractors at <https://cdxappstest.epacdx.net/ocspp-oppt-leadhub/firm-location-search>. Select RRP Contractor, then NJ, then enter your zip code to search for contractors. After completion of interim control work, a lead-based paint post-remediation with dust wipes will be required. After completion of abatement work, a lead-based paint abatement clearance will be required..
