## Visual Paint Assessment Report

For 102 Windsor ct Hillsborough Township, NJ 08844  
02/12/2024

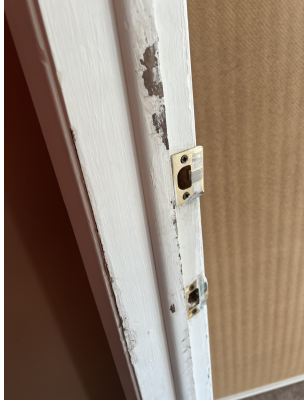
Hazard: Bedroom 2 | Door Casing | Deteriorated Paint

Identified hazards shall be remediated using either abatement (permanent) or interim controls (temporary). Abatement is permanent but has a higher cost, as Interim controls are temporary but can be much more affordable. Abatement shall be performed by a NJ Licensed lead abatement firm using licensed lead abatement supervisors and workers. You can find the list of NJ licensed lead abatement contractors at [https://www.nj.gov/dca/divisions/codes/publications/pdf\\_lead/ld\\_abat\\_c.pdf](https://www.nj.gov/dca/divisions/codes/publications/pdf_lead/ld_abat_c.pdf). Interim control work shall be performed by EPA RRP certified firms using an EPA certified RRP Renovator. You can find certified EPA RRP contractors at <https://cdxappstest.epacdx.net/ocspp-oppt-leadhub/firm-location-search>. Select RRP Contractor, then NJ, then enter your zip code to search for contractors. After completion of interim control work, a lead-based paint post-remediation with dust wipes will be required. After completion of abatement work, a lead-based paint abatement clearance will be required..

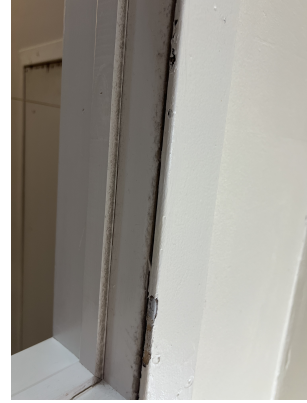
Hazard: Bathroom 3 | Door Casing | Deteriorated Paint

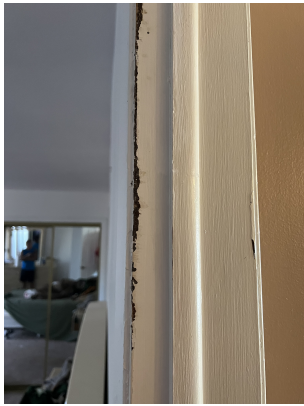
Hazard: Bedroom 1 | Door Casing | Deteriorated Paint
