Visual Paint Assessment Report

For 110 Township Line Road Hillsborough Township, NJ
12/14/2023

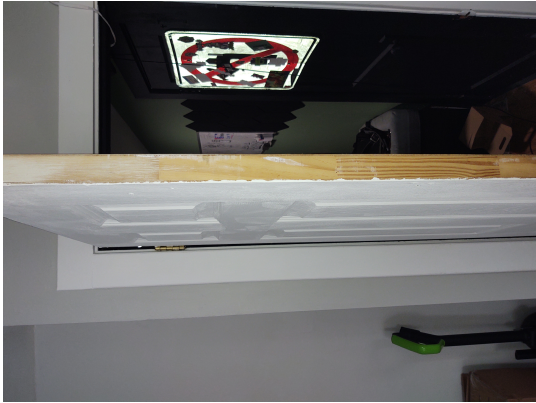
| Room | Component | Hazard |
|---|---|---|
| Living Room | Door | Deteriorated Paint |

Hazard: Living Room | Door | Deteriorated Paint

Identified hazards shall be remediated using either abatement (permanent) or interim controls (temporary). Abatement shall be performed by a NJ Licensed lead abatement firm using licensed lead abatement supervisors and workers. Interim control work shall be performed by EPA RRP certified firms using an EPA certified RRP Renovator. After completion of interim control work, a lead-based paint post-remediation with dust wipes will be required. After completion of abatement work, a lead-based paint abatement clearance will be required.

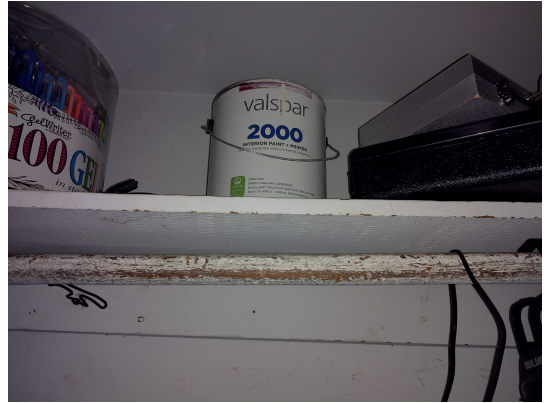
| Room | Component | Hazard |
|---|---|---|
| Office | Closet Shelf and Clothes Pole | Deteriorated Paint |

Hazard: Office | Closet Shelf and Clothes Pole | Deteriorated Paint

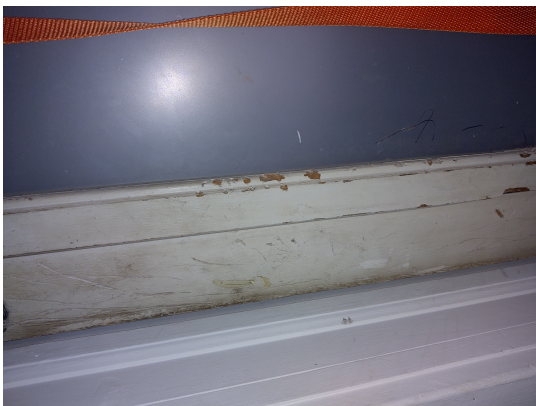
Hazard: Kitchen | Door | Deteriorated Paint

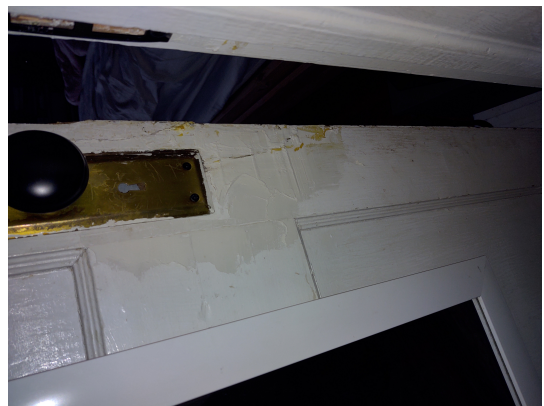
Hazard: Kitchen | Door | Deteriorated Paint

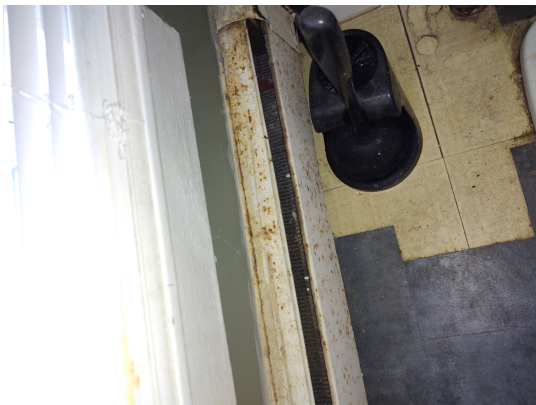
| Room | Component | Hazard |
|---|---|---|
| Bedroom 1 | Door | Deteriorated Paint |

Hazard: Bedroom 1 | Door | Deteriorated Paint

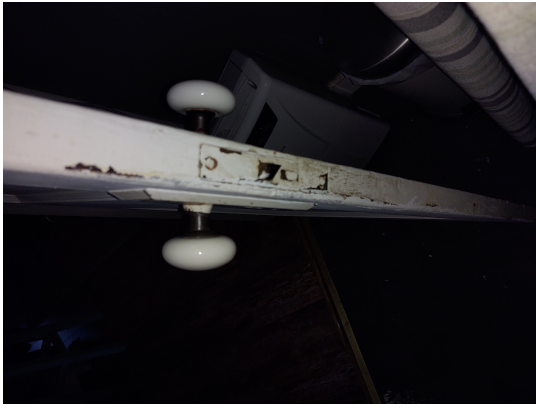
| Room | Component | Hazard |
|---|---|---|
| Bathroom 1 | Door | Deteriorated Paint |

Hazard: Bathroom 1 | Door | Deteriorated Paint

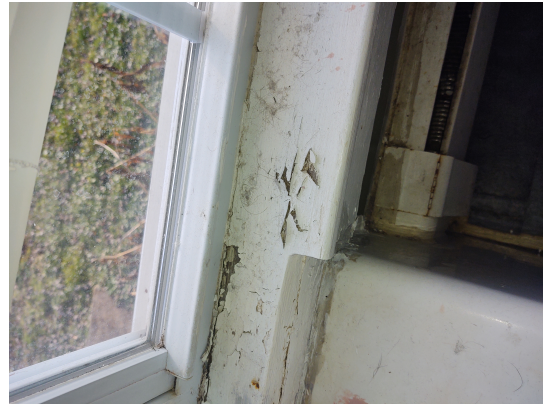
| Room | Component | Hazard |
|---|---|---|
| Bathroom 1 | Window Sill | Deteriorated Paint |

Hazard: Bathroom 1 | Window Sill | Deteriorated Paint

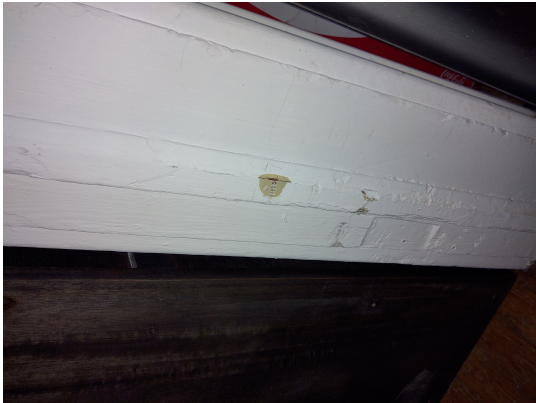
| Room | Component | Hazard |
|---|---|---|
| Living Room | Door Stop | Deteriorated Paint |

Hazard: Living Room | Door Stop | Deteriorated Paint

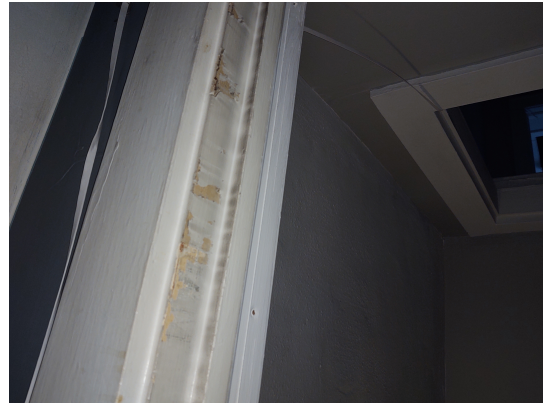
| Room | Component | Hazard |
|---|---|---|
| Bedroom 2 | Door Jamb | Deteriorated Paint |

Hazard: Bedroom 2 | Door Jamb | Deteriorated Paint

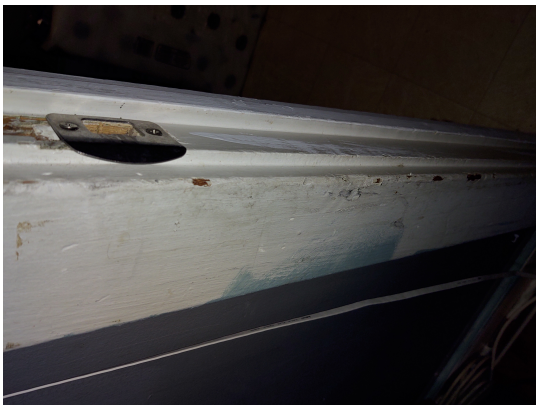
| Room | Component | Hazard |
|---|---|---|
| Bedroom 2 | Door Casing | Deteriorated Paint |

Hazard: Bedroom 2 | Door Casing | Deteriorated Paint

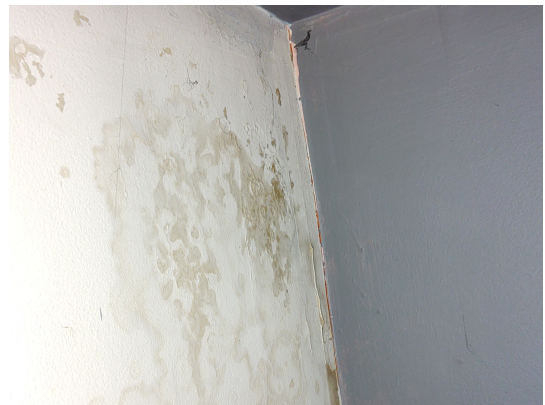
| Room | Component | Hazard |
|---|---|---|
| Bedroom 2 | Ceiling | Deteriorated Paint |

Hazard: Bedroom 2 | Ceiling | Deteriorated Paint

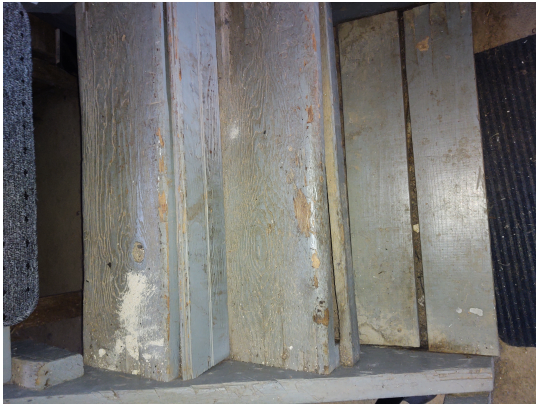
| Room | Component | Hazard |
|---|---|---|
| Basement | Stair Tread | Deteriorated Paint |

Hazard: Basement | Stair Tread | Deteriorated Paint

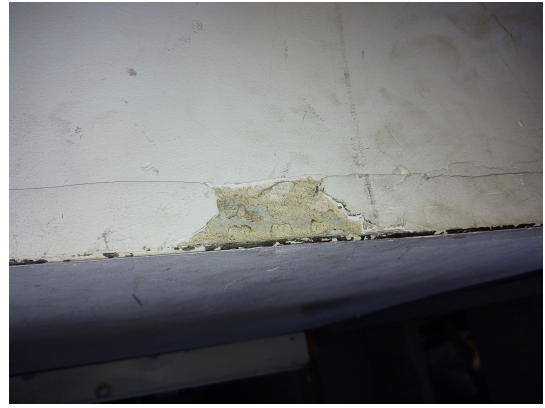
| Room | Component | Hazard |
|---|---|---|
| Basement | Wall | Deteriorated Paint |

Hazard: Basement | Wall | Deteriorated Paint

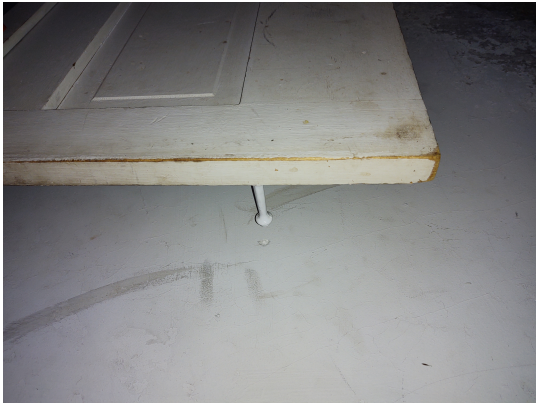
| Room | Component | Hazard |
|---|---|---|
| Basement | Door | Deteriorated Paint |

Hazard: Basement | Door | Deteriorated Paint
