Visual Paint Assessment Report

For 121 Sylvan St Unit:121 Rutherford Borough, NJ 07070
11/23/2024

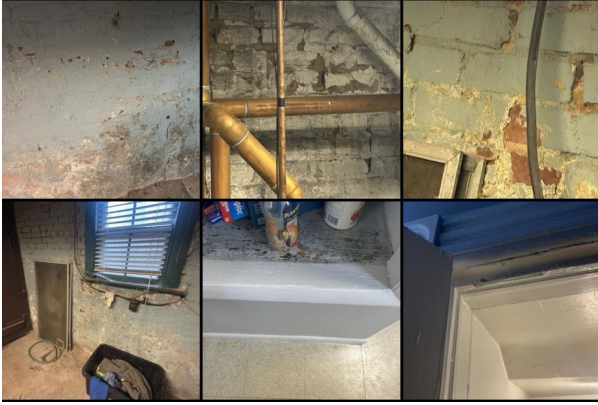
Hazard: Bedroom 2 | Door | Deteriorated Paint

Identified hazards shall be remediated using either abatement (permanent) or interim controls (temporary). Abatement is permanent but has a higher cost, as Interim controls are temporary but can be much more affordable. Abatement shall be performed by a NJ Licensed lead abatement firm using licensed lead abatement supervisors and workers. You can find the list of NJ licensed lead abatement contractors at https://www.nj.gov/dca/divisions/codes/publications/pdf_lead/ld_abat_c.pdf. Interim control work shall be performed by EPA RRP certified firms using an EPA certified RRP Renovator. You can find certified EPA RRP contractors at <https://cdxapps.epa.gov/ocspp-oppt-lead/firm-location-search>. Select RRP Contractor, then NJ, then enter your zip code to search for contractors. After completion of interim control work, a lead-based paint post-remediation with dust wipes will be required. After completion of abatement work, a lead-based paint abatement clearance will be required.

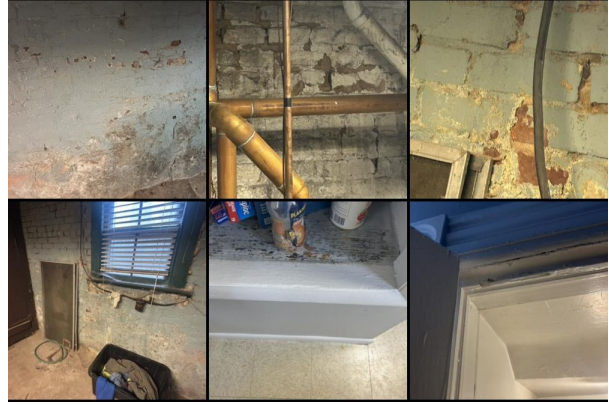
Hazard: Pantry | cabinet | Deteriorated Paint

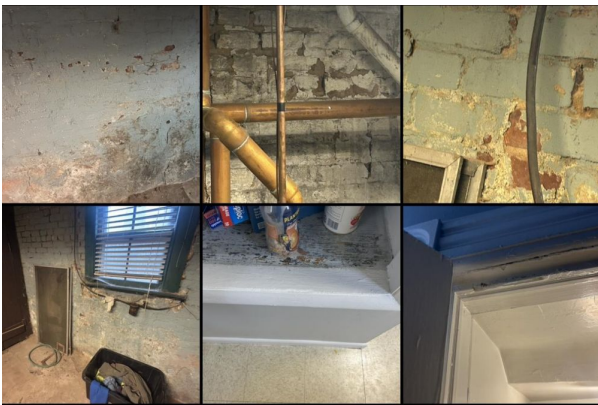
Hazard: basement wall | Wall | Deteriorated Paint
