Visual Paint Assessment Report

For 121 Sylvan St Unit:123 Rutherford Borough, NJ 07070
11/23/2024

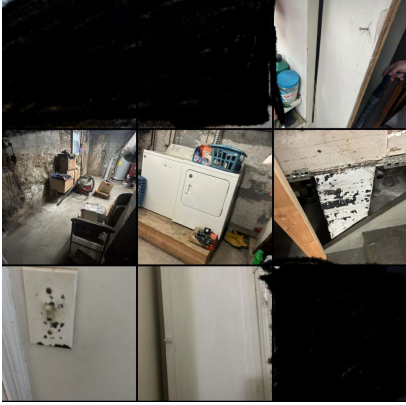
Hazard: Bathroom 1 | closet door | Cracking Paint

Identified hazards shall be remediated using either abatement (permanent) or interim controls (temporary). Abatement is permanent but has a higher cost, as Interim controls are temporary but can be much more affordable. Abatement shall be performed by a NJ Licensed lead abatement firm using licensed lead abatement supervisors and workers. You can find the list of NJ licensed lead abatement contractors at https://www.nj.gov/dca/divisions/codes/publications/pdf_lead/ld_abat_c.pdf. Interim control work shall be performed by EPA RRP certified firms using an EPA certified RRP Renovator. You can find certified EPA RRP contractors at <https://cdxapps.epa.gov/ocspp-oppt-lead/firm-location-search>. Select RRP Contractor, then NJ, then enter your zip code to search for contractors. After completion of interim control work, a lead-based paint post-remediation with dust wipes will be required. After completion of abatement work, a lead-based paint abatement clearance will be required.

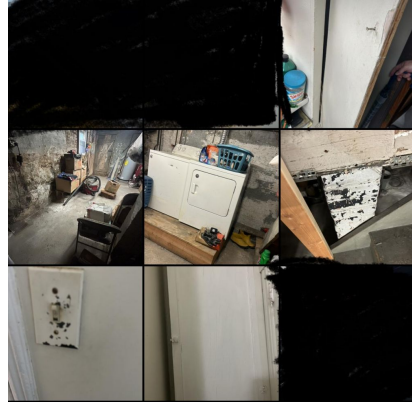
Hazard: bedroom lightswitch | Wall | Deteriorated Paint

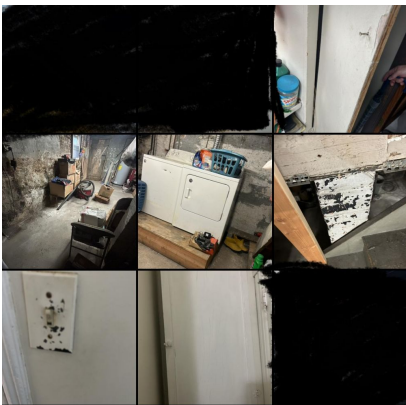
Hazard: Basement | Wall | Deteriorated Paint

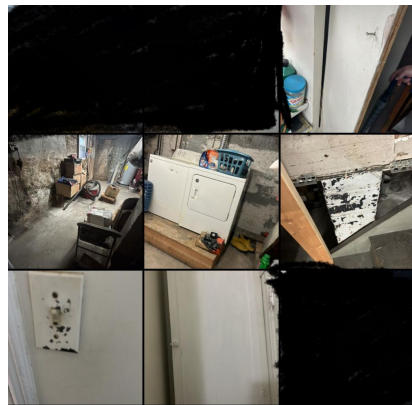
Hazard: Pantry | Door | Cracking Paint
