Visual Paint Assessment Report

For 12 White Deer Plaza Sparta Township, NJ 07871
 06/10/2024

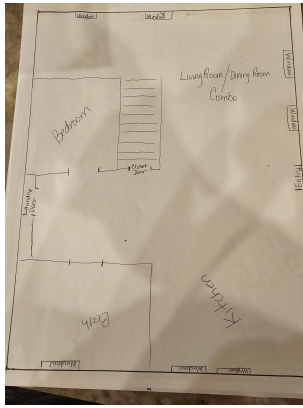
Hazard: Foyer | ceiling | Deteriorated Paint

Identified hazards shall be remediated using either abatement (permanent) or interim controls (temporary). Abatement is permanent but has a higher cost, as Interim controls are temporary but can be much more affordable. Abatement shall be performed by a NJ Licensed lead abatement firm using licensed lead abatement supervisors and workers. You can find the list of NJ licensed lead abatement contractors at https://www.nj.gov/dca/divisions/codes/publications/pdf_lead/ld_abat_c.pdf. Interim control work shall be performed by EPA RRP certified firms using an EPA certified RRP Renovator. You can find certified EPA RRP contractors at <https://cdxappstest.epacdx.net/ocspp-oppt-leadhub/firm-location-search>. Select RRP Contractor, then NJ, then enter your zip code to search for contractors. After completion of interim control work, a lead-based paint post-remediation with dust wipes will be required. After completion of abatement work, a lead-based paint abatement clearance will be required..

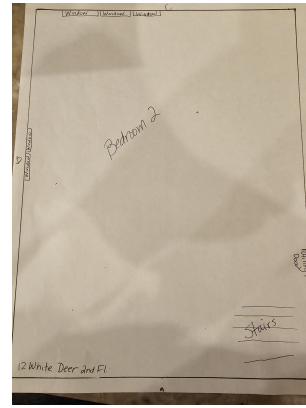
Hazard: Bedroom 2 | ceiling | Deteriorated Paint

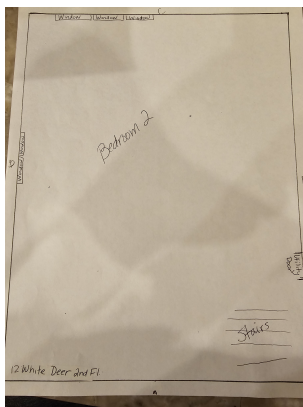
Hazard: Bedroom 2 | Window Sill | Dust
