## Visual Paint Assessment Report

For 147A West Main St Freehold Borough, NJ 07728  
06/10/2024

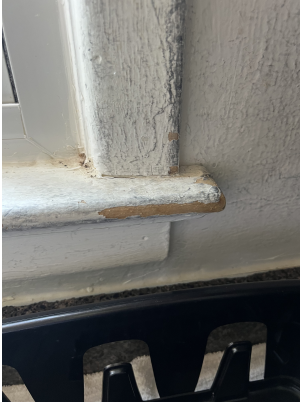
Hazard: Kitchen | Window Sill | Deteriorated Paint

Identified hazards shall be remediated using either abatement (permanent) or interim controls (temporary). Abatement is permanent but has a higher cost, as Interim controls are temporary but can be much more affordable. Abatement shall be performed by a NJ Licensed lead abatement firm using licensed lead abatement supervisors and workers. You can find the list of NJ licensed lead abatement contractors at [https://www.nj.gov/dca/divisions/codes/publications/pdf\\_lead/ld\\_abat\\_c.pdf](https://www.nj.gov/dca/divisions/codes/publications/pdf_lead/ld_abat_c.pdf). Interim control work shall be performed by EPA RRP certified firms using an EPA certified RRP Renovator. You can find certified EPA RRP contractors at <https://cdxappstest.epacdx.net/ocspp-oppt-leadhub/firm-location-search>. Select RRP Contractor, then NJ, then enter your zip code to search for contractors. After completion of interim control work, a lead-based paint post-remediation with dust wipes will be required. After completion of abatement work, a lead-based paint abatement clearance will be required..

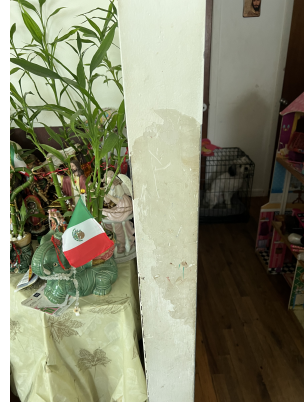
Hazard: Living Room | Wall | Deteriorated Paint

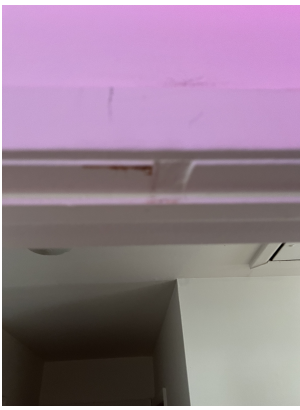
Hazard: Bedroom 1 | Door Casing | Deteriorated Paint

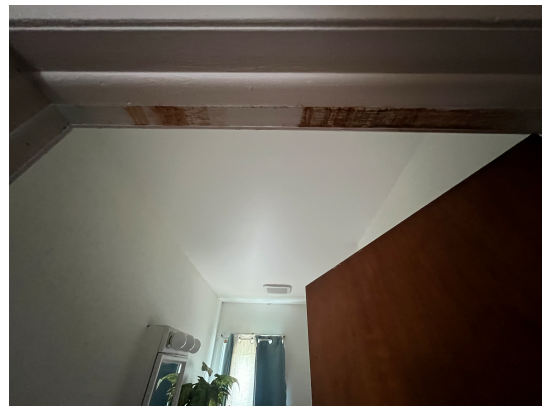
Hazard: Bathroom 1 | Door Casing | Deteriorated Paint

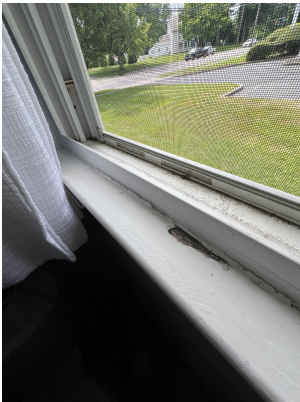
Hazard: Bathroom 1 | Window Sill | Deteriorated Paint
