Visual Paint Assessment Report

For 14 Lincoln Place Freehold Borough, NJ 07728
 06/10/2024

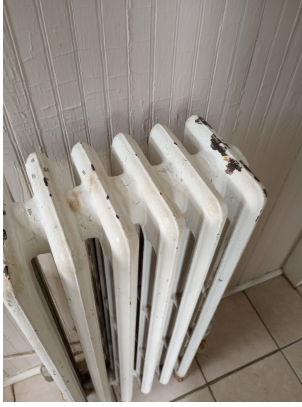
Hazard: Bath | Radiator | Deteriorated Paint

Identified hazards shall be remediated using either abatement (permanent) or interim controls (temporary). Abatement is permanent but has a higher cost, as Interim controls are temporary but can be much more affordable. Abatement shall be performed by a NJ Licensed lead abatement firm using licensed lead abatement supervisors and workers. You can find the list of NJ licensed lead abatement contractors at https://www.nj.gov/dca/divisions/codes/publications/pdf_lead/ld_abat_c.pdf. Interim control work shall be performed by EPA RRP certified firms using an EPA certified RRP Renovator. You can find certified EPA RRP contractors at <https://cdxappstest.epacdx.net/ocspp-oppt-leadhub/firm-location-search>. Select RRP Contractor, then NJ, then enter your zip code to search for contractors. After completion of interim control work, a lead-based paint post-remediation with dust wipes will be required. After completion of abatement work, a lead-based paint abatement clearance will be required..

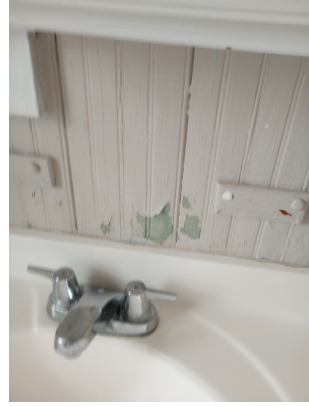
Hazard: Bath | Wall | Deteriorated Paint

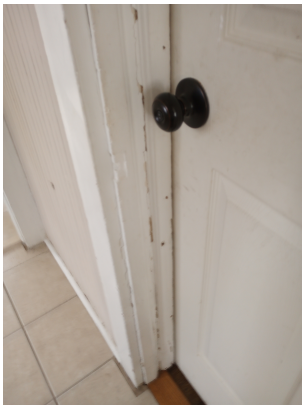
Hazard: Hallway | Door Jamb and Casing | Deteriorated
Paint
