## Visual Paint Assessment Report

For 14 Lincoln Place Freehold Borough, NJ 07728  
 06/10/2024

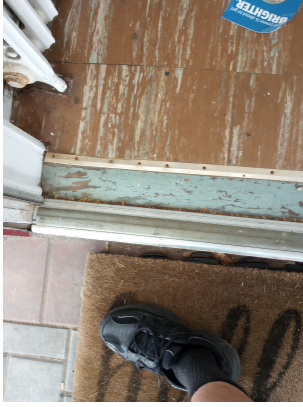
Hazard: Stairhall | Threshold | Deteriorated Paint

Identified hazards shall be remediated using either abatement (permanent) or interim controls (temporary). Abatement is permanent but has a higher cost, as Interim controls are temporary but can be much more affordable. Abatement shall be performed by a NJ Licensed lead abatement firm using licensed lead abatement supervisors and workers. You can find the list of NJ licensed lead abatement contractors at [https://www.nj.gov/dca/divisions/codes/publications/pdf\\_lead/ld\\_abat\\_c.pdf](https://www.nj.gov/dca/divisions/codes/publications/pdf_lead/ld_abat_c.pdf). Interim control work shall be performed by EPA RRP certified firms using an EPA certified RRP Renovator. You can find certified EPA RRP contractors at <https://cdxappstest.epacdx.net/ocspp-oppt-leadhub/firm-location-search>. Select RRP Contractor, then NJ, then enter your zip code to search for contractors. After completion of interim control work, a lead-based paint post-remediation with dust wipes will be required. After completion of abatement work, a lead-based paint abatement clearance will be required..

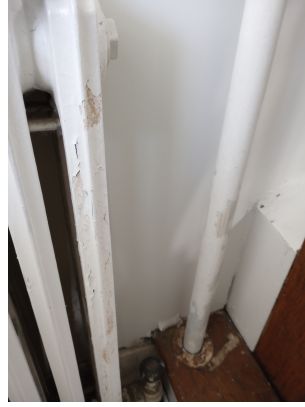
Hazard: Stairhall | pipe and radiator | Deteriorated Paint

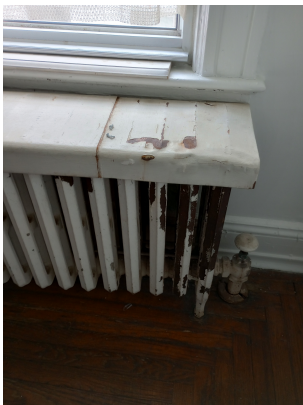
Hazard: Living Room | Radiator | Deteriorated Paint

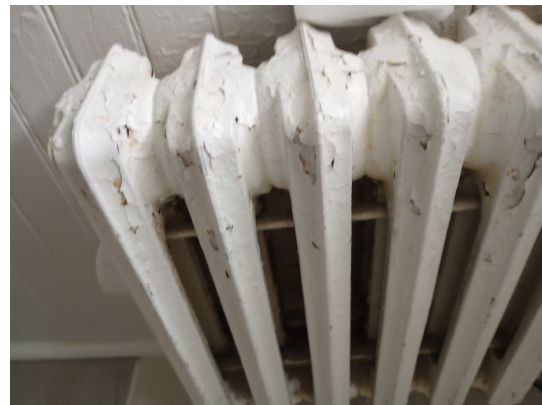
Hazard: Bathroom | Radiator | Deteriorated Paint
