Visual Paint Assessment Report

For 158 Wilson st Boonton Town, NJ 07005
06/10/2024

Site: 158 Wilson st. unit A, Burlington, NJ

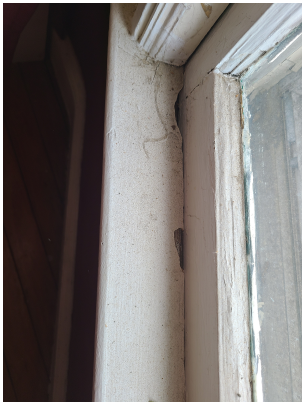
Hazard: Living Room | Window Sill |
Deteriorated Paint

Identified hazards shall be remediated using either abatement (permanent) or interim controls (temporary). Abatement is permanent but has a higher cost, as Interim controls are temporary but can be much more affordable. Abatement shall be performed by a NJ Licensed lead abatement firm using licensed lead abatement supervisors and workers. You can find the list of NJ licensed lead abatement contractors at https://www.nj.gov/dca/divisions/codes/publications/pdf_lead/ld_abat_c.pdf. Interim control work shall be performed by EPA RRP certified firms using an EPA certified RRP Renovator. You can find certified EPA RRP contractors at <https://cdxappstest.epacdx.net/ocspp-oppt-leadhub/firm-location-search>. Select RRP Contractor, then NJ, then enter your zip code to search for contractors. After completion of interim control work, a lead-based paint post-remediation with dust wipes will be required. After completion of abatement work, a lead-based paint abatement clearance will be required..

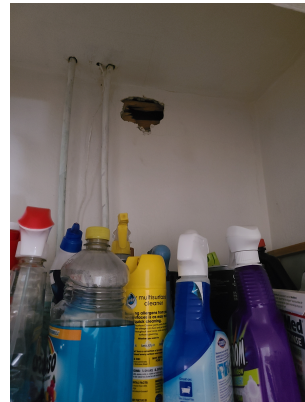
Hazard: Hall | Closet Wall | Deteriorated Paint

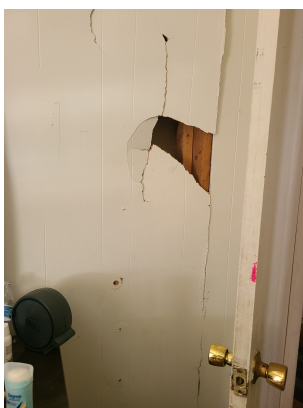
Hazard: Bedroom 2 | Wall C | Deteriorated Paint

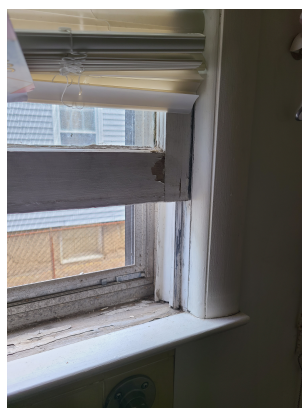
Hazard: Kitchen | Window Sill and Sash | Deteriorated Paint

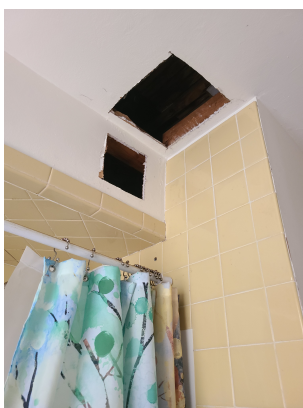
Hazard: Bathroom | Wall and Ceiling | Deteriorated Paint

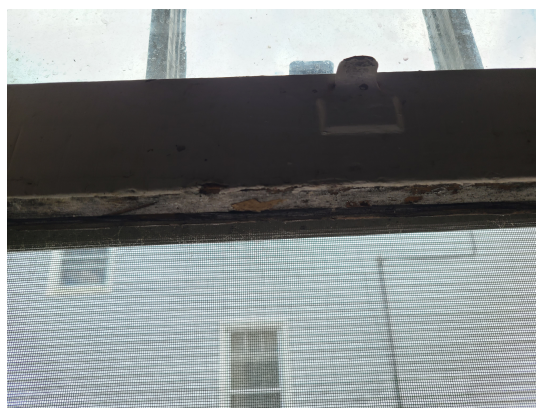
Hazard: Bathroom | Window Sash | Deteriorated Paint
