Visual Paint Assessment Report

For 17 Factory Street Freehold Borough, NJ 07728
04/18/2024

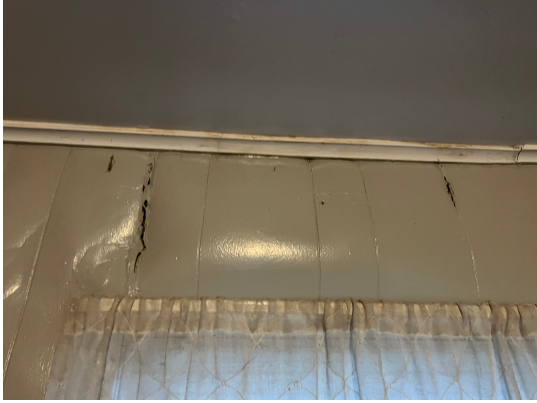
Hazard: Living Room | Wall | Deteriorated Paint

Identified hazards shall be remediated using either abatement (permanent) or interim controls (temporary). Abatement is permanent but has a higher cost, as Interim controls are temporary but can be much more affordable. Abatement shall be performed by a NJ Licensed lead abatement firm using licensed lead abatement supervisors and workers. You can find the list of NJ licensed lead abatement contractors at https://www.nj.gov/dca/divisions/codes/publications/pdf_lead/ld_abat_c.pdf. Interim control work shall be performed by EPA RRP certified firms using an EPA certified RRP Renovator. You can find certified EPA RRP contractors at <https://cdxappstest.epacdx.net/ocspp-oppt-leadhub/firm-location-search>. Select RRP Contractor, then NJ, then enter your zip code to search for contractors. After completion of interim control work, a lead-based paint post-remediation with dust wipes will be required. After completion of abatement work, a lead-based paint abatement clearance will be required..

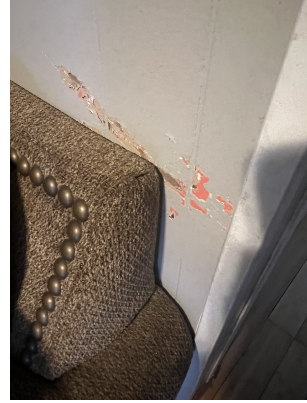
Hazard: Living Room | Wall | Deteriorated Paint
