Visual Paint Assessment Report

For 181 Jacoby Street Maplewood Township, NJ 07040
 07/01/2024

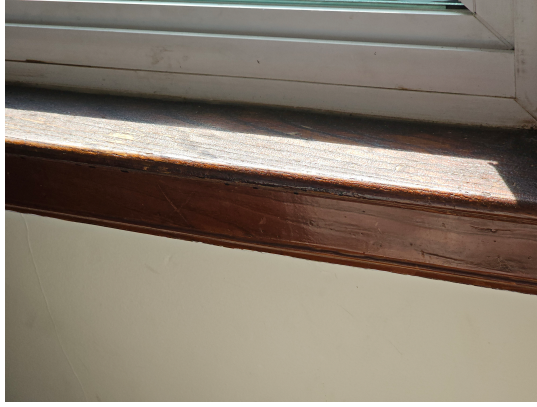
Hazard: All Rooms | Window sills | Dust

Identified hazards shall be remediated using either abatement (permanent) or interim controls (temporary). Abatement is permanent but has a higher cost, as Interim controls are temporary but can be much more affordable. Abatement shall be performed by a NJ Licensed lead abatement firm using licensed lead abatement supervisors and workers. You can find the list of NJ licensed lead abatement contractors at https://www.nj.gov/dca/divisions/codes/publications/pdf_lead/ld_abat_c.pdf. Interim control work shall be performed by EPA RRP certified firms using an EPA certified RRP Renovator. You can find certified EPA RRP contractors at <https://cdxappstest.epacdx.net/ocspp-oppt-leadhub/firm-location-search>. Select RRP Contractor, then NJ, then enter your zip code to search for contractors. After completion of interim control work, a lead-based paint post-remediation with dust wipes will be required. After completion of abatement work, a lead-based paint abatement clearance will be required..

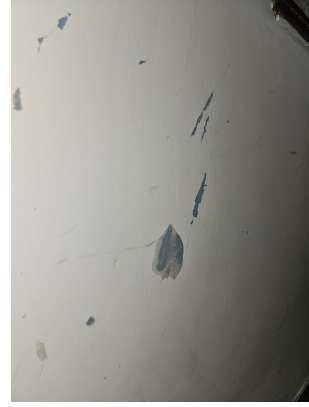
Hazard: Foyer/Hall | Wall | Deteriorated Paint

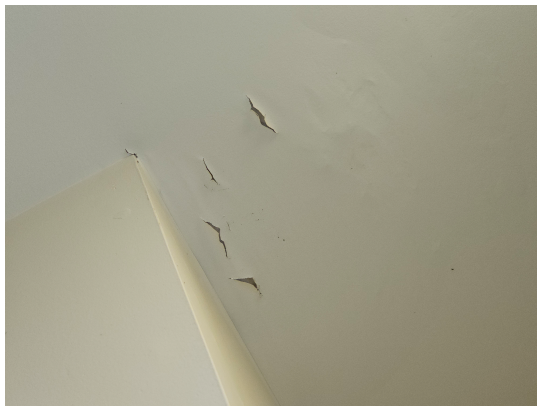
Hazard: Foyer/Hall | Ceiling | Deteriorated Paint
