Lead Dust Wipe Report

For 207 Donaldson Ave Unit:2 Rutherford Borough, NJ 07070
12/29/2024

Visual Paint Assessment Report

For 207 Donaldson Avenue Unit:FL 2 Rutherford Borough, NJ 07070
 10/25/2024

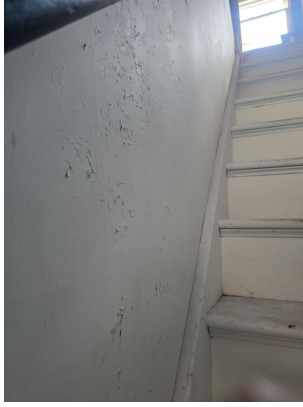
Hazard: Attic Stairwell | Wall | Deteriorated Paint

Identified hazards shall be remediated using either abatement (permanent) or interim controls (temporary). Abatement is permanent but has a higher cost, as Interim controls are temporary but can be much more affordable. Abatement shall be performed by a NJ Licensed lead abatement firm using licensed lead abatement supervisors and workers. You can find the list of NJ licensed lead abatement contractors at https://www.nj.gov/dca/divisions/codes/publications/pdf_lead/ld_abat_c.pdf. Interim control work shall be performed by EPA RRP certified firms using an EPA certified RRP Renovator. You can find certified EPA RRP contractors at <https://cdxapps.epa.gov/ocspp-oppt-lead/firm-location-search>. Select RRP Contractor, then NJ, then enter your zip code to search for contractors. After completion of interim control work, a lead-based paint post-remediation with dust wipes will be required. After completion of abatement work, a lead-based paint abatement clearance will be required..

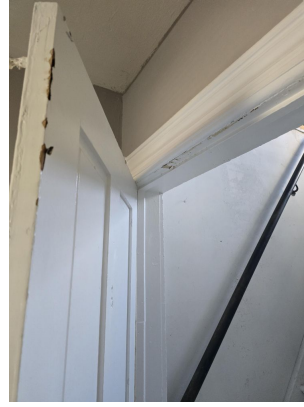
Hazard: Attic Stairwell | Door Components | Deteriorated Paint

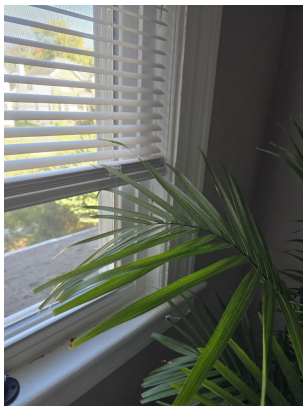
Hazard: Living Room | Window Components | Deteriorated Paint

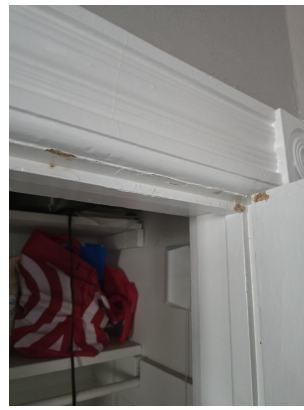
Hazard: Living Room | Closet Door Components | Deteriorated Paint

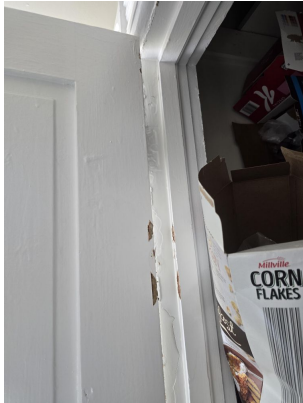
Hazard: Kitchen | Closet Door Components | Deteriorated Paint

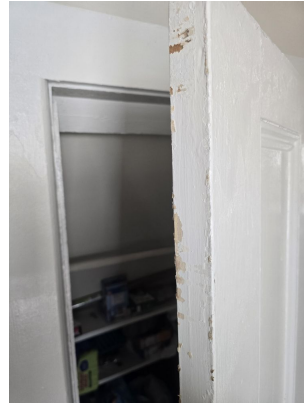
Hazard: Foyer/Hall | Closet Door Components | Deteriorated Paint

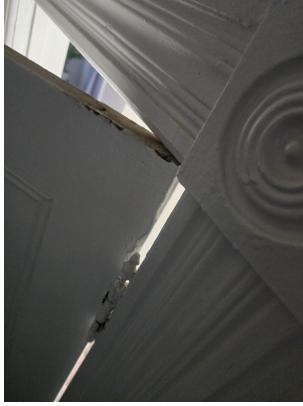
Hazard: Bedroom | Door Components |
Deteriorated Paint
