## Visual Paint Assessment Report

For 21 Palmer Street Roxbury Township, NJ 07850  
 06/08/2024

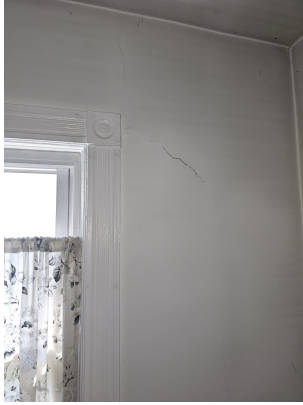
Hazard: Kitchen | Wall | Deteriorated Paint

Identified hazards shall be remediated using either abatement (permanent) or interim controls (temporary). Abatement is permanent but has a higher cost, as Interim controls are temporary but can be much more affordable. Abatement shall be performed by a NJ Licensed lead abatement firm using licensed lead abatement supervisors and workers. You can find the list of NJ licensed lead abatement contractors at [https://www.nj.gov/dca/divisions/codes/publications/pdf\\_lead/ld\\_abat\\_c.pdf](https://www.nj.gov/dca/divisions/codes/publications/pdf_lead/ld_abat_c.pdf). Interim control work shall be performed by EPA RRP certified firms using an EPA certified RRP Renovator. You can find certified EPA RRP contractors at <https://cdxappstest.epacdx.net/ocspp-oppt-leadhub/firm-location-search>. Select RRP Contractor, then NJ, then enter your zip code to search for contractors. After completion of interim control work, a lead-based paint post-remediation with dust wipes will be required. After completion of abatement work, a lead-based paint abatement clearance will be required..

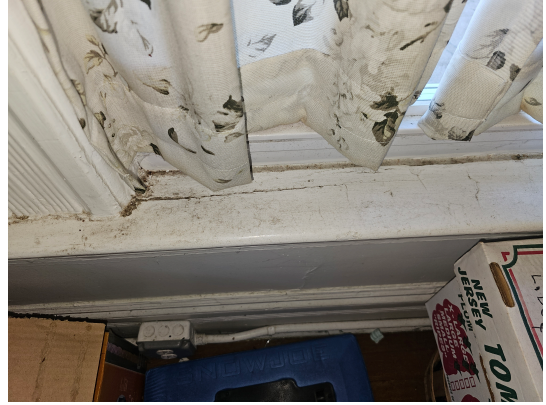
Hazard: Kitchen | Window Sill | Dust

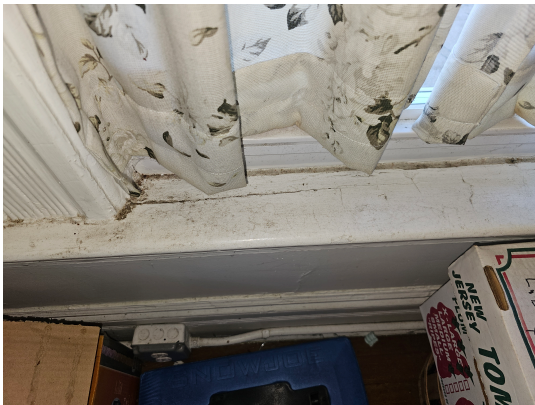
Hazard: Kitchen | Window Sill | Deteriorated Paint

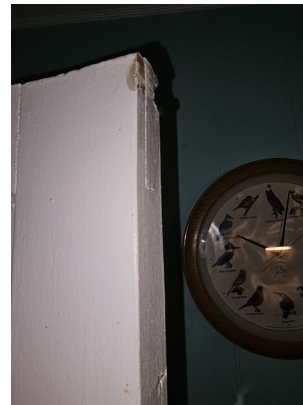
Hazard: Foyer | Door | Deteriorated Paint

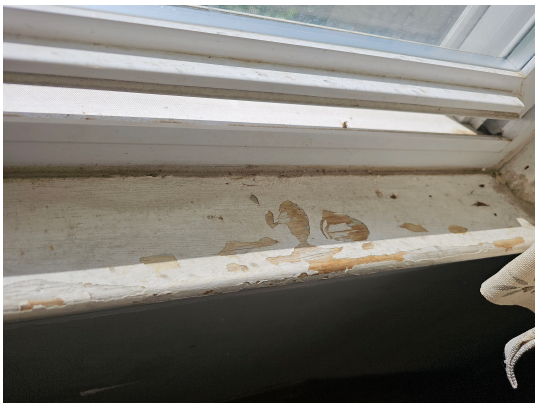
Hazard: Foyer | Window Sill | Deteriorated Paint
