Visual Paint Assessment Report

For 25 Canal St Roxbury Township, NJ 07852
06/07/2024

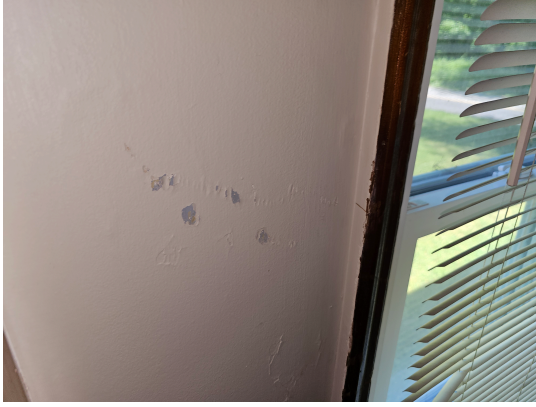
Hazard: Living Room | Wall | Deteriorated Paint

Identified hazards shall be remediated using either abatement (permanent) or interim controls (temporary). Abatement is permanent but has a higher cost, as Interim controls are temporary but can be much more affordable. Abatement shall be performed by a NJ Licensed lead abatement firm using licensed lead abatement supervisors and workers. You can find the list of NJ licensed lead abatement contractors at https://www.nj.gov/dca/divisions/codes/publications/pdf_lead/ld_abat_c.pdf. Interim control work shall be performed by EPA RRP certified firms using an EPA certified RRP Renovator. You can find certified EPA RRP contractors at <https://cdxappstest.epacdx.net/ocspp-oppt-leadhub/firm-location-search>. Select RRP Contractor, then NJ, then enter your zip code to search for contractors. After completion of interim control work, a lead-based paint post-remediation with dust wipes will be required. After completion of abatement work, a lead-based paint abatement clearance will be required..

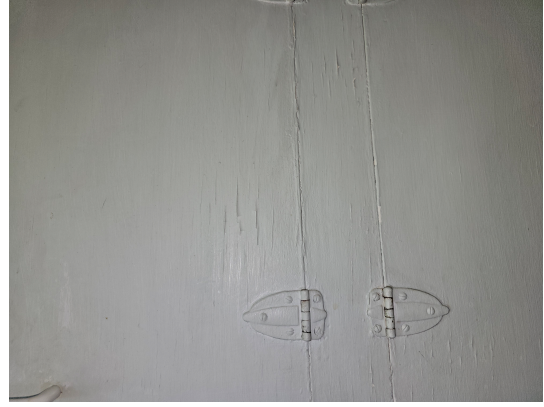
Hazard: Kitchen | upper cabinets | Deteriorated Paint

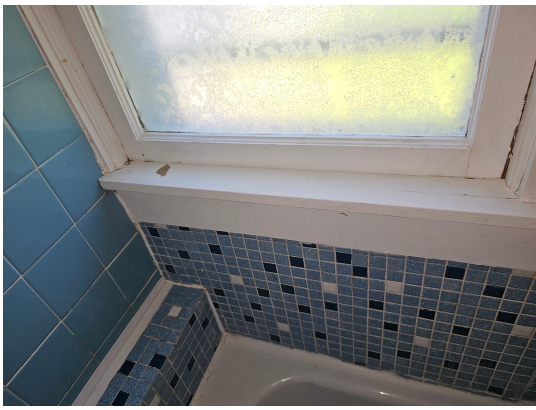
Hazard: Bathroom 1 | Window Sill | Deteriorated Paint

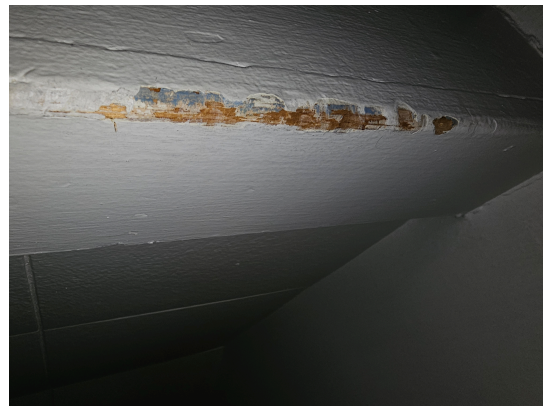
Hazard: Foyer | Baseboard | Deteriorated Paint
