Visual Paint Assessment Report

For: 806 Eves Dr, Apt 2-S, Hillsborough, NJ 08844
March 10, 2024

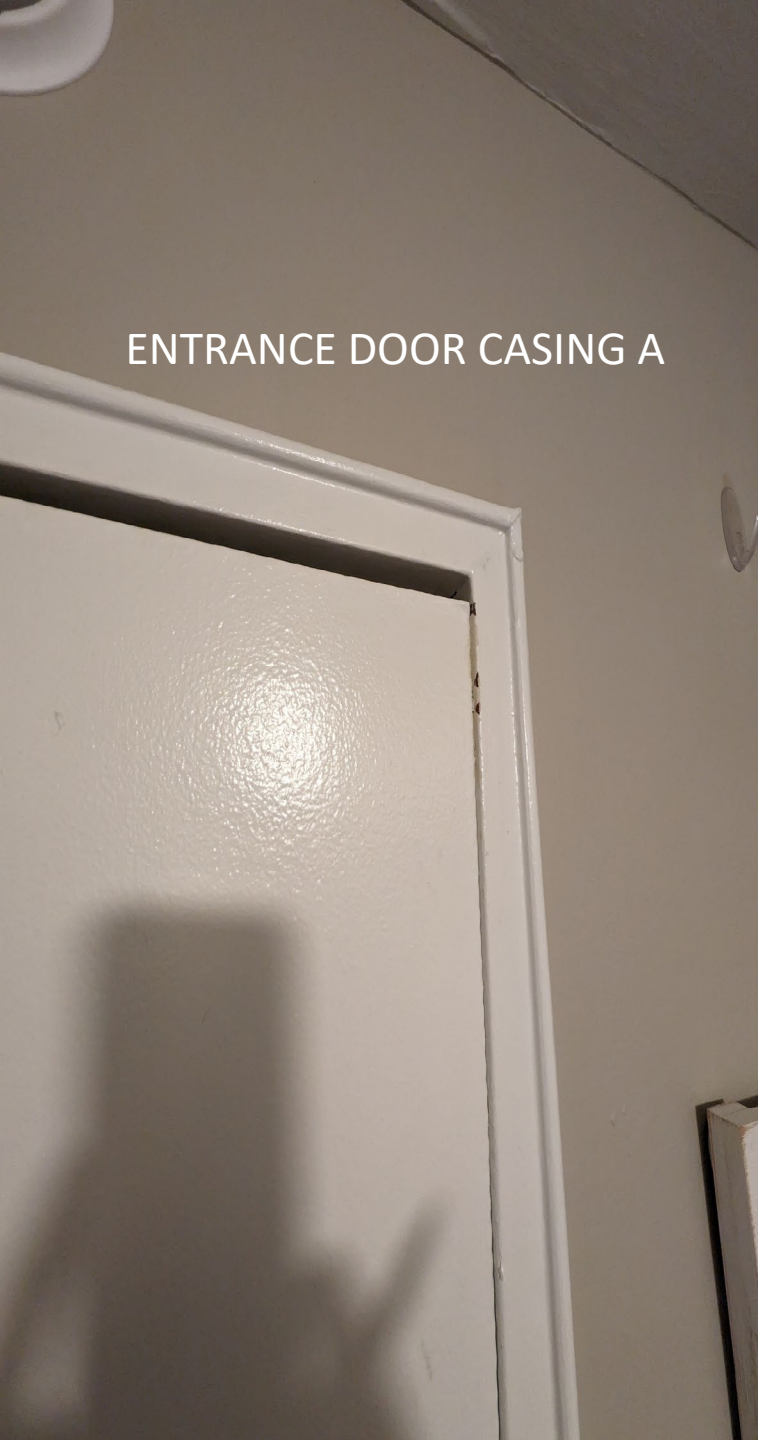
ENTRANCE DOOR CASING A

Room	Component	Hazard
Foyer	Entrance Door Casing A	Deteriorated Paint
Foyer	Closet Door B	Deteriorated Paint
Foyer	Closet Head Jamb B	Deteriorated Paint
Foyer	Closet Head Jamb D	Deteriorated Paint
Bathroom	Head Jamb B	Deteriorated Paint
Foyer	Bedroom Door Casing B	Deteriorated Paint
Bedroom Closet	Ceiling	Deteriorated Paint
Bedroom	Door Jamb D	Deteriorated Paint
Bedroom	Window Jamb B (drywall corner)	Deteriorated Paint
Bedroom	Closet Head Jamb C	Deteriorated Paint
Bedroom	AC Metal Sleeve B	Deteriorated Paint
Living Room	Wall A (Behind Couch)	Deteriorated Paint

Identified hazards shall be remediated using either abatement (permanent) or interim controls (temporary). Abatement shall be performed by a NJ Licensed lead abatement firm using licensed lead abatement supervisors and workers. Interim control work shall be performed by EPA RRP certified firms using an EPA certified RRP Renovator. After completion of interim control work, a lead-based paint post-remediation with dust wipes will be required. After completion of abatement work, a lead-based paint abatement clearance will be required.
