LEAD-BASED PAINT EVALUATION REPORT DWELLING UNIT(S) INSPECTION

11 W. Central Ave Unit 2
Wharton, NJ 07885

Inspection Date: 03/07/24
Project Number: 1409

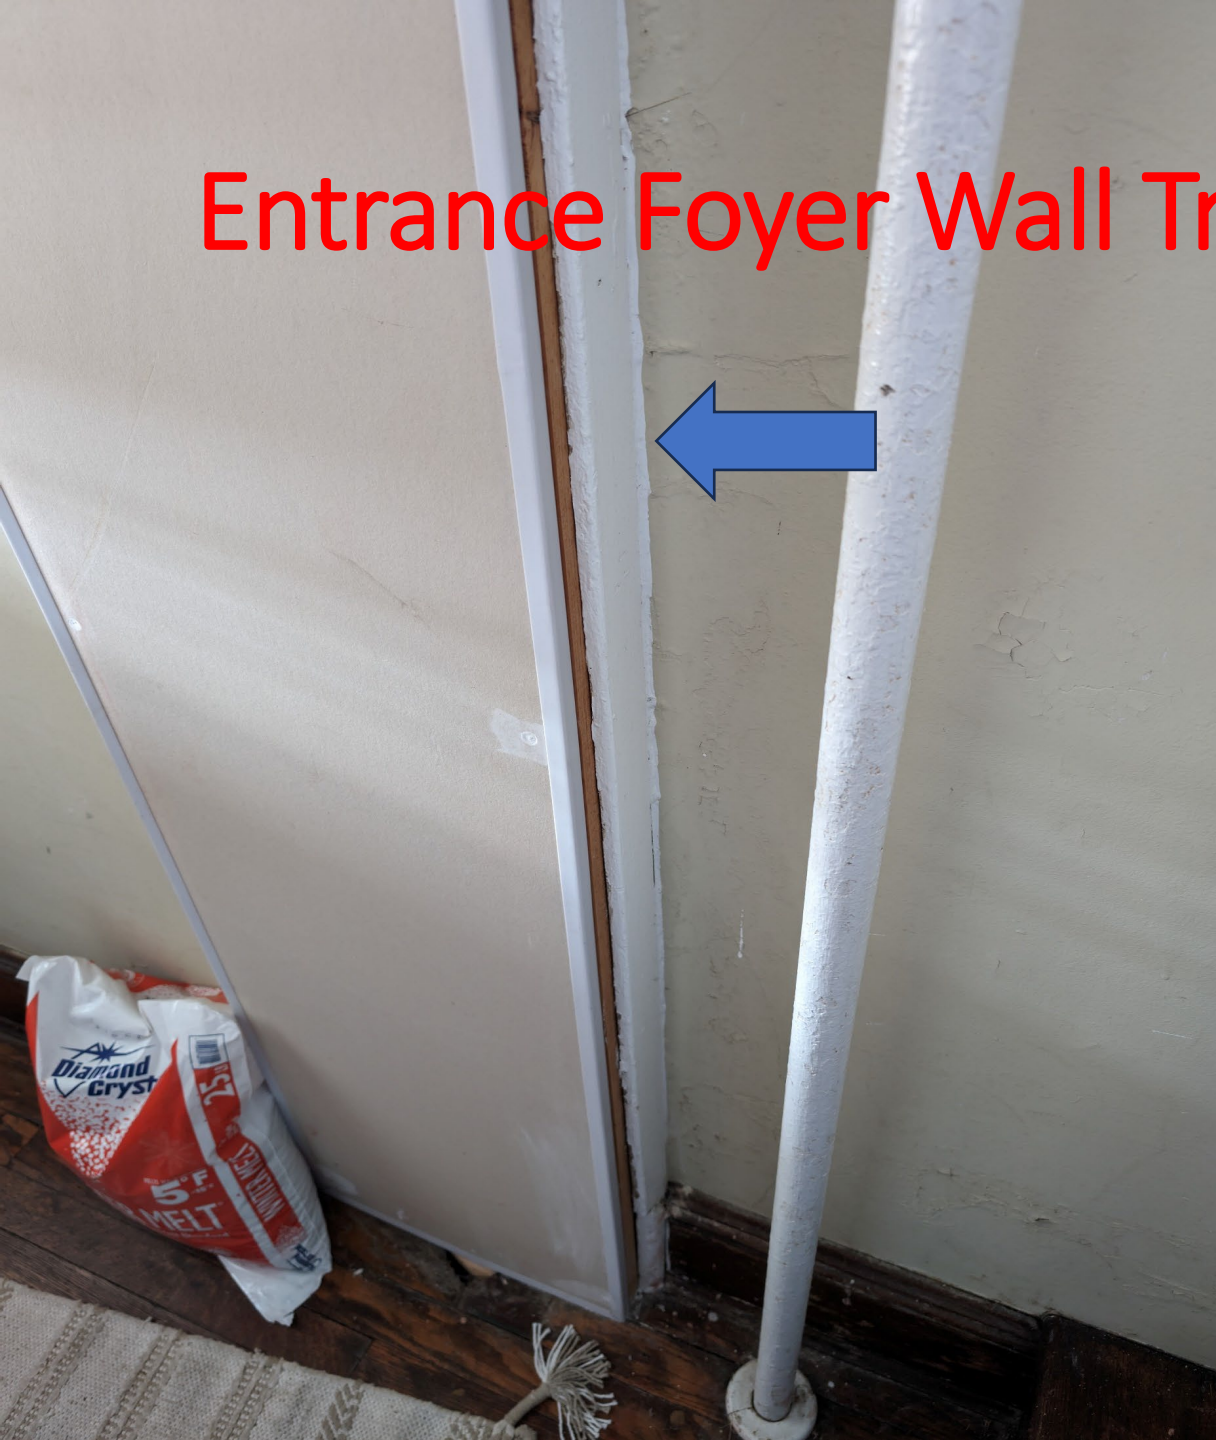
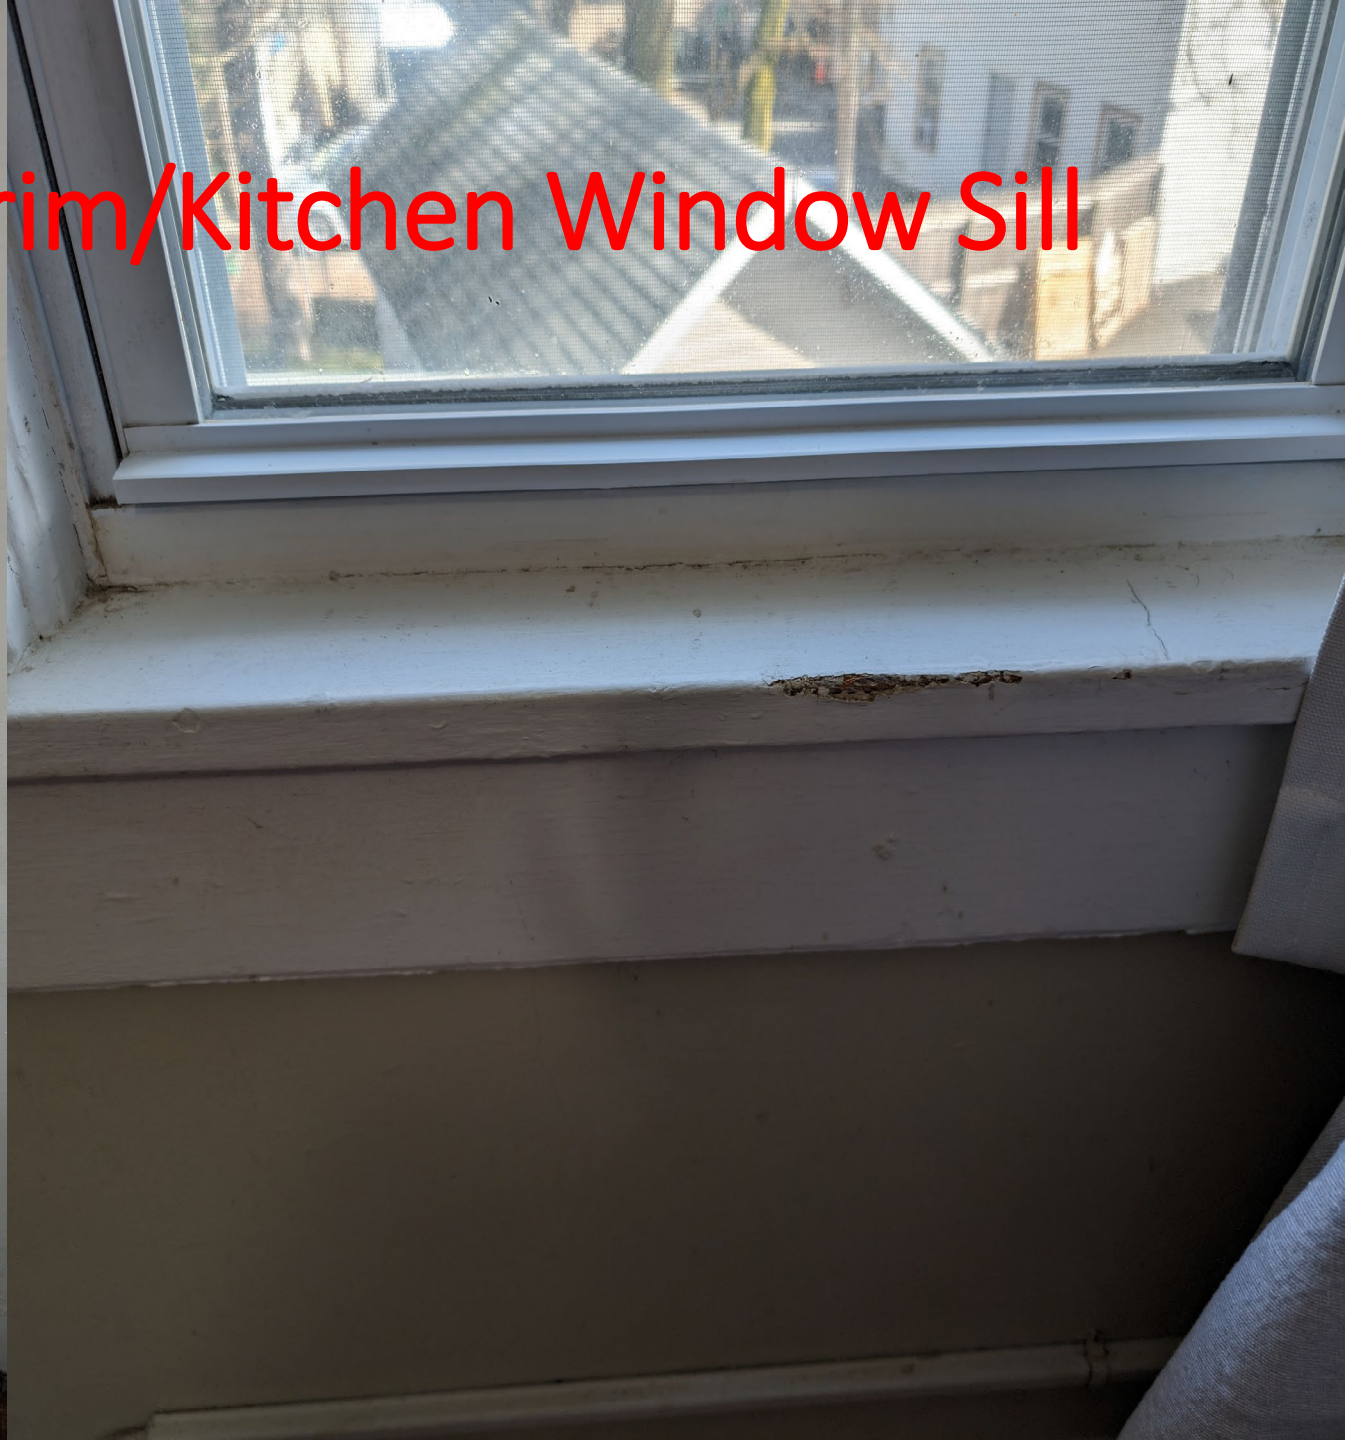
Entrance Foyer Wall Trim/Kitchen Window Sill

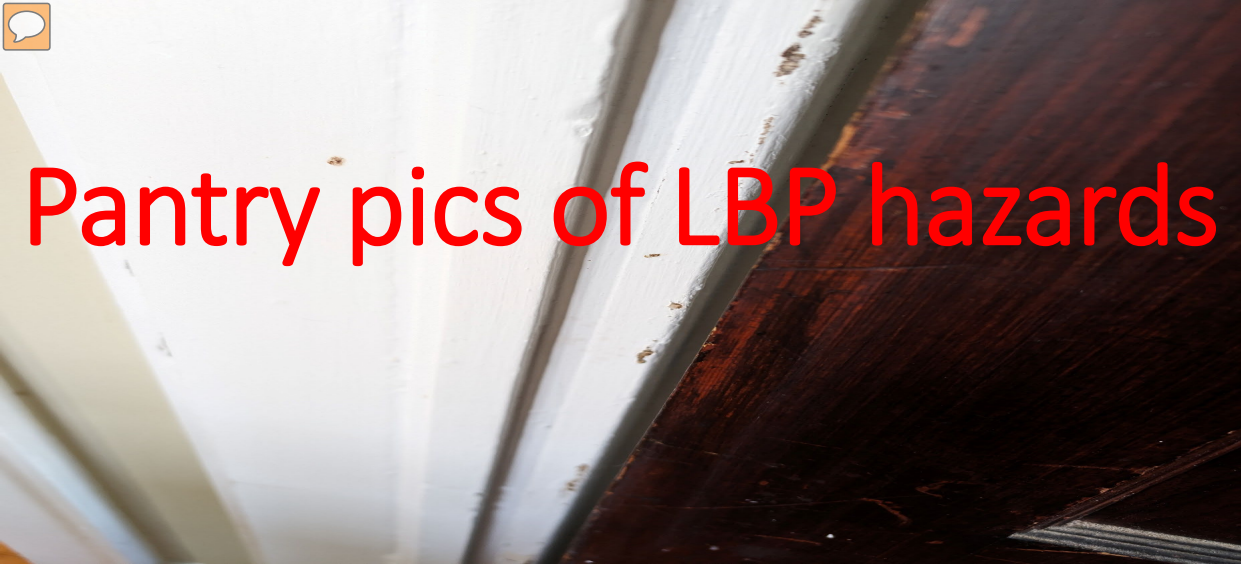
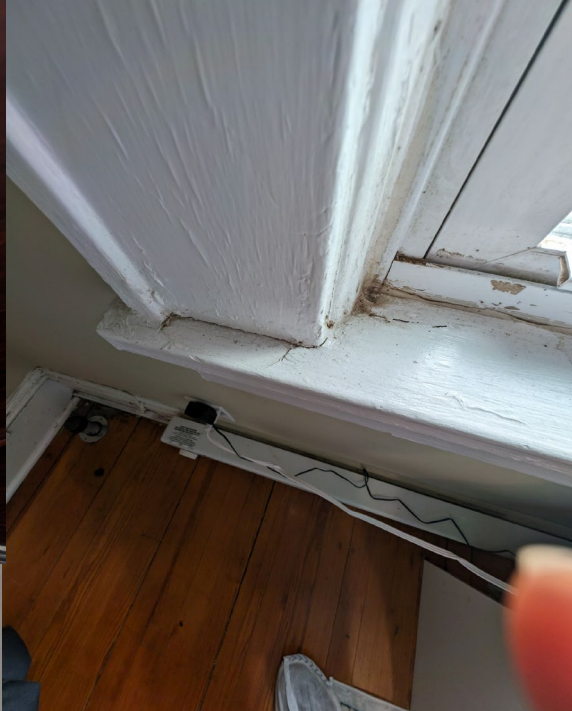
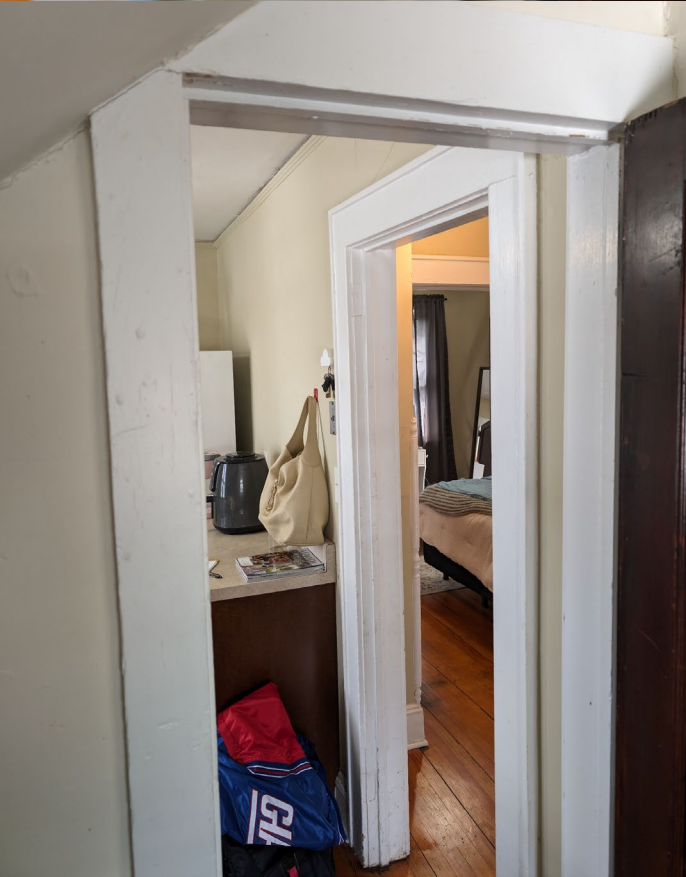
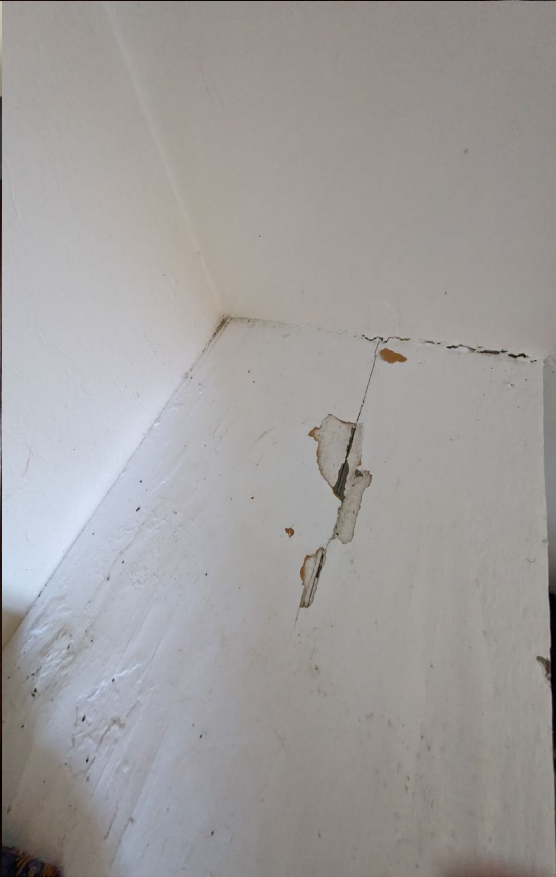
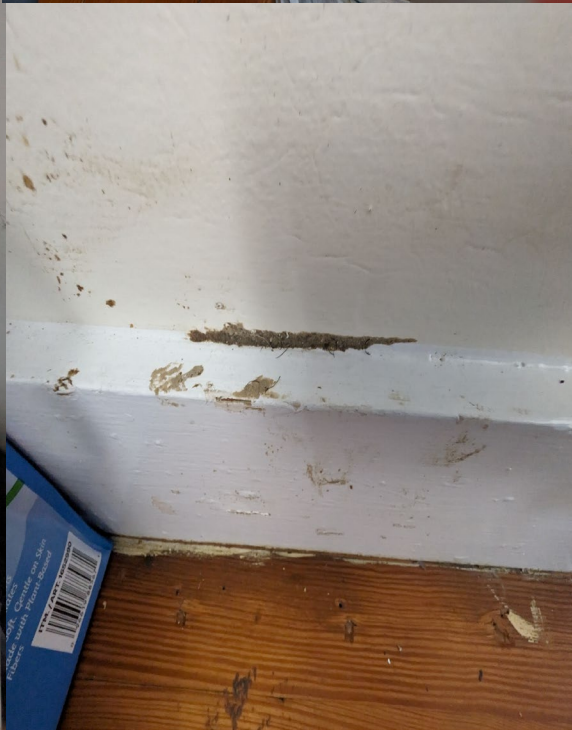
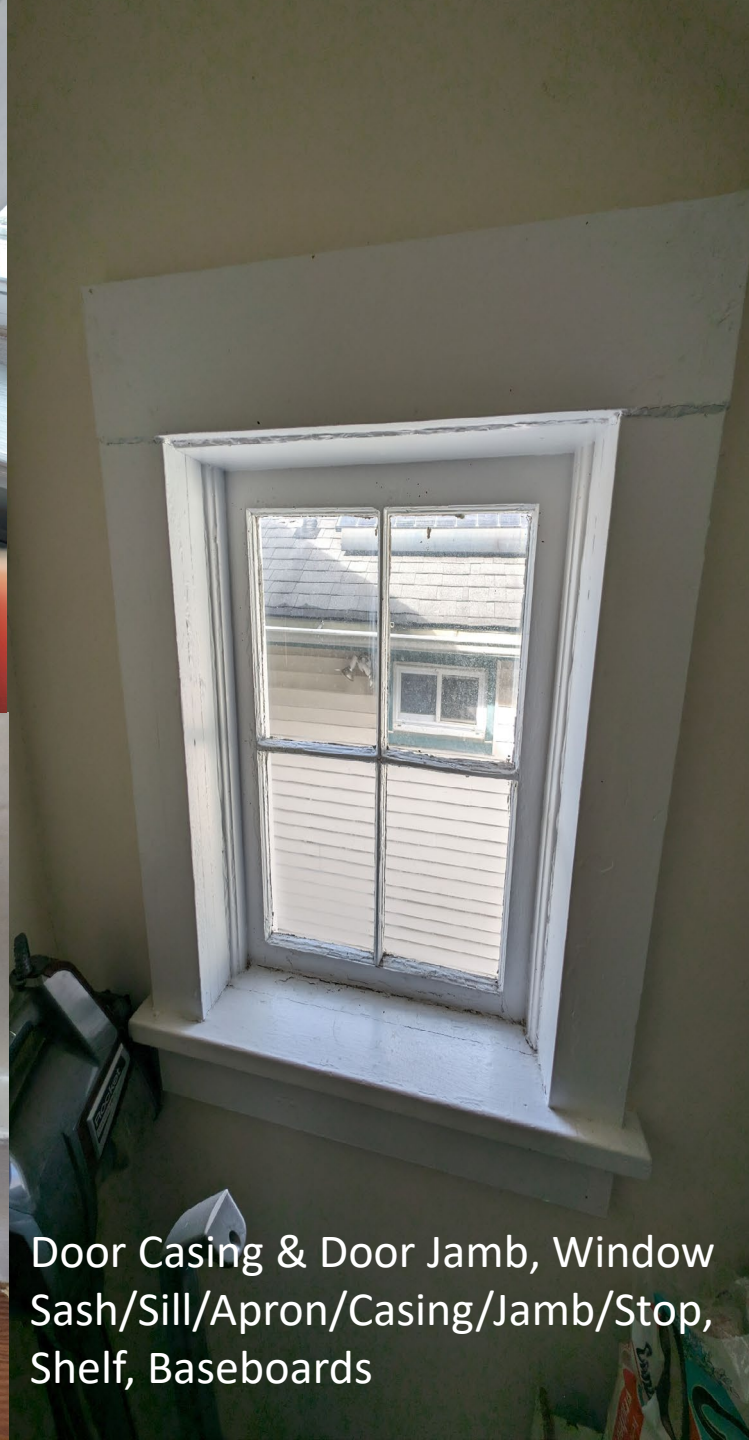
Pantry pics of LBP hazards

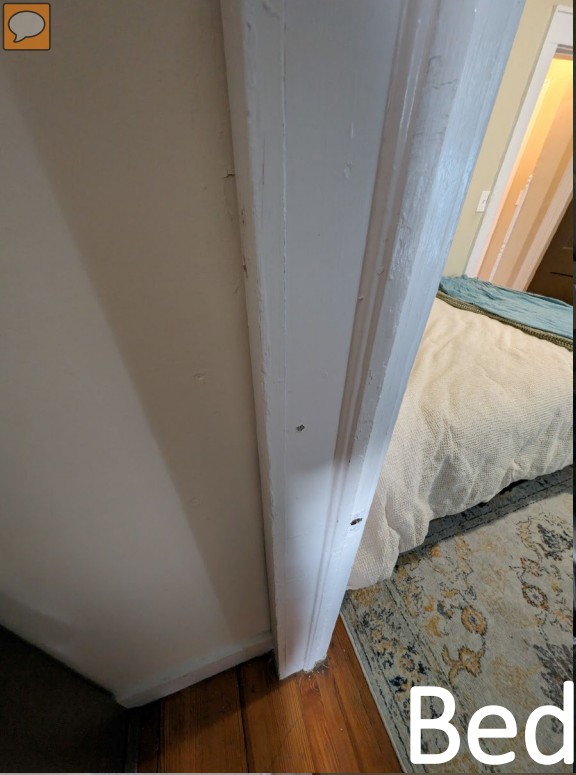
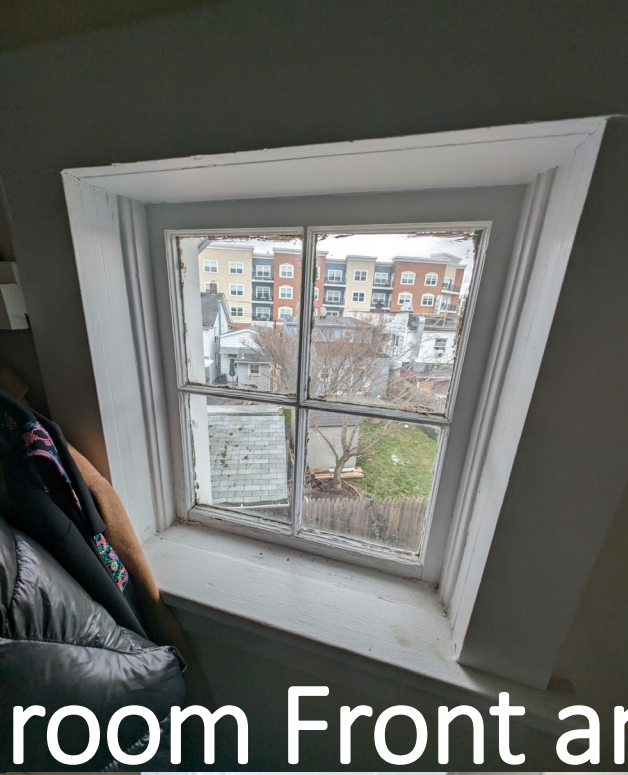
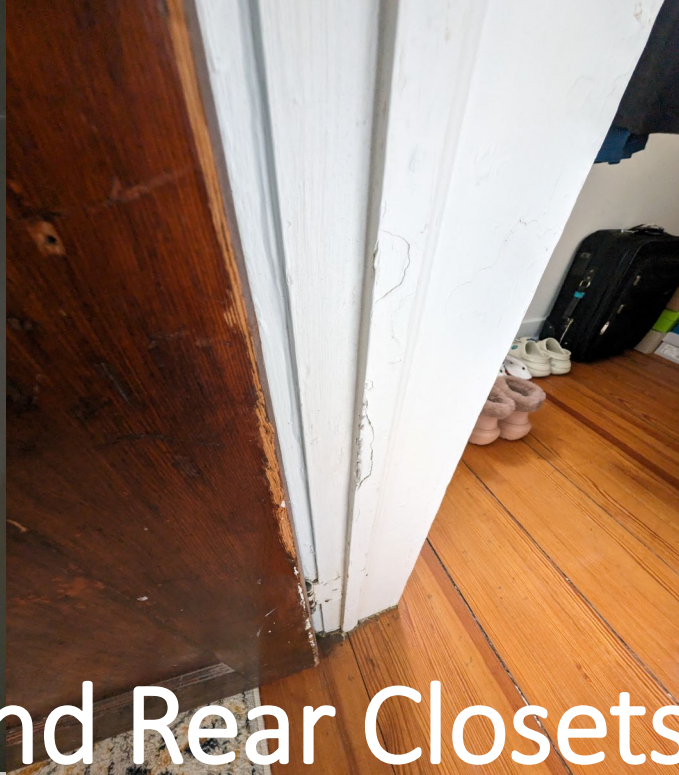
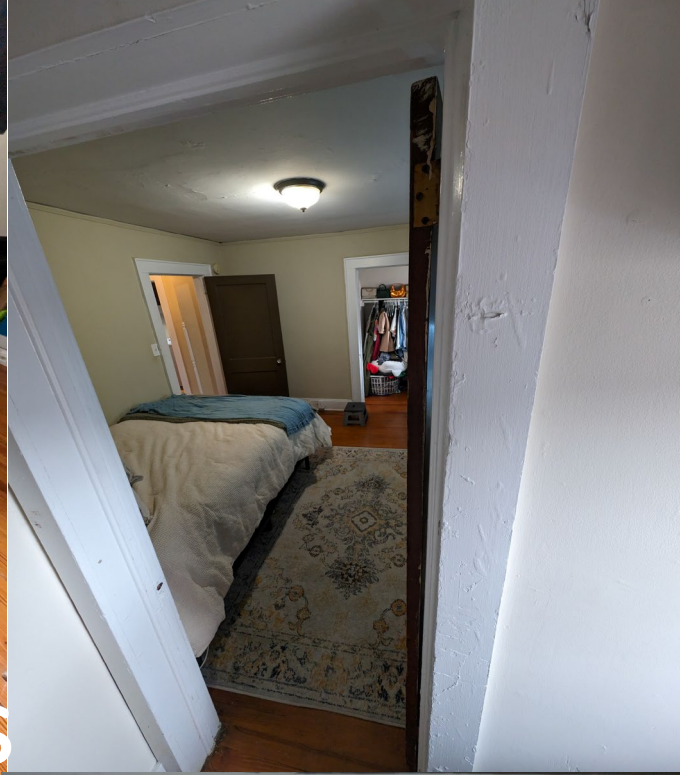
Door Casing & Door Jamb, Window Sash/Sill/Apron/Casing/Jamb/Stop, Shelf, Baseboards

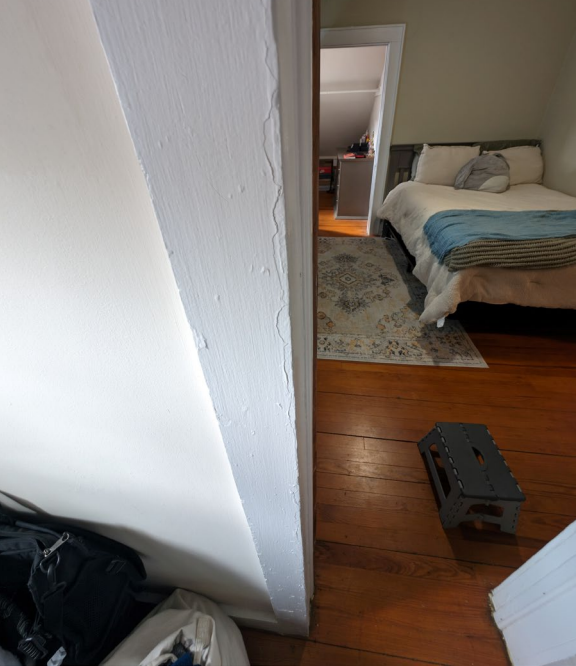
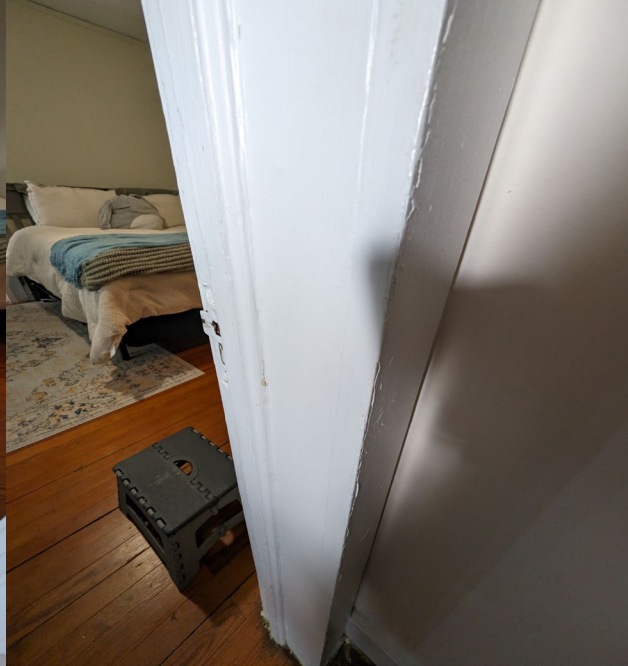
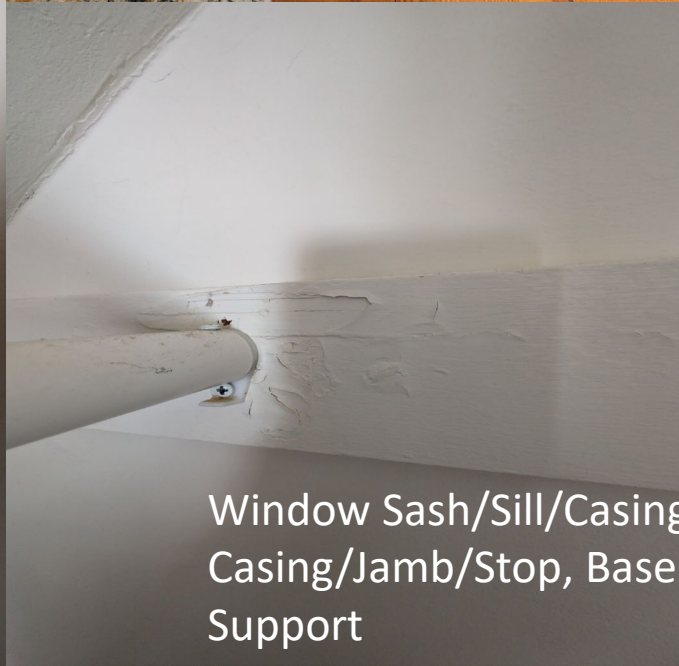
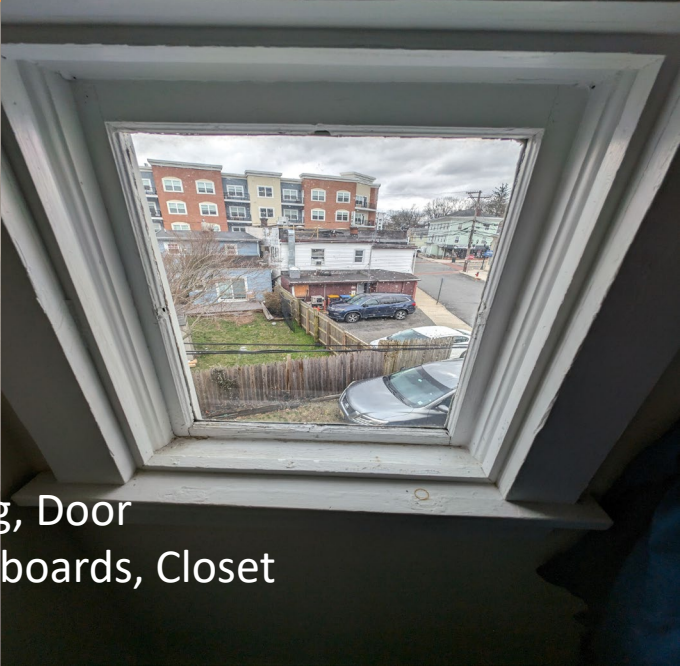
Bedroom Front and Rear Closets

Window Sash/Sill/Casing, Door Casing/Jamb/Stop, Baseboards, Closet Support

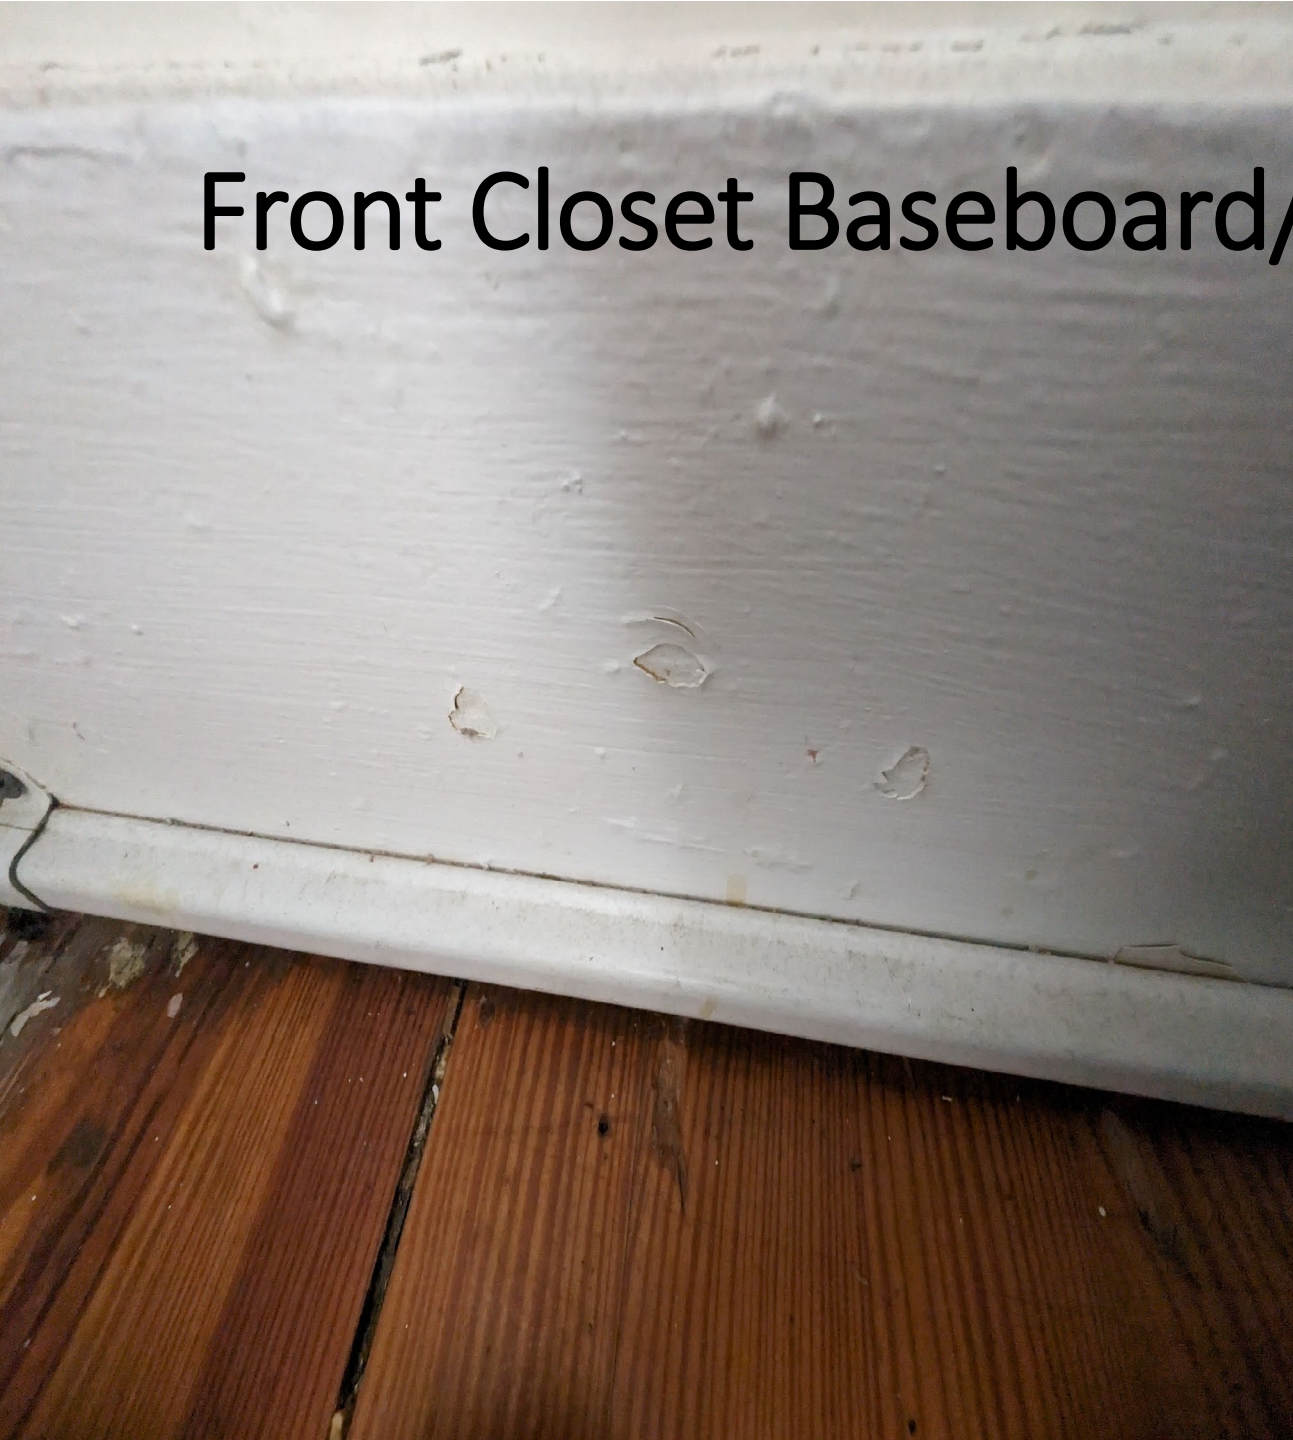
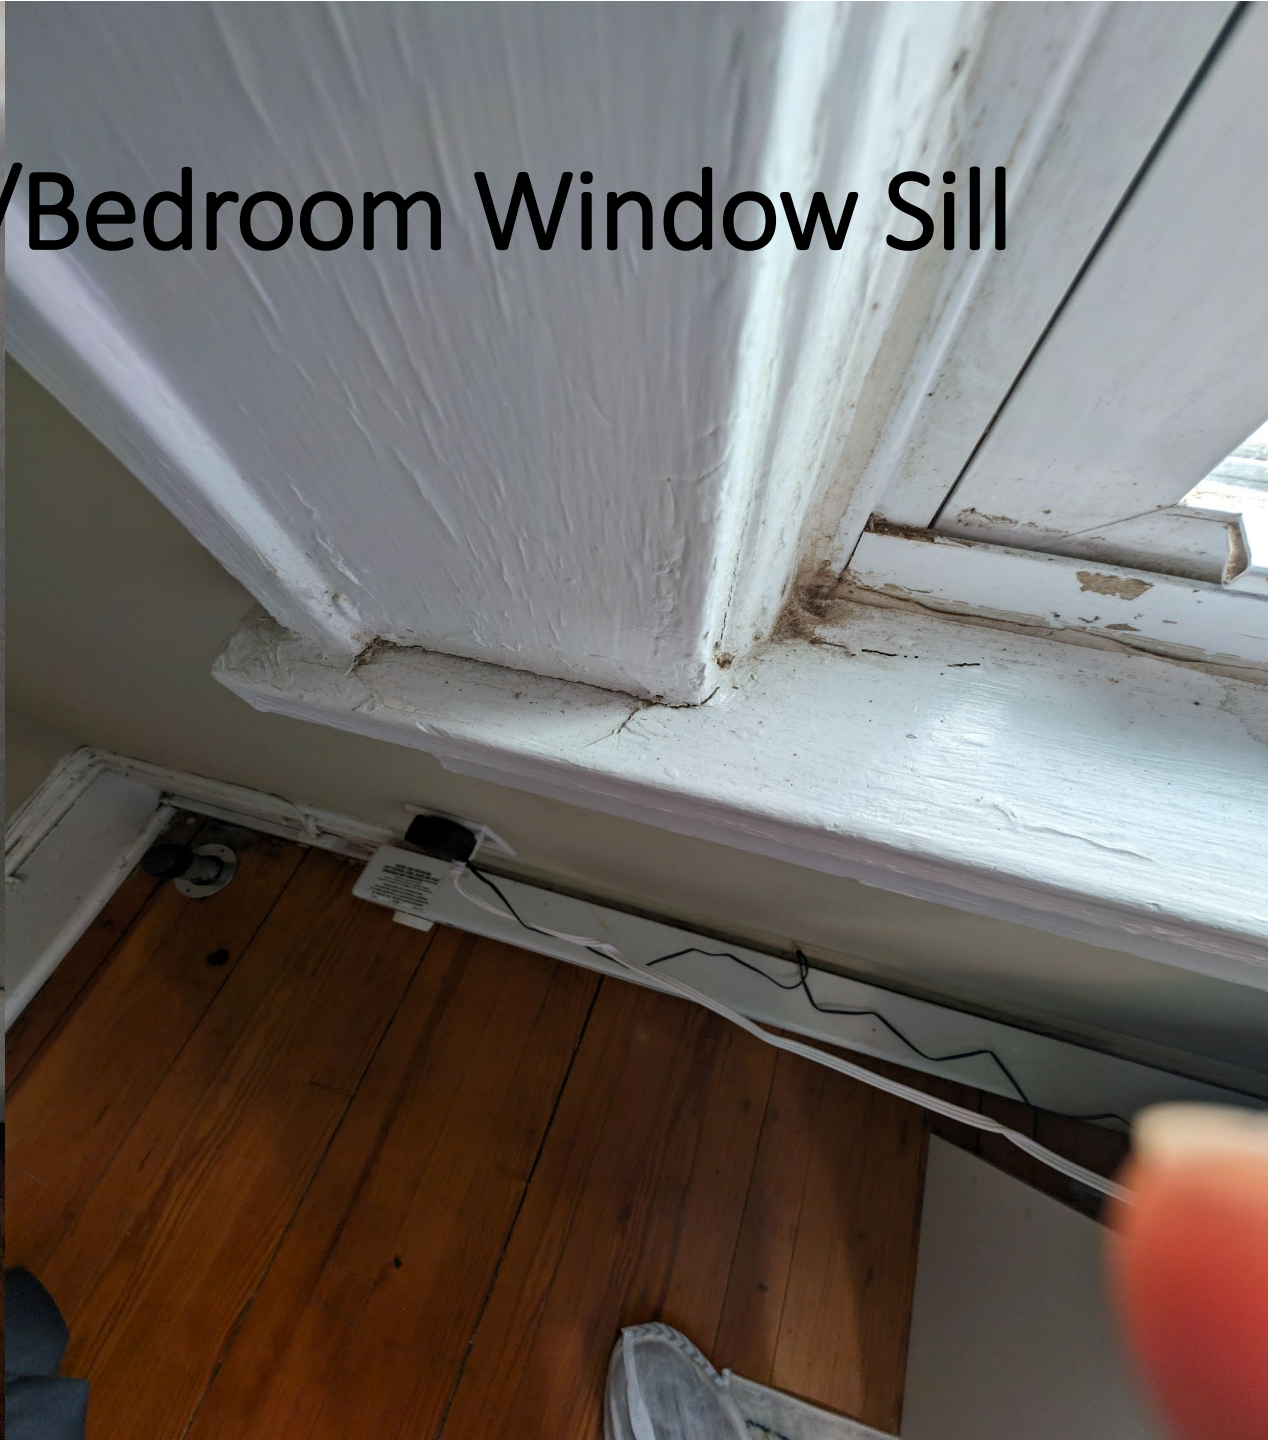
Front Closet Baseboard/Bedroom Window Sill

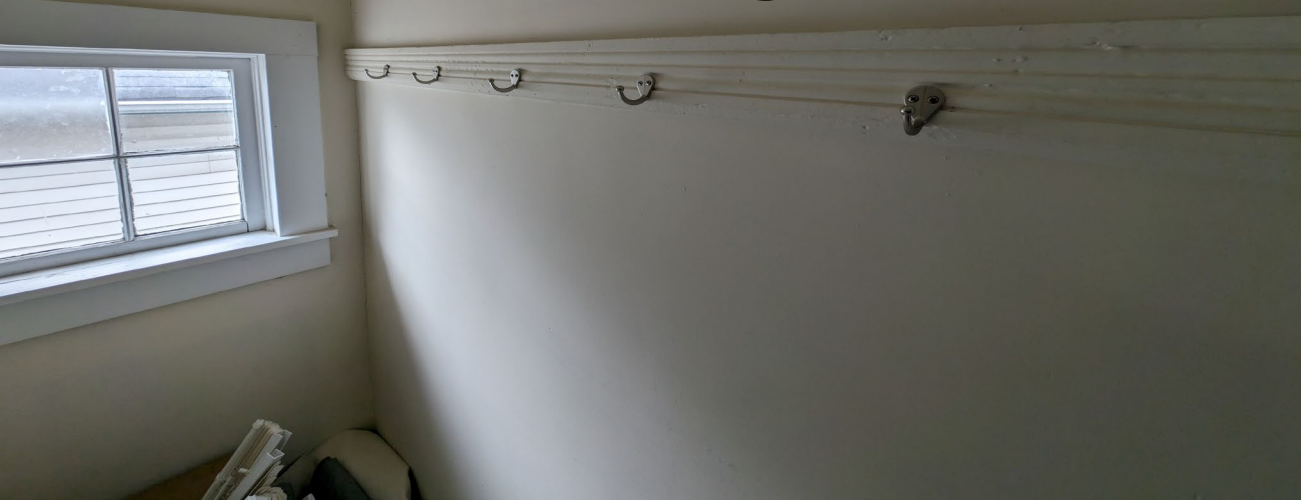
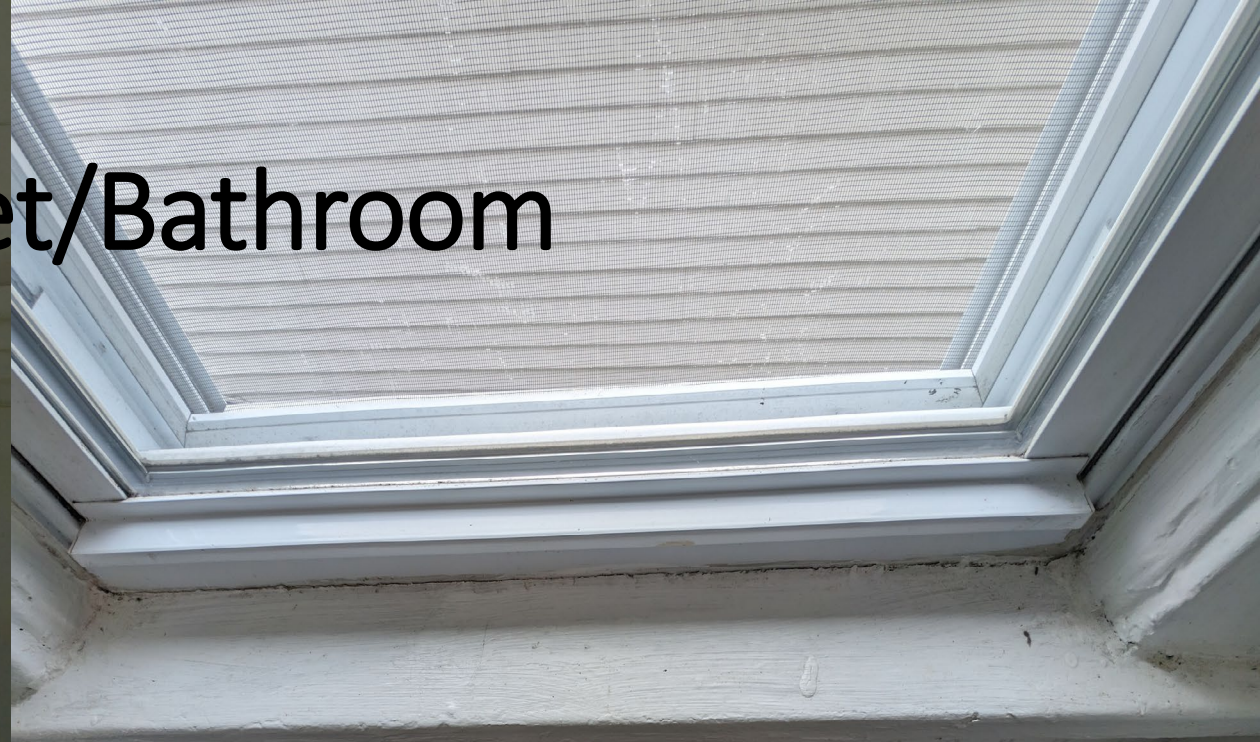
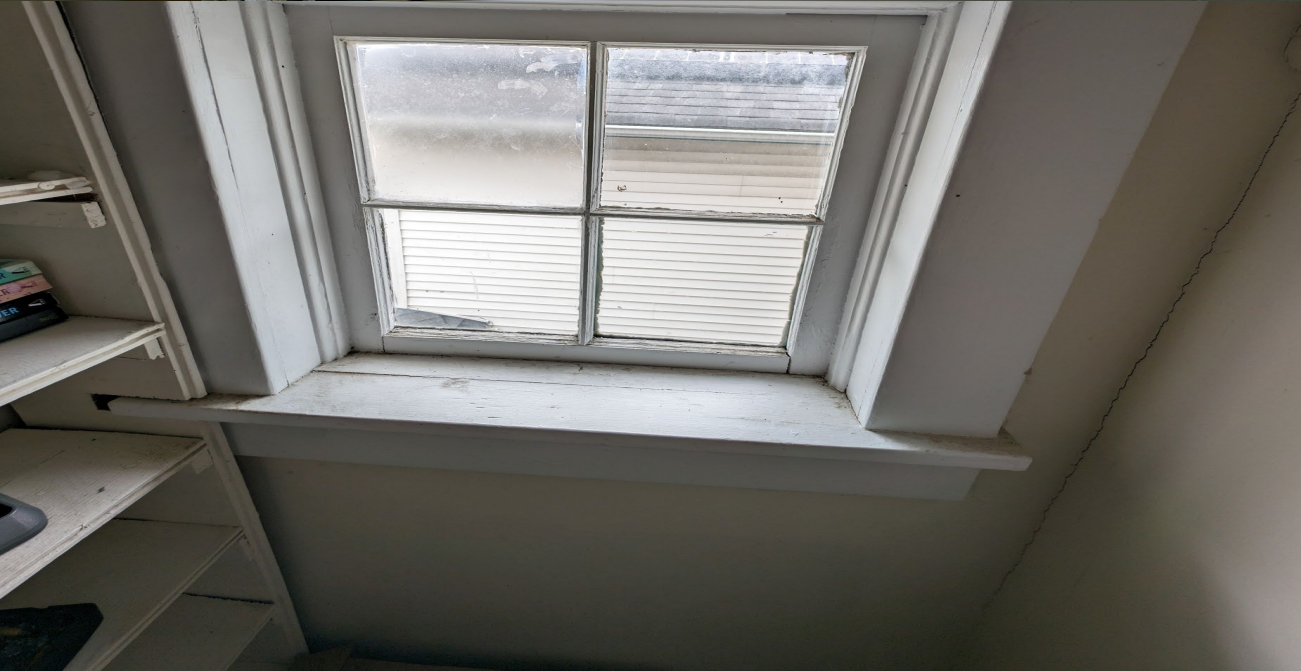
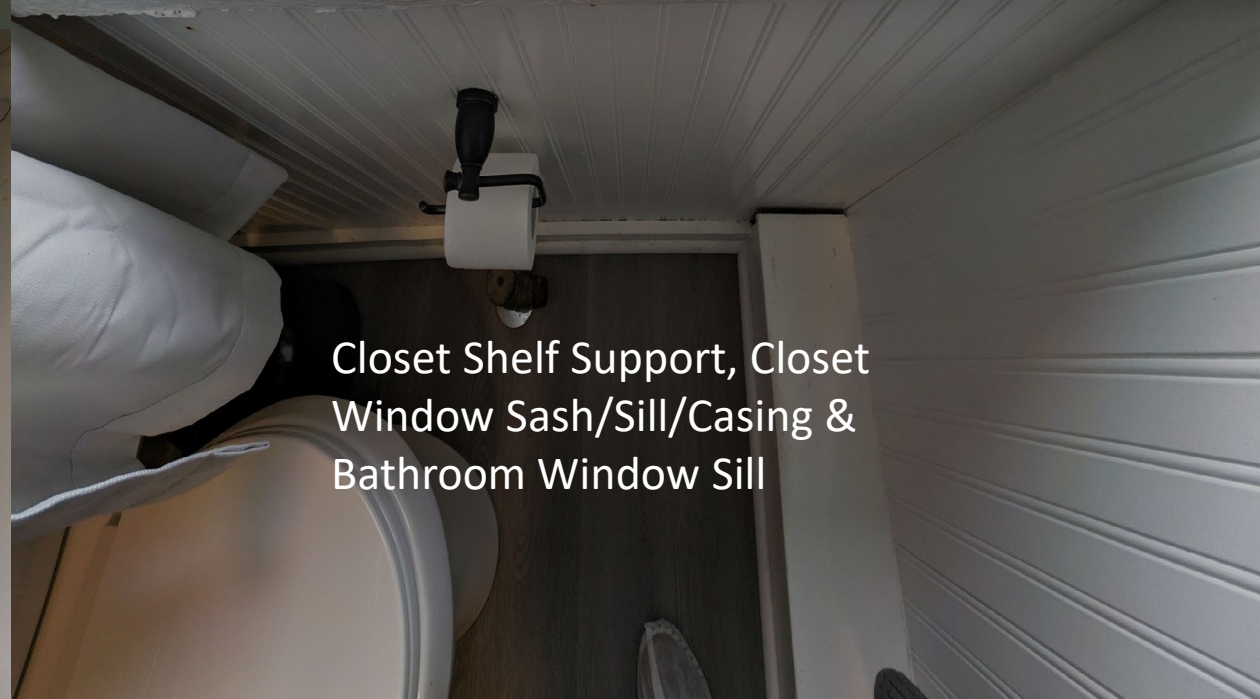
Livingroom Closet/Bathroom

Closet Shelf Support, Closet Window Sash/Sill/Casing & Bathroom Window Sill
