Visual Paint Assessment Report

For: 255 S. Branch Rd Unit 2 – Hillsborough, NJ 08844
March 25, 2024

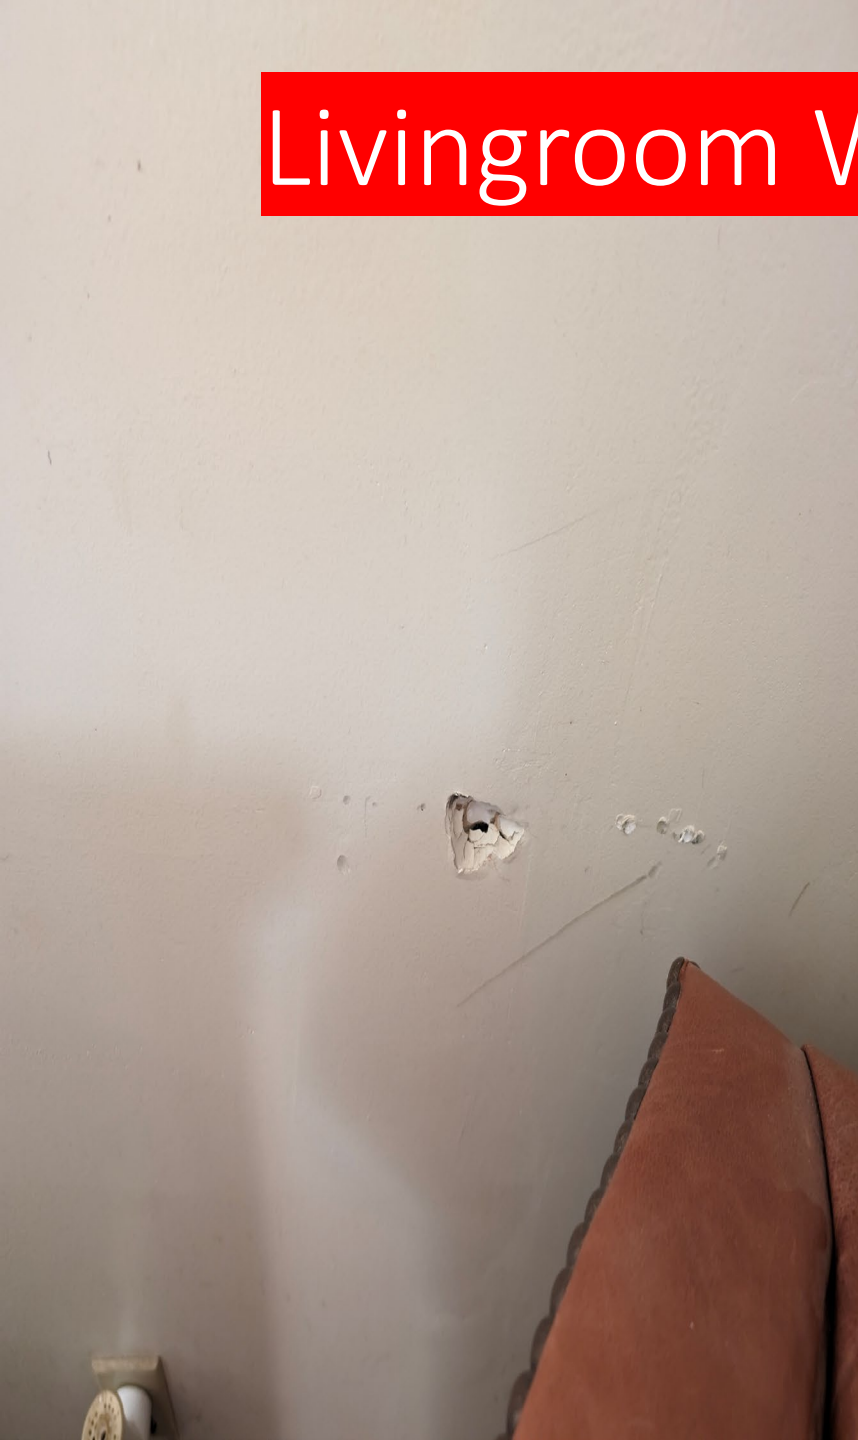
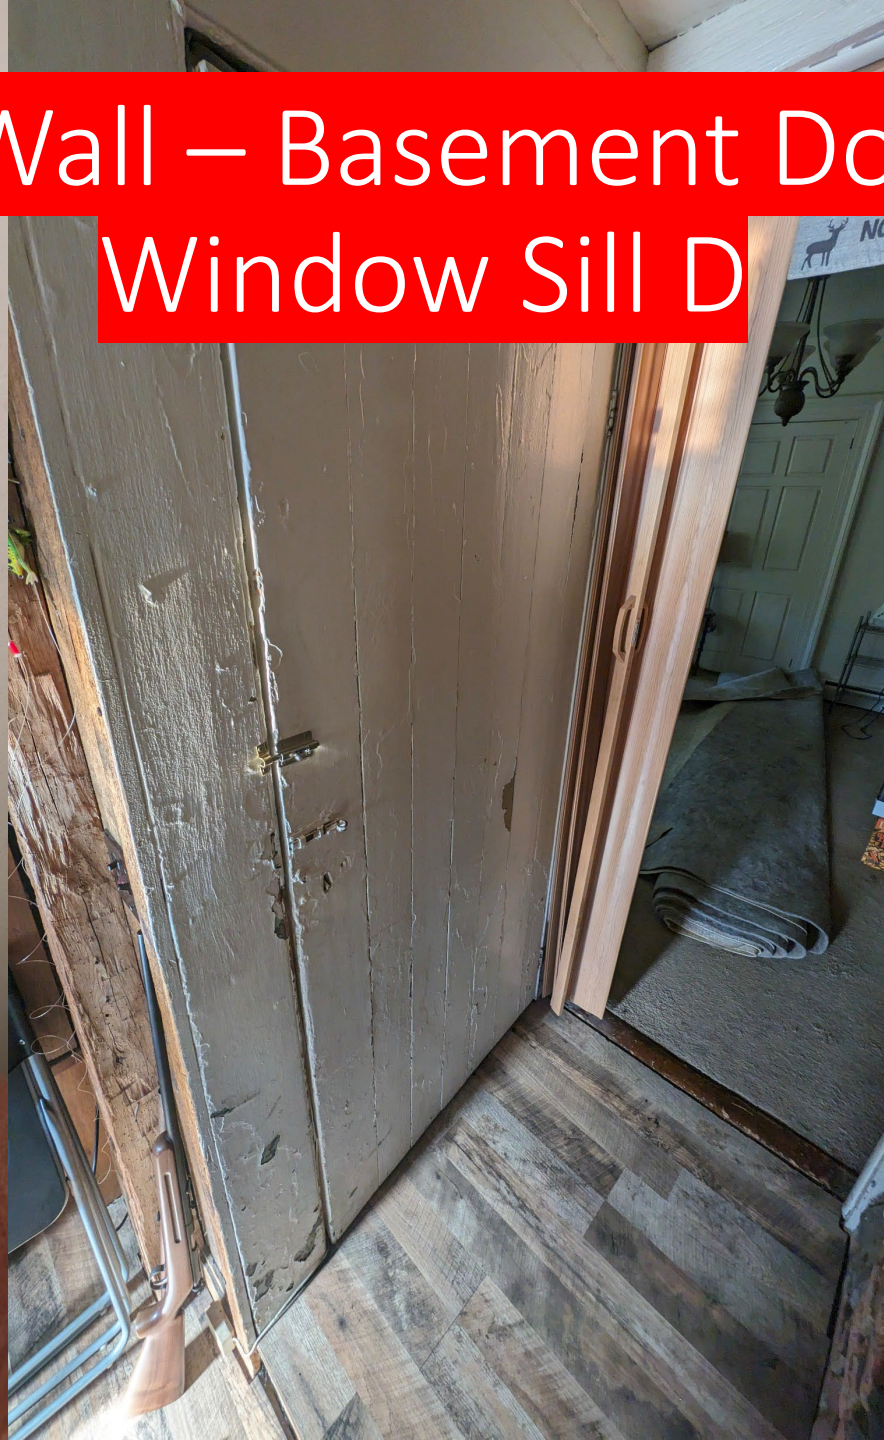
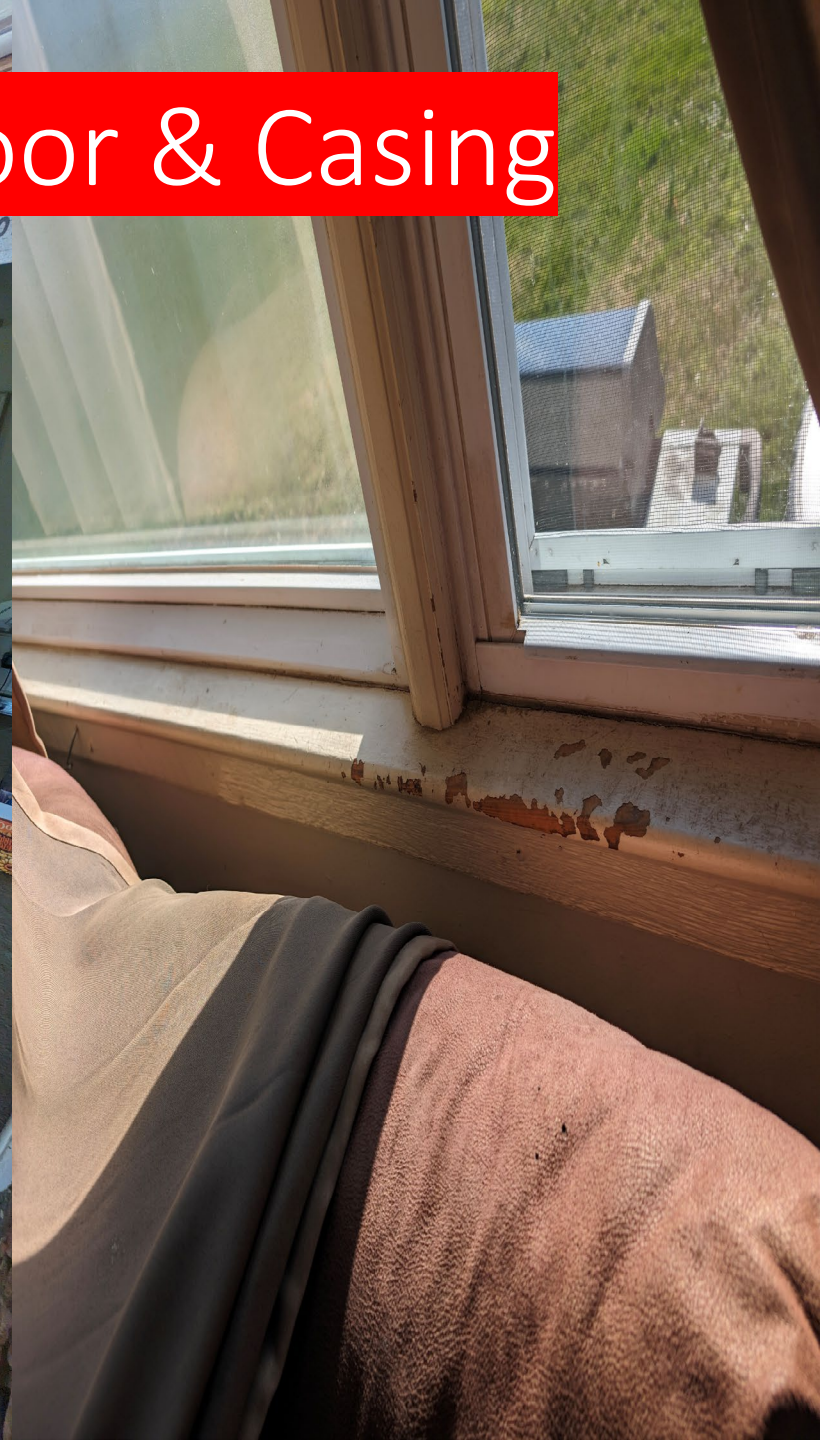
Livingroom Wall – Basement Door & Casing Window Sill D

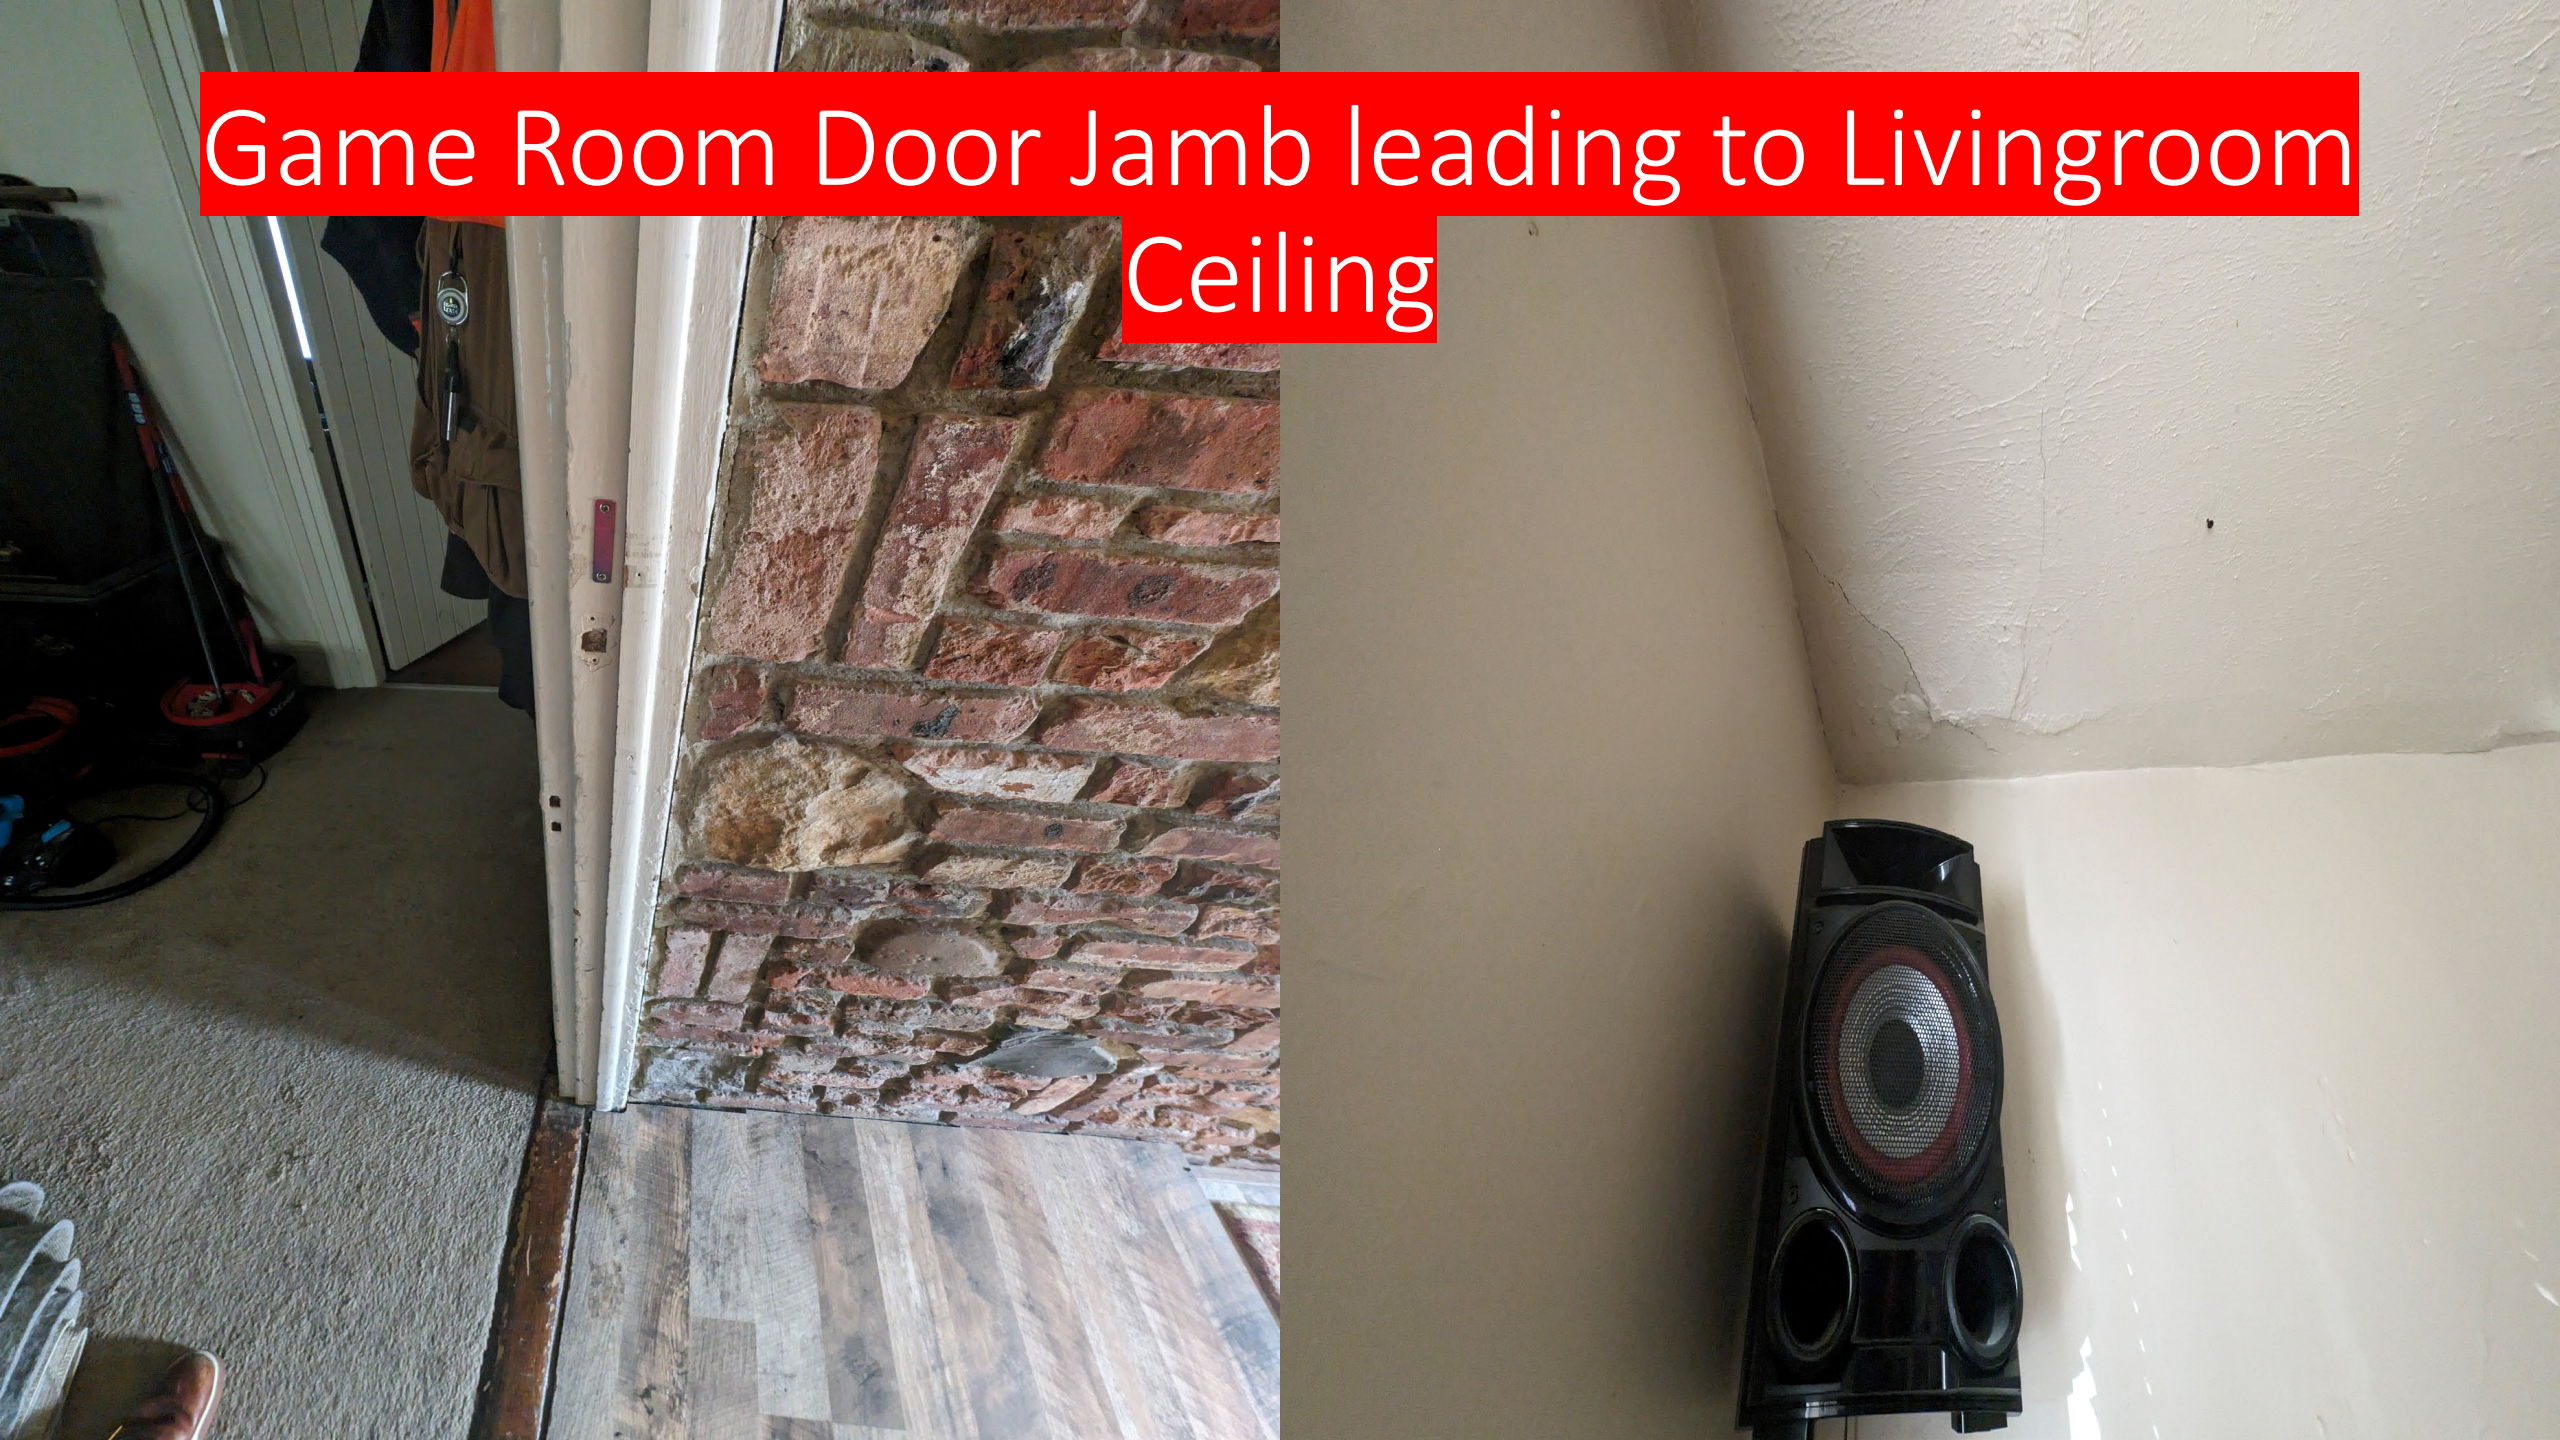
Game Room Door Jamb leading to Livingroom Ceiling

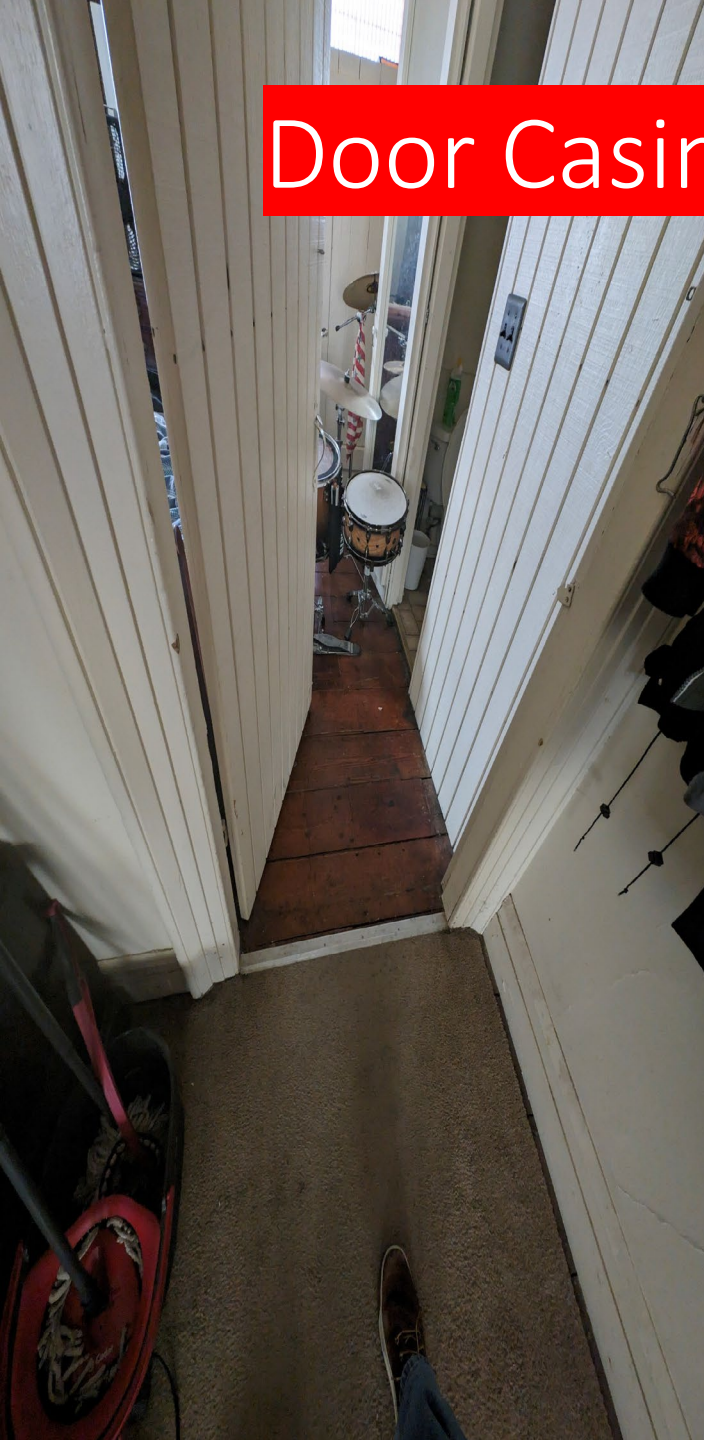
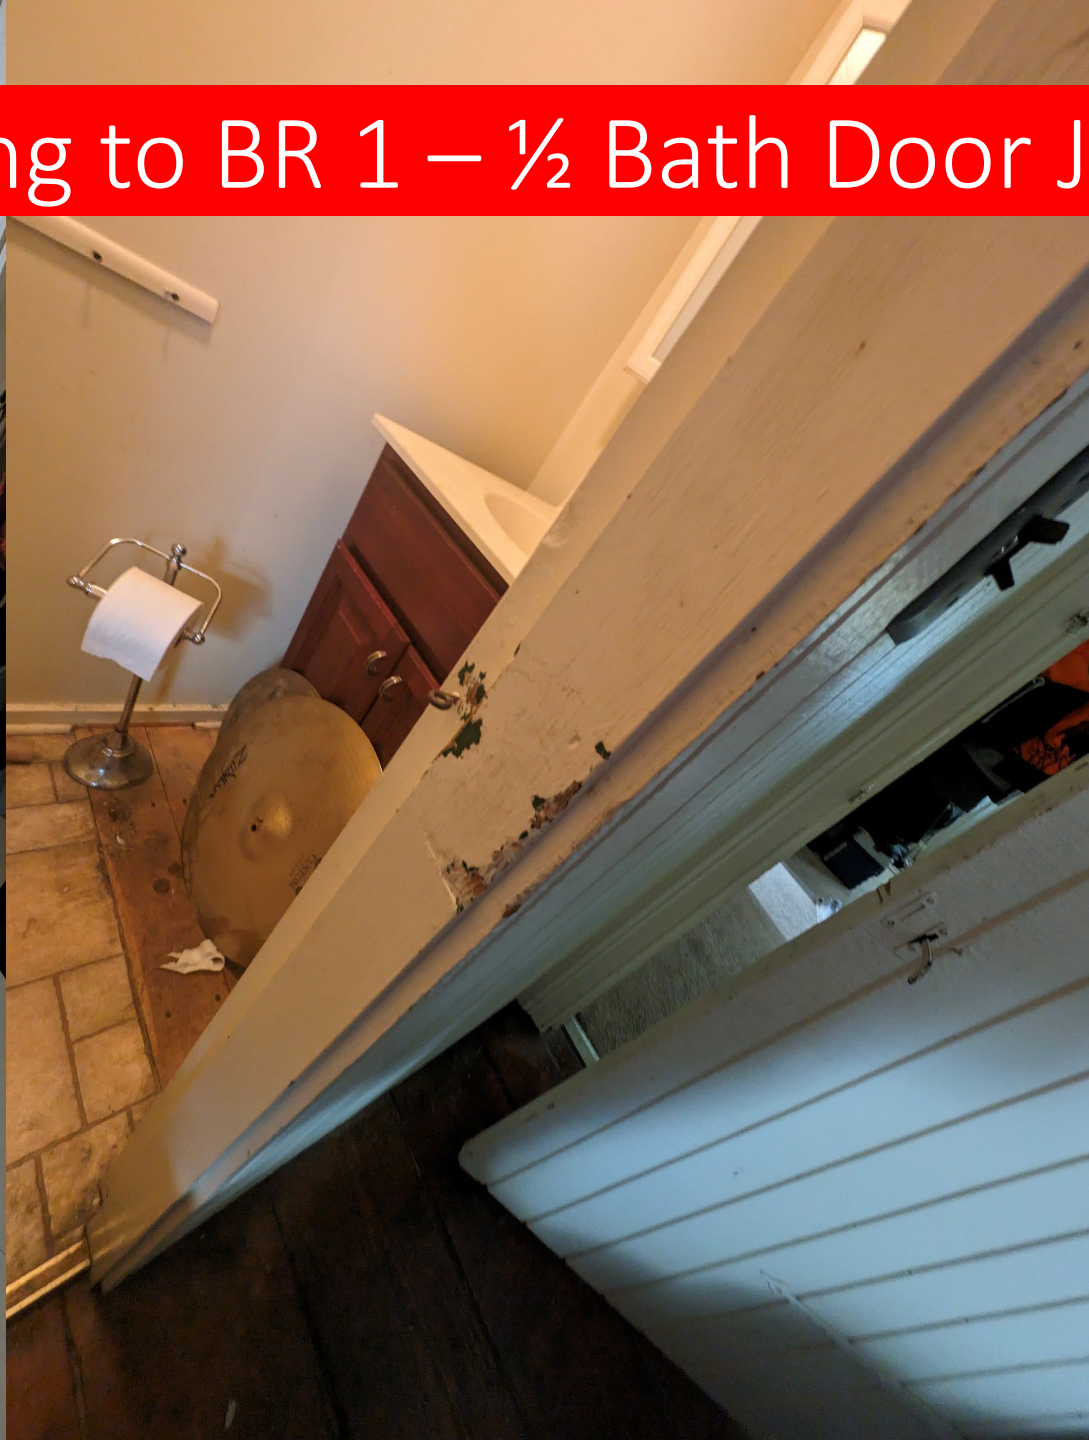
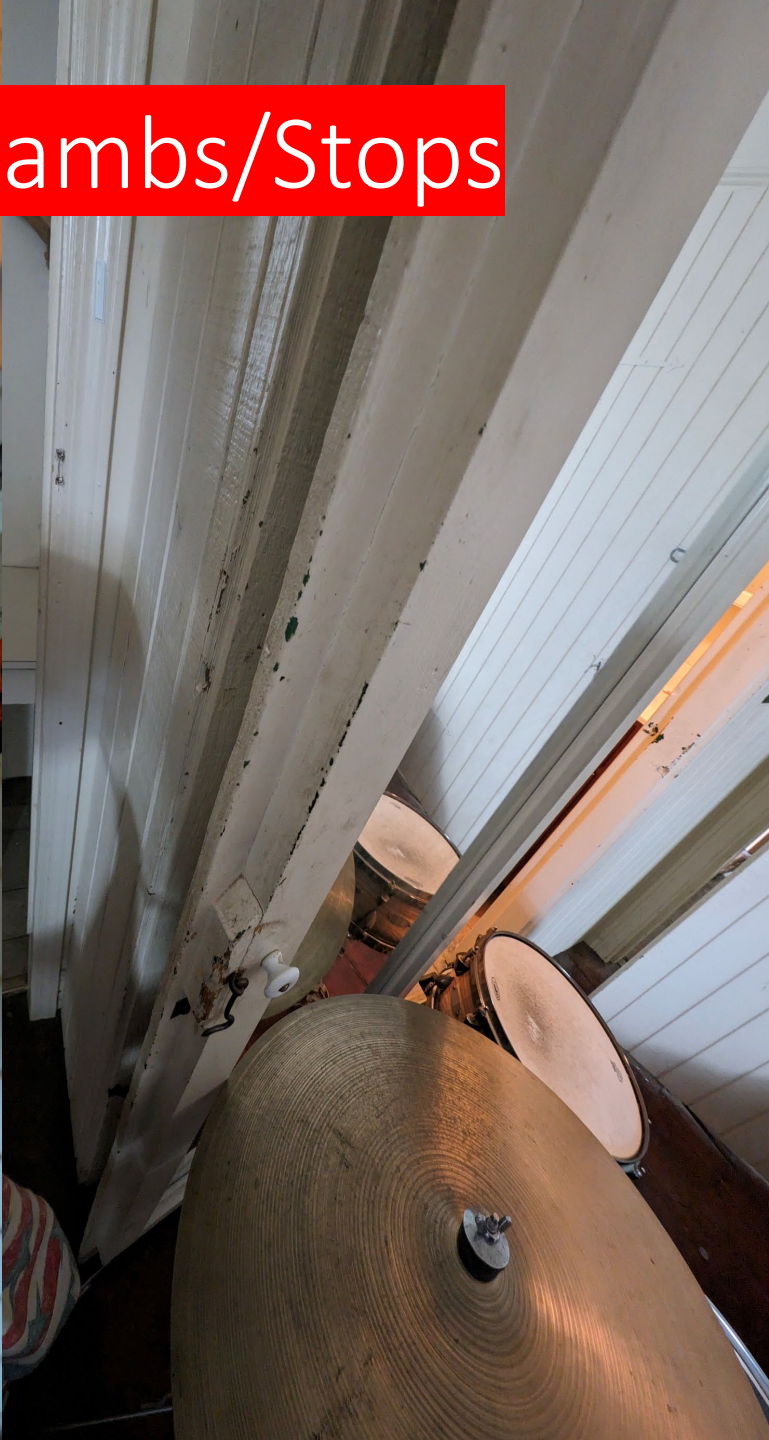
Door Casing to BR 1 – ½ Bath Door Jambs/Stops

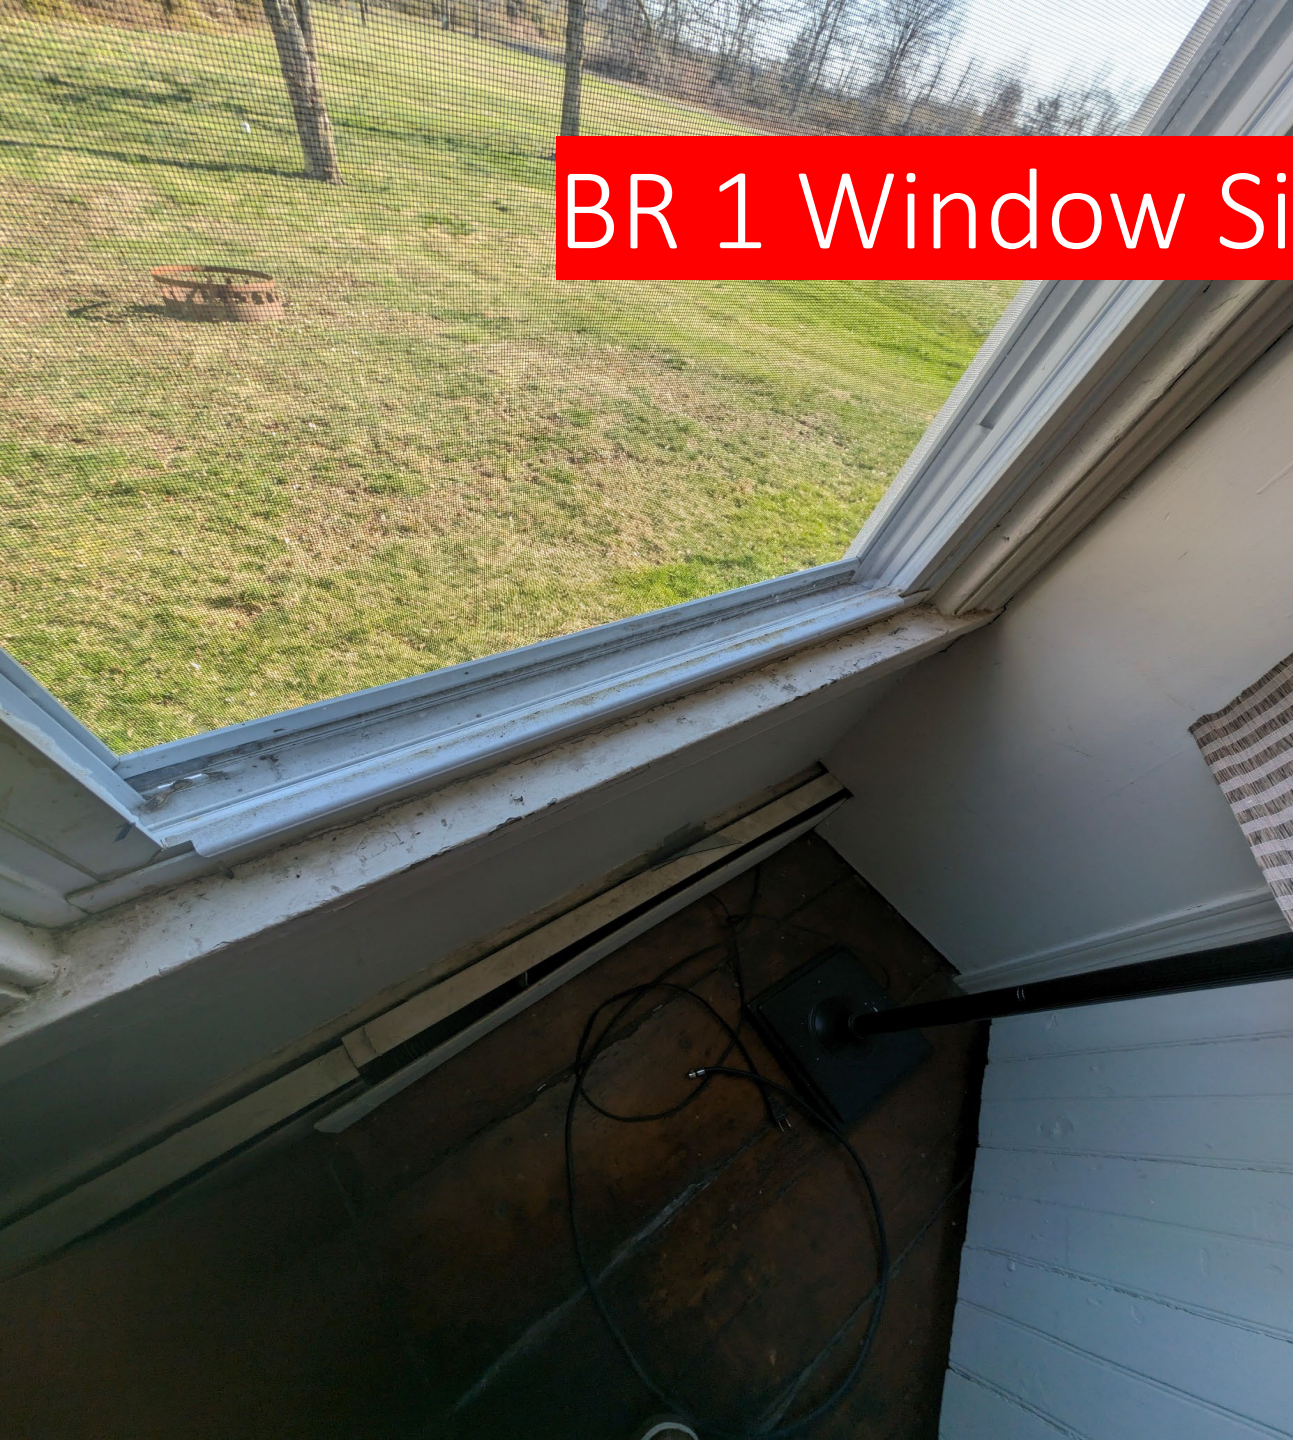
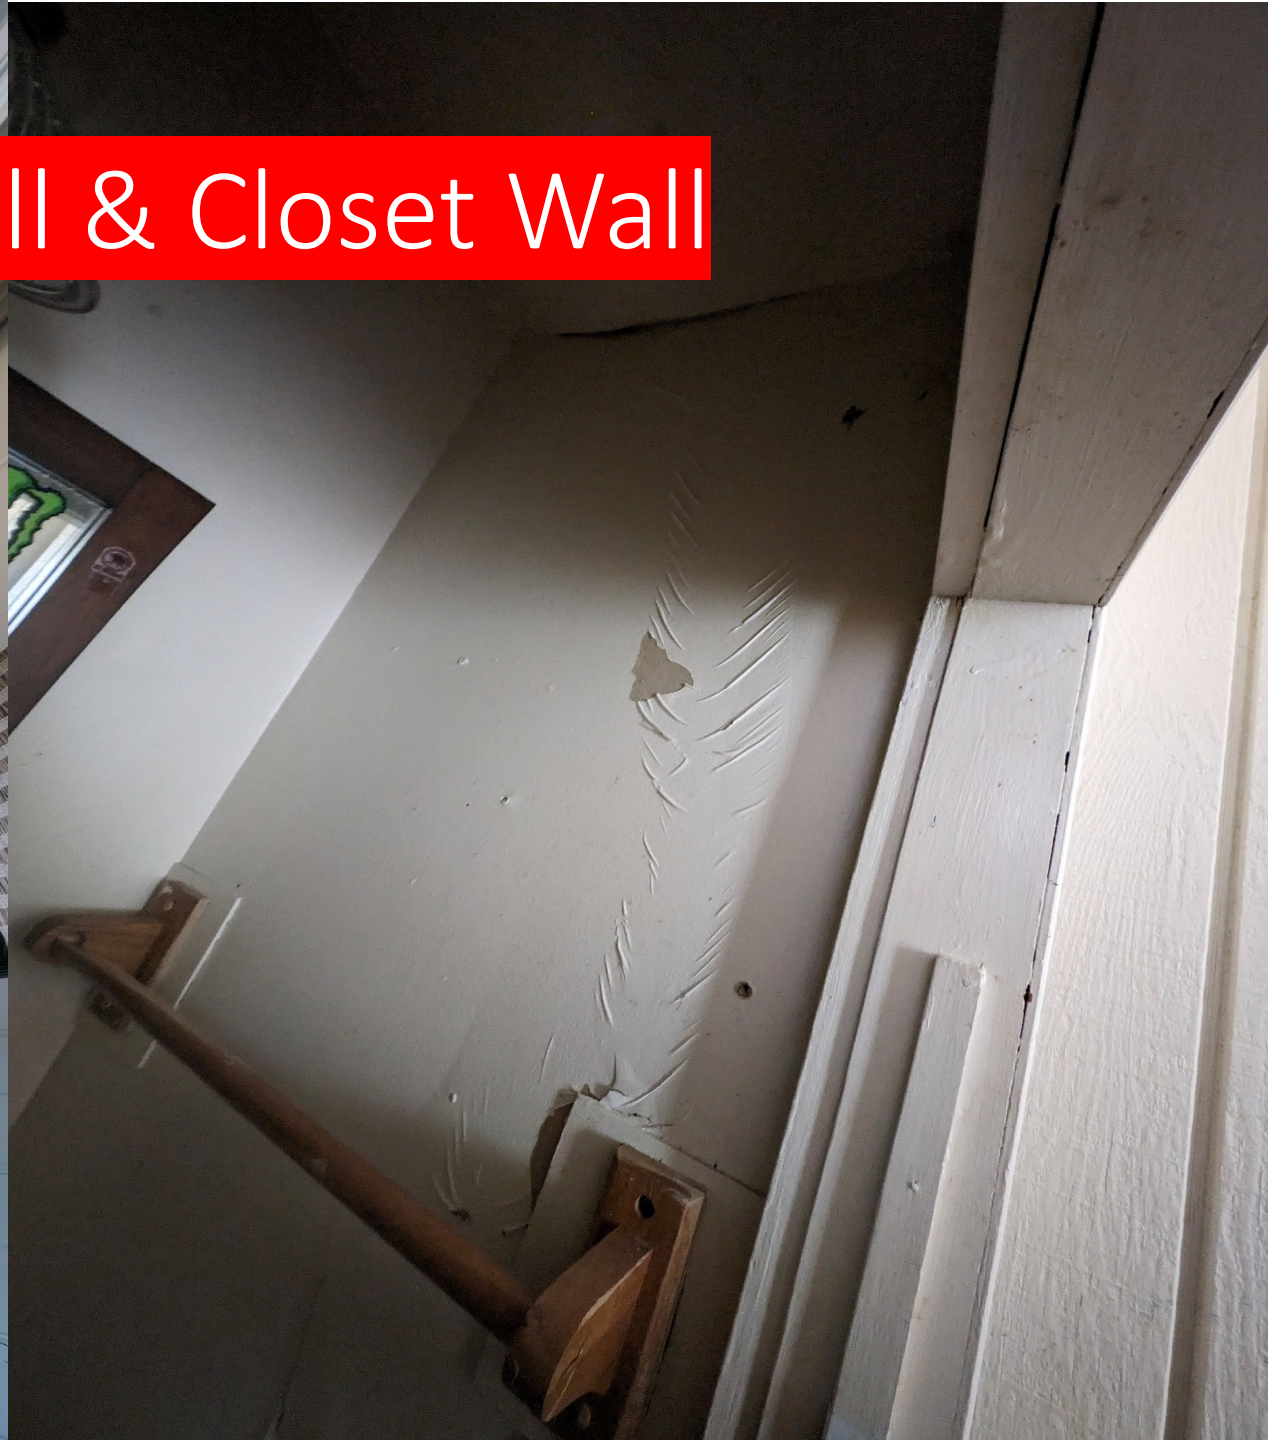
BR 1 Window Sill & Closet Wall

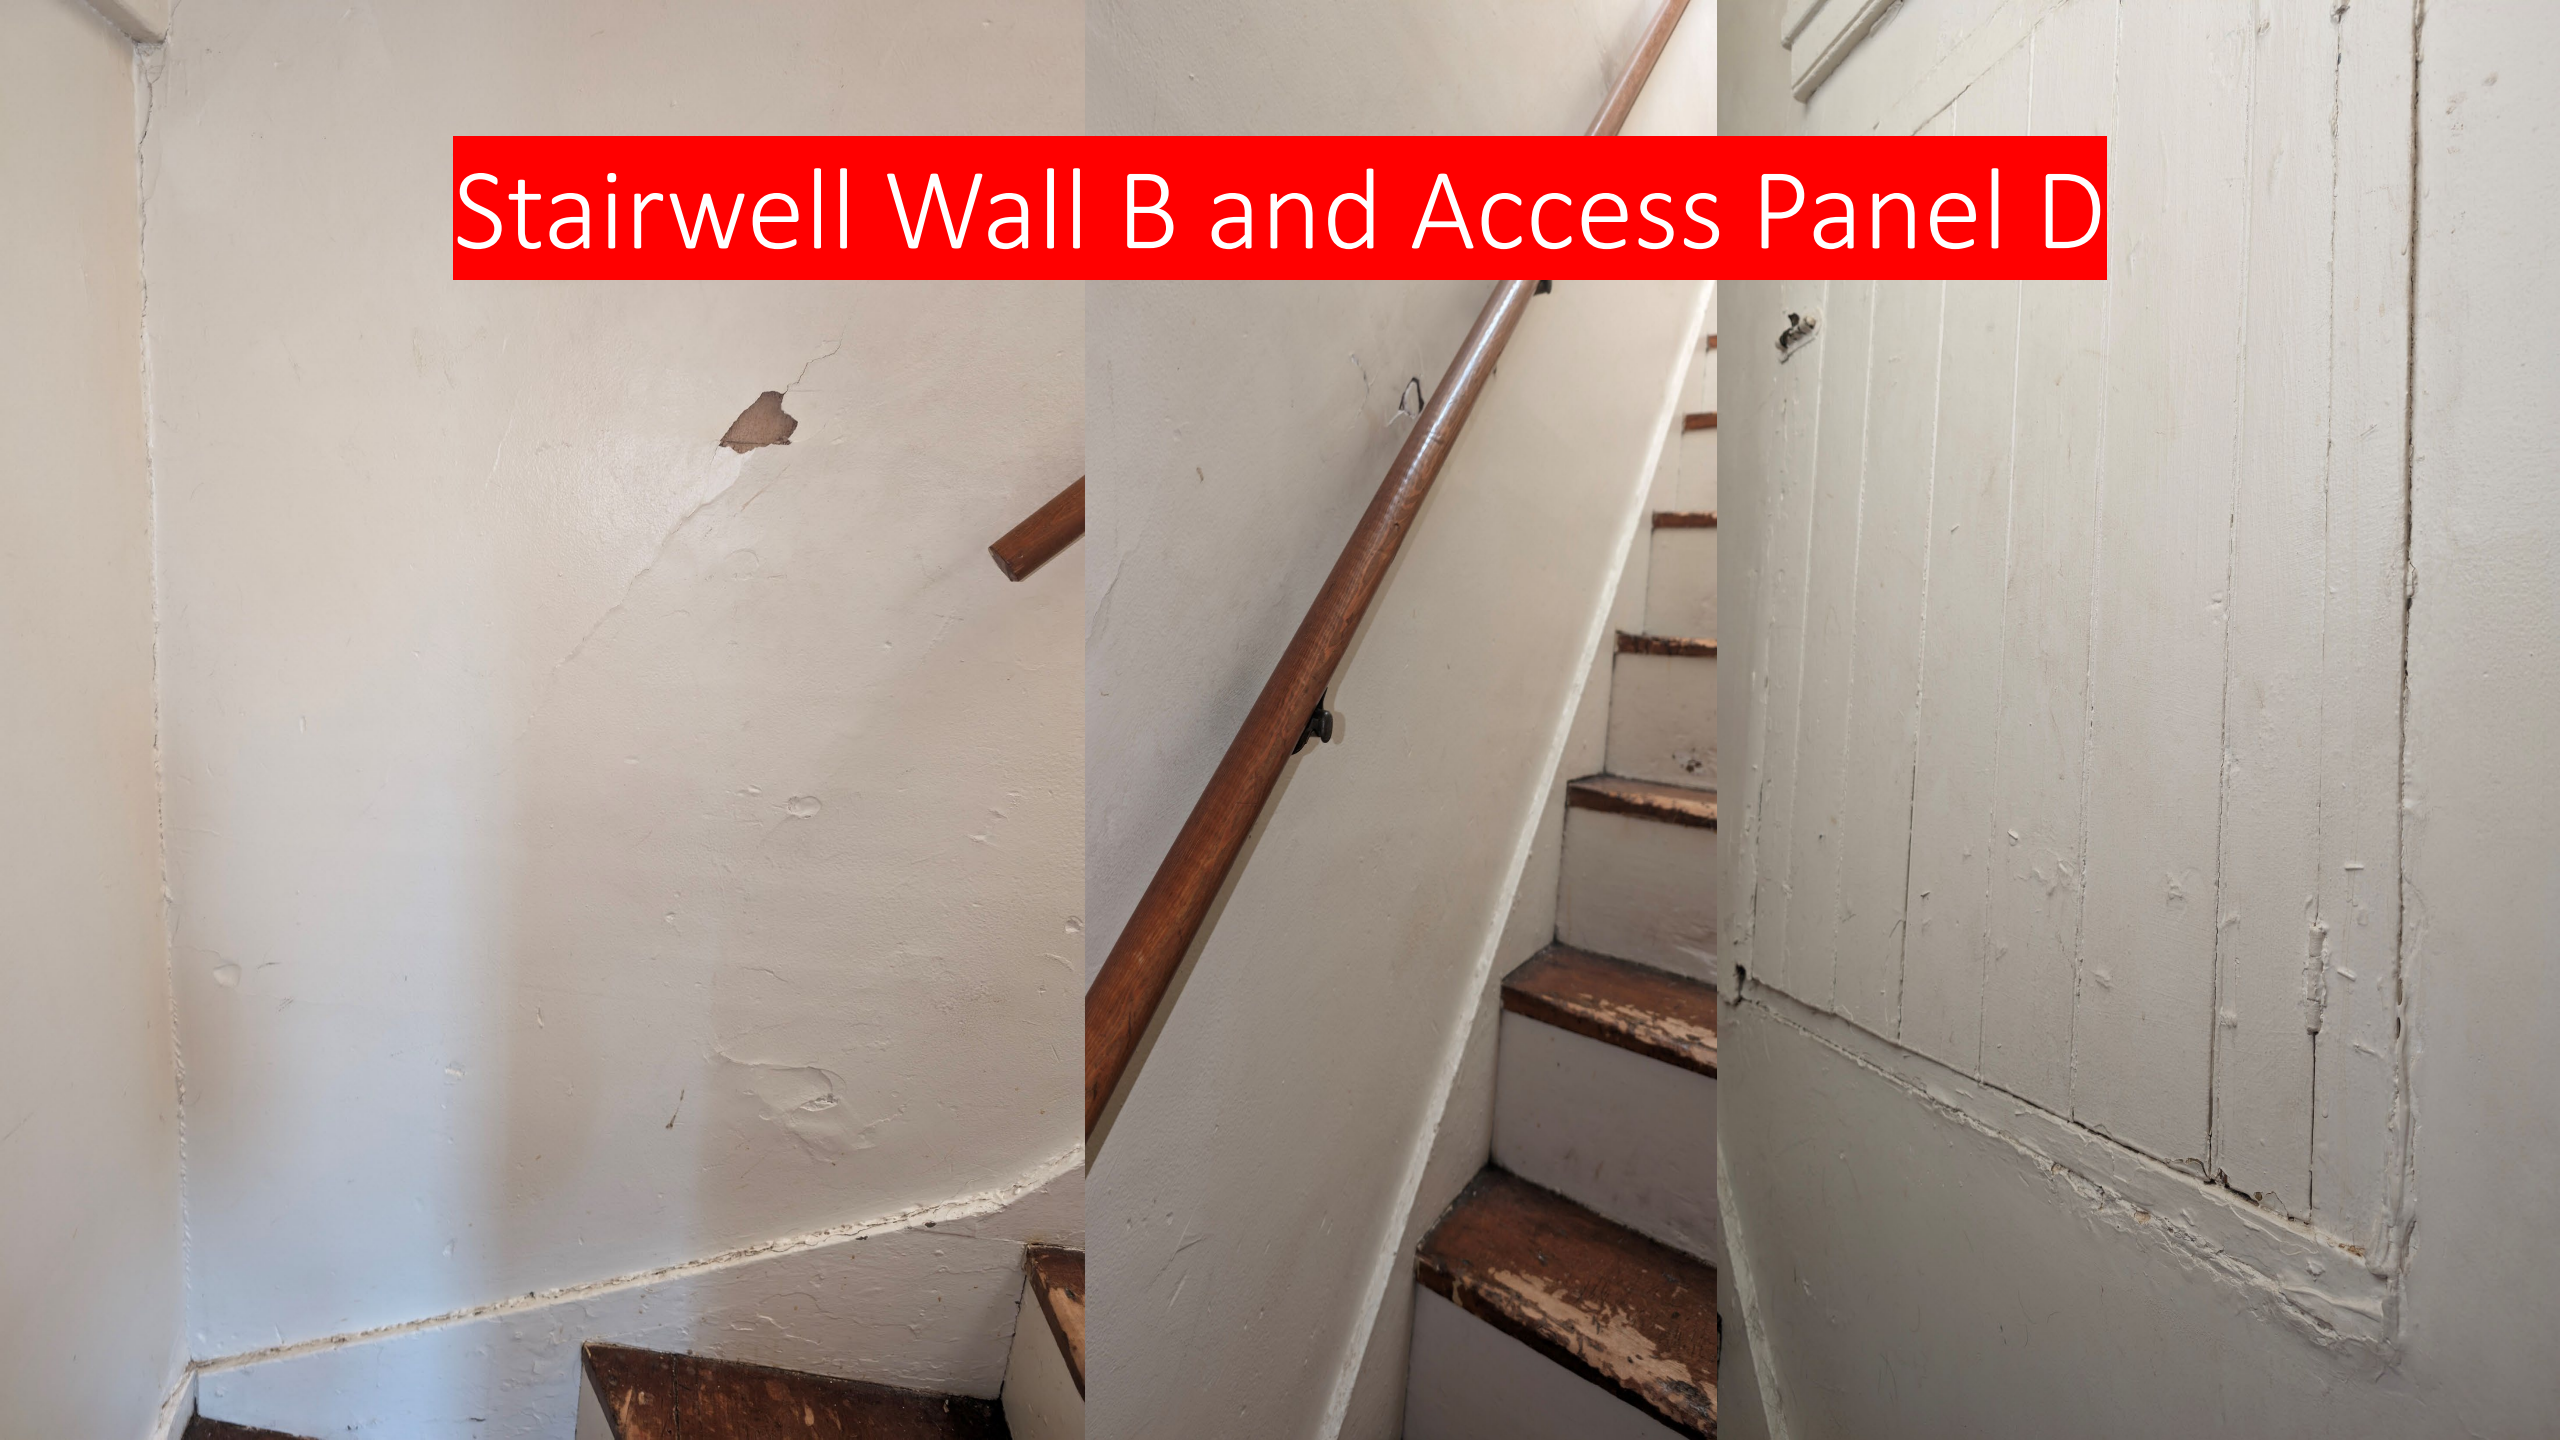
Stairwell Wall B and Access Panel D

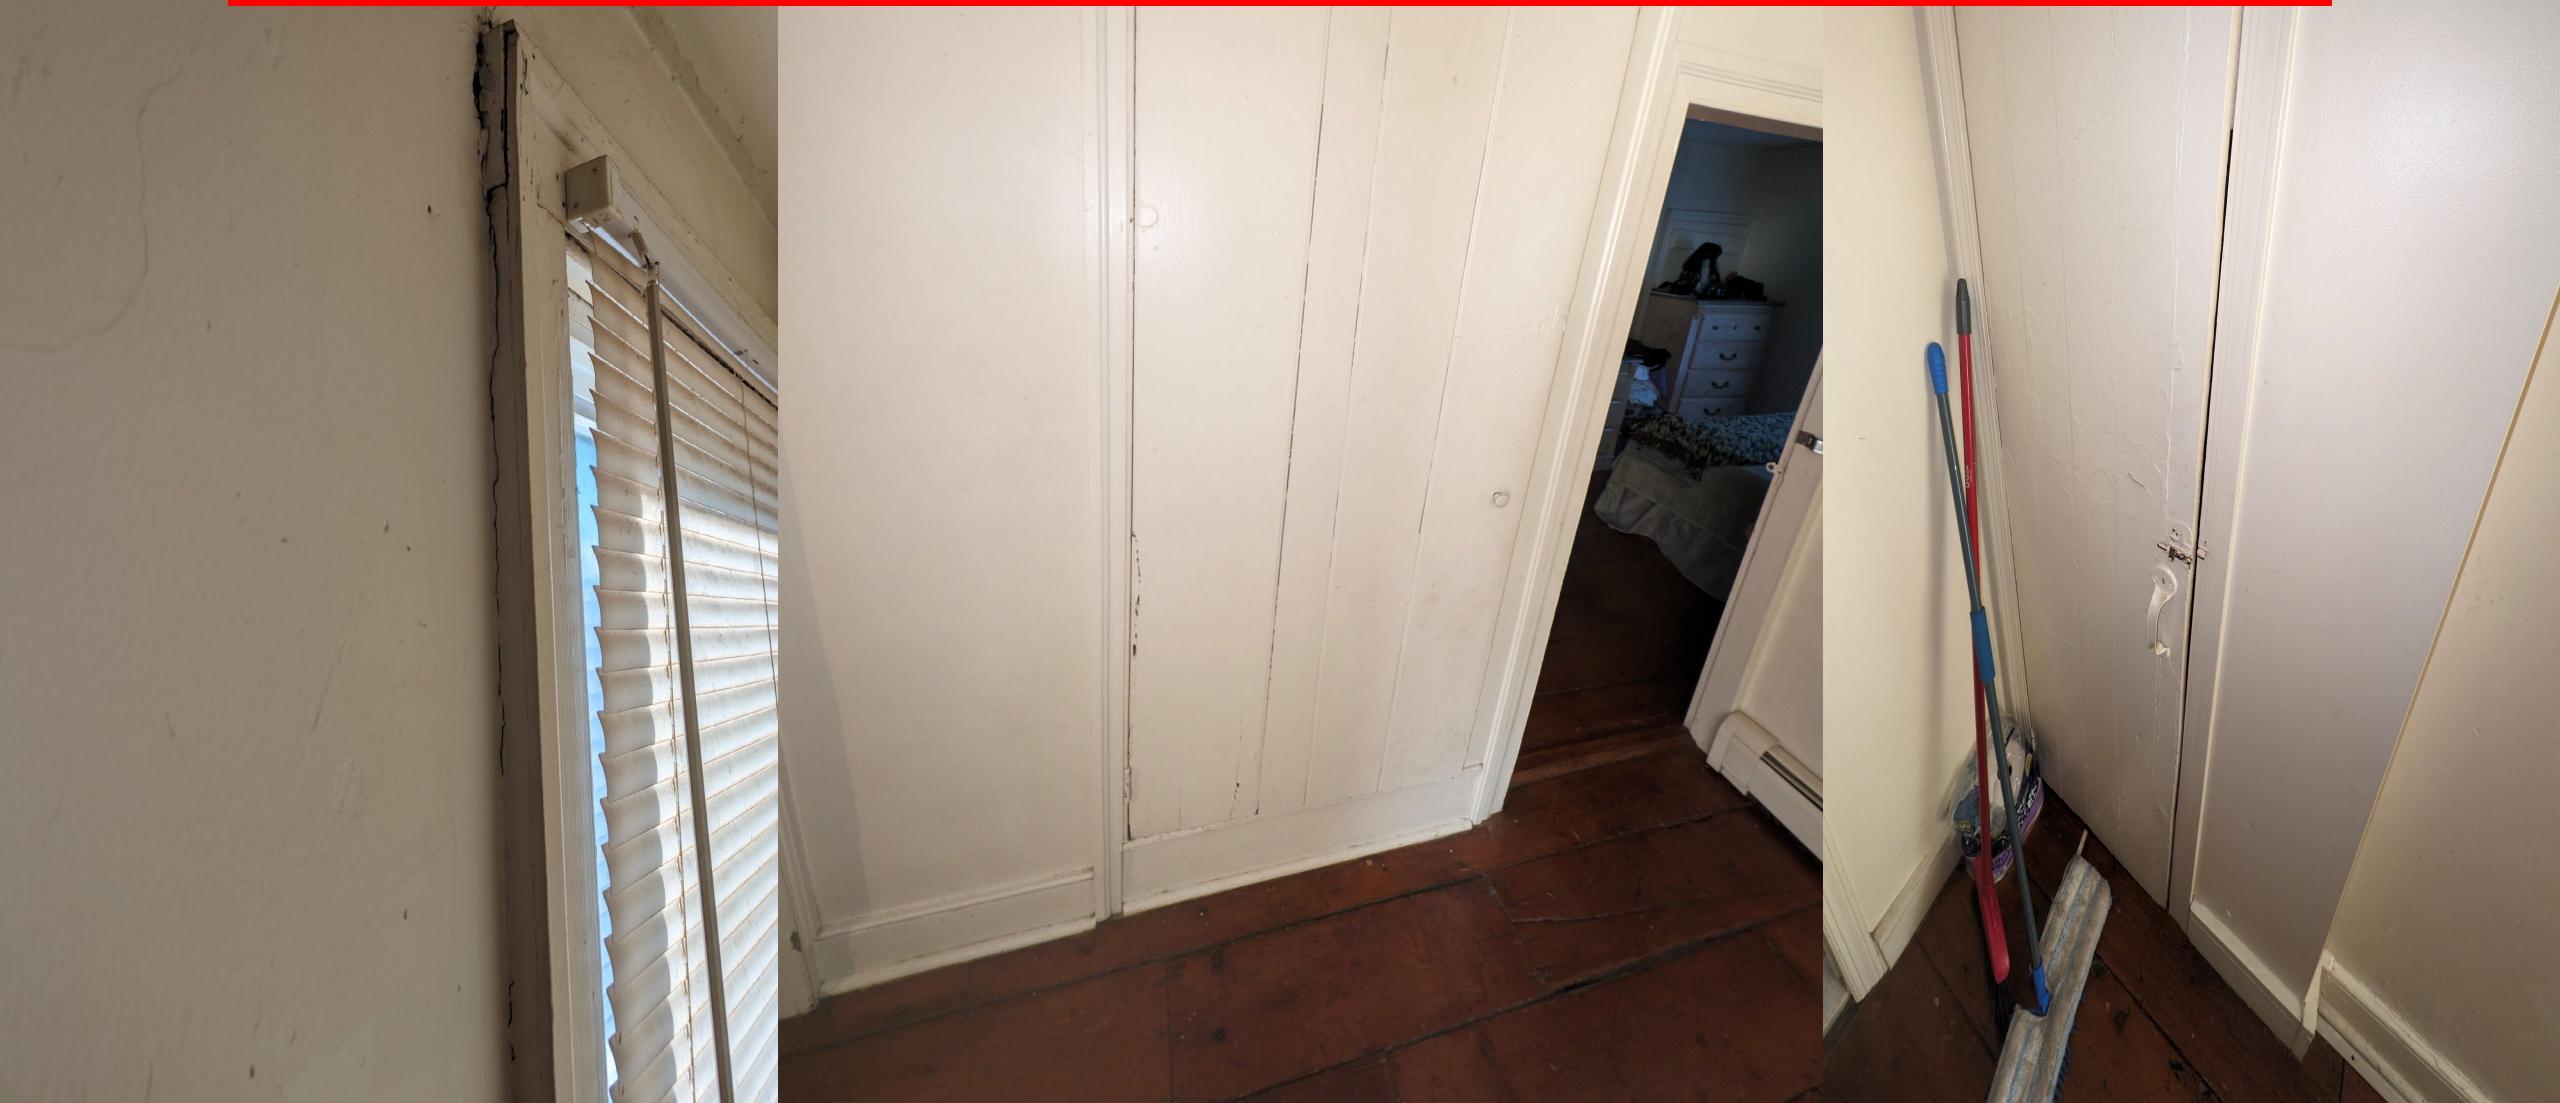
2nd Floor Foyer Window Casing D
Door leading to Attic B – Linen Closet Door D
