Visual Paint Assessment Report

For: 255 S. Branch Rd Unit 2 – Hillsborough, NJ 08844
March 25, 2024

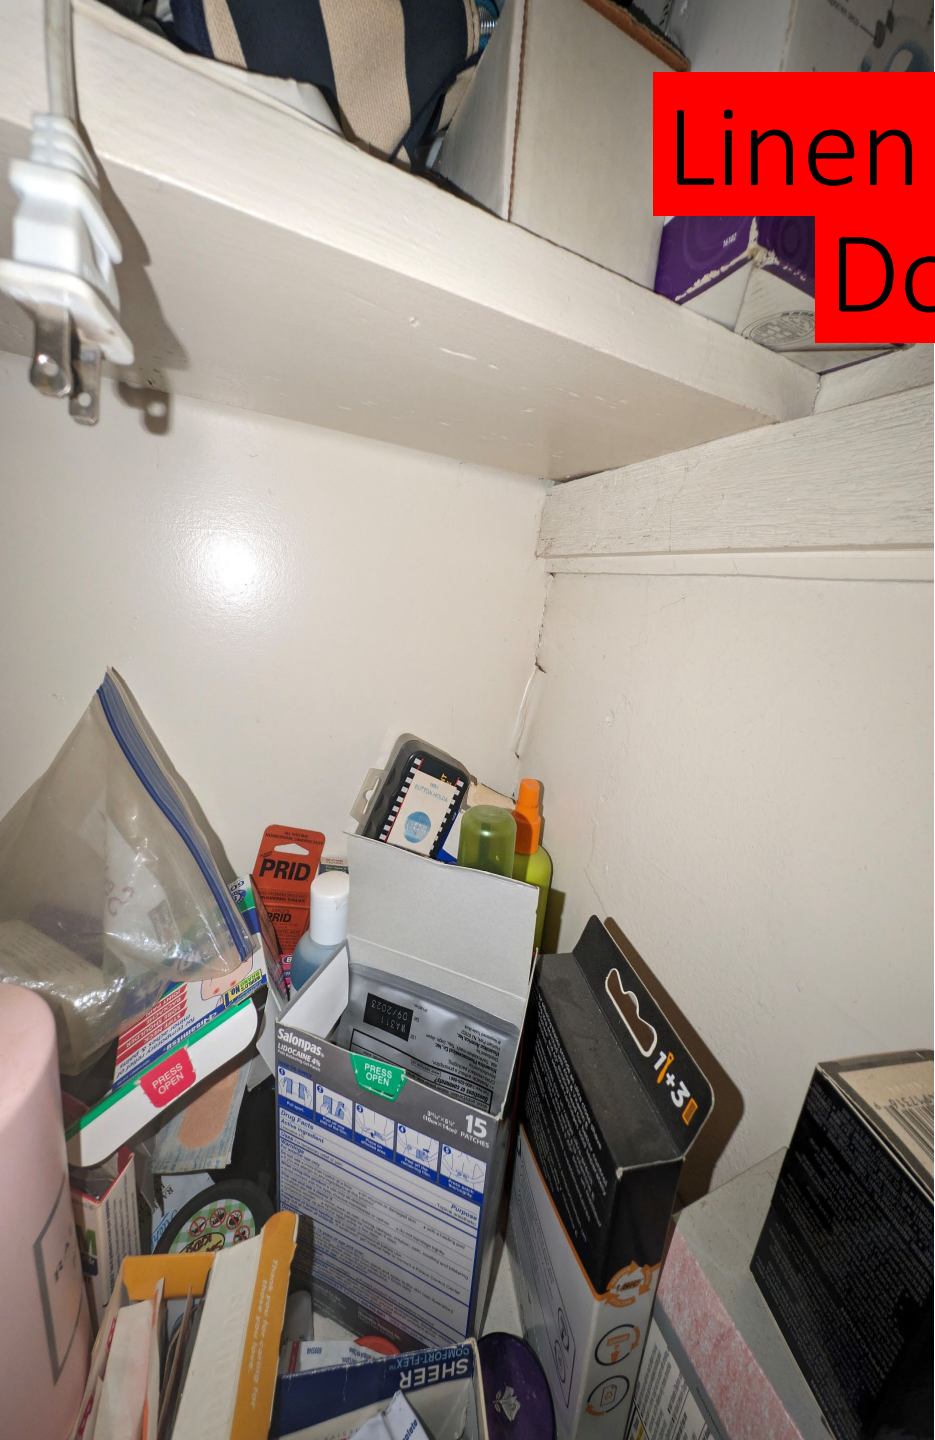
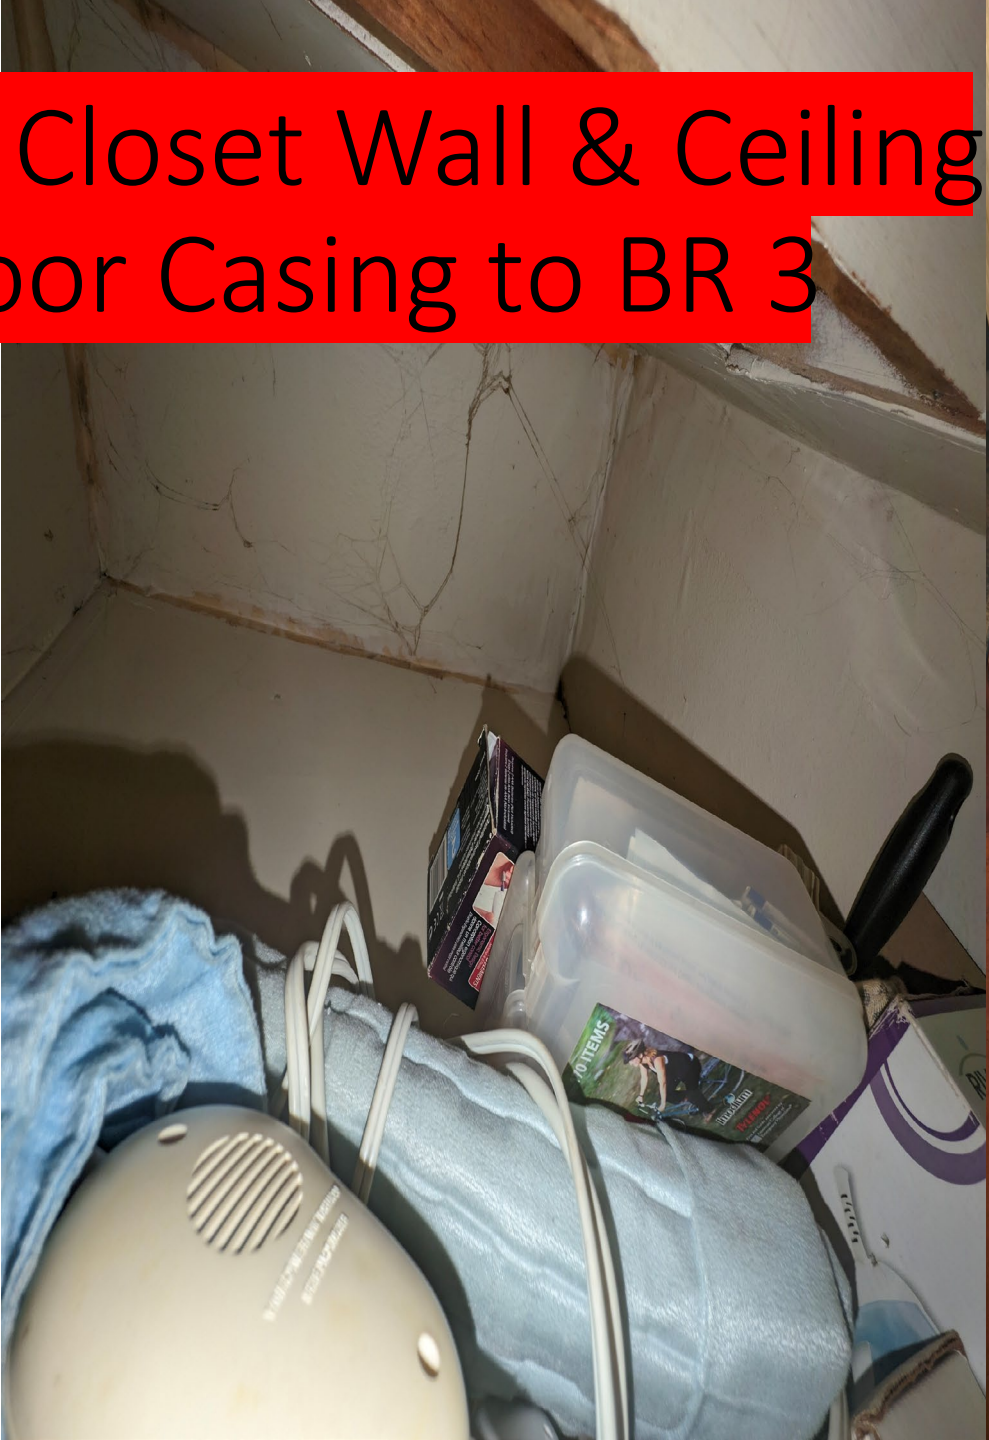
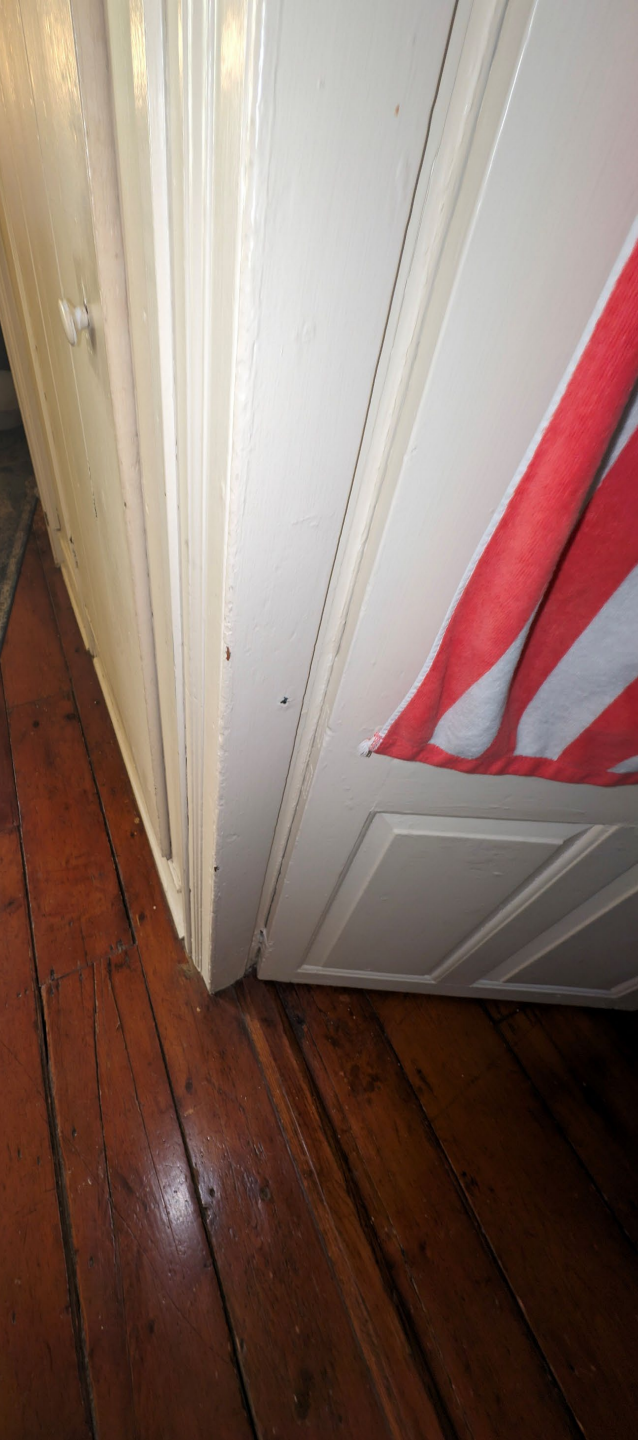
Linen Closet Wall & Ceiling Door Casing to BR 3

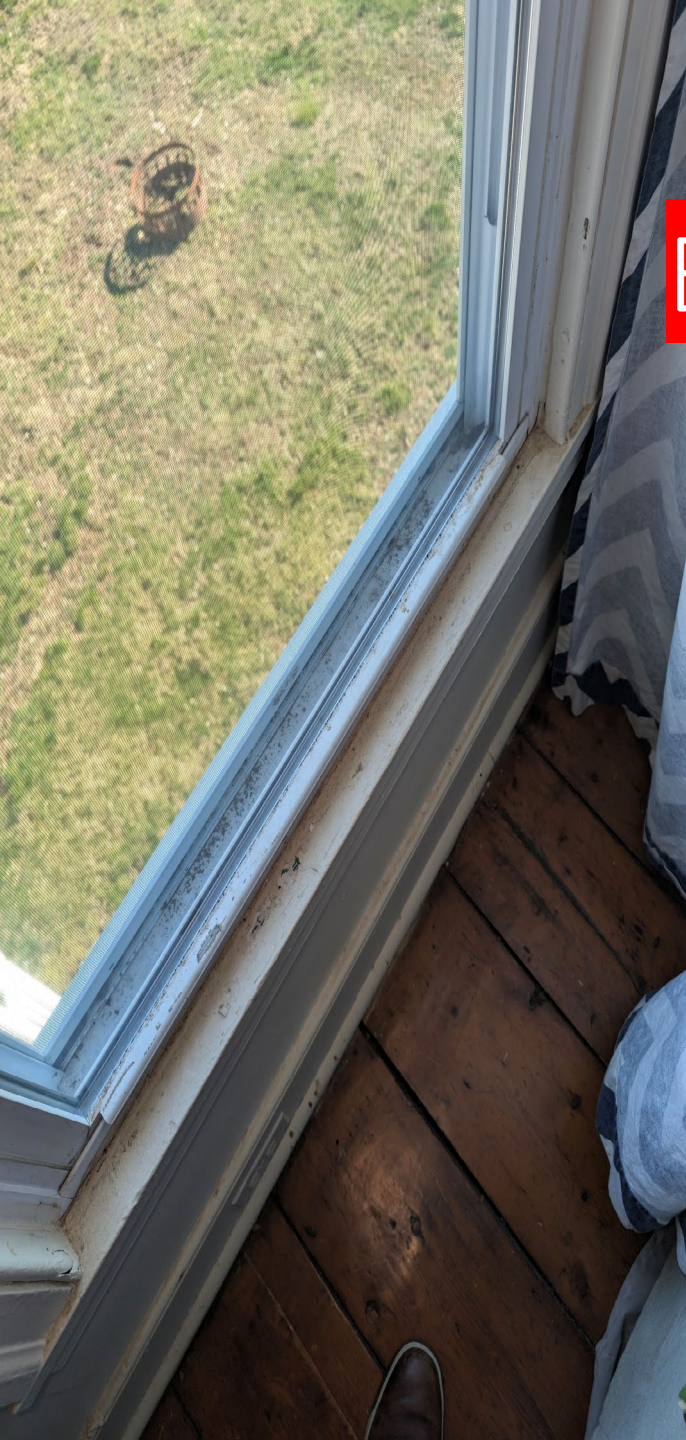
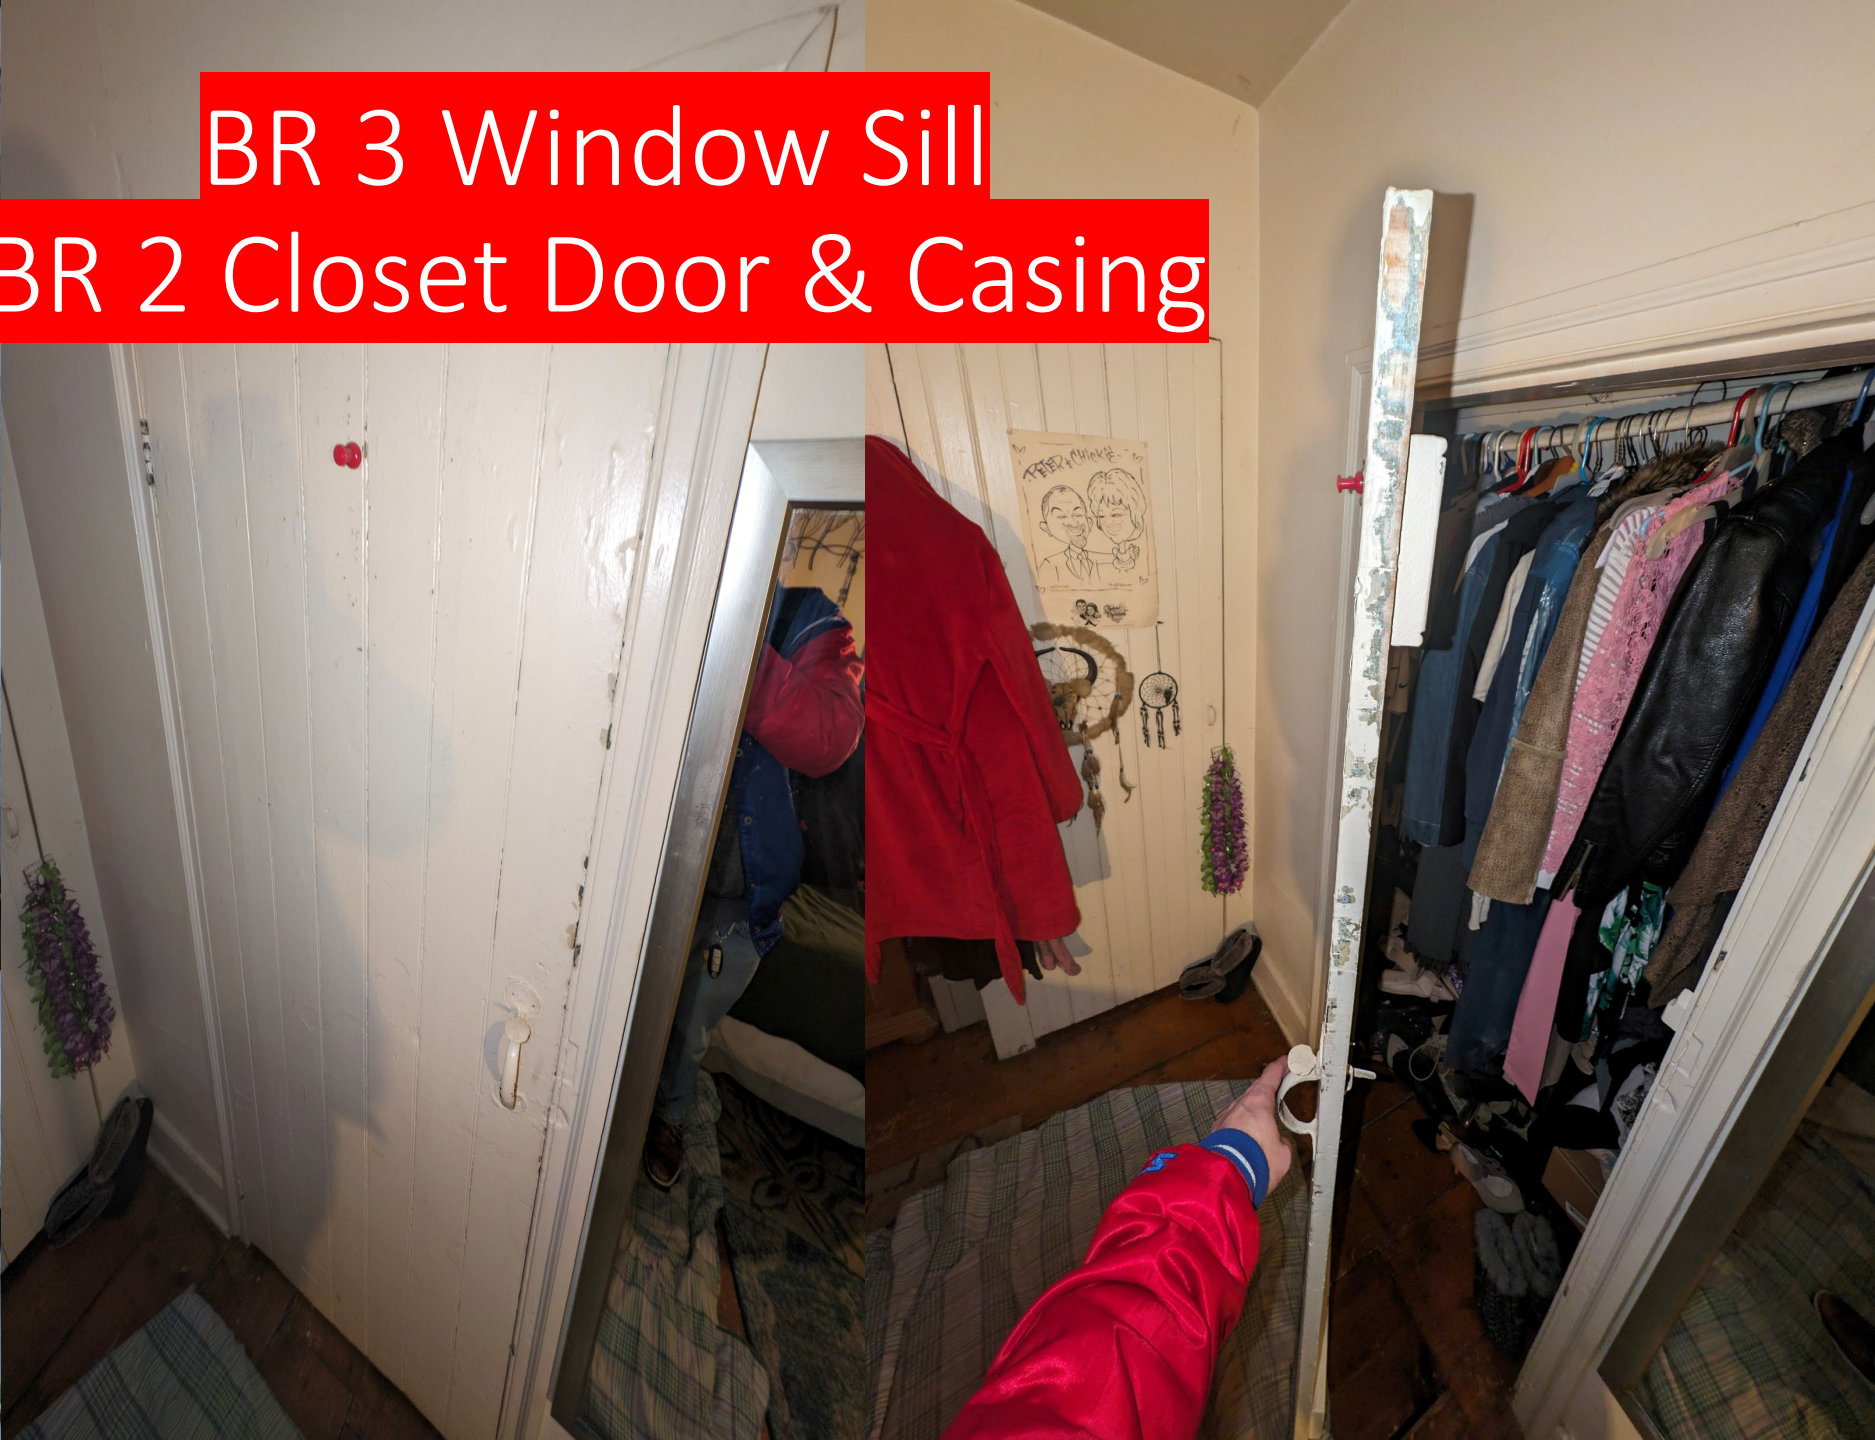
BR 3 Window Sill
BR 2 Closet Door & Casing

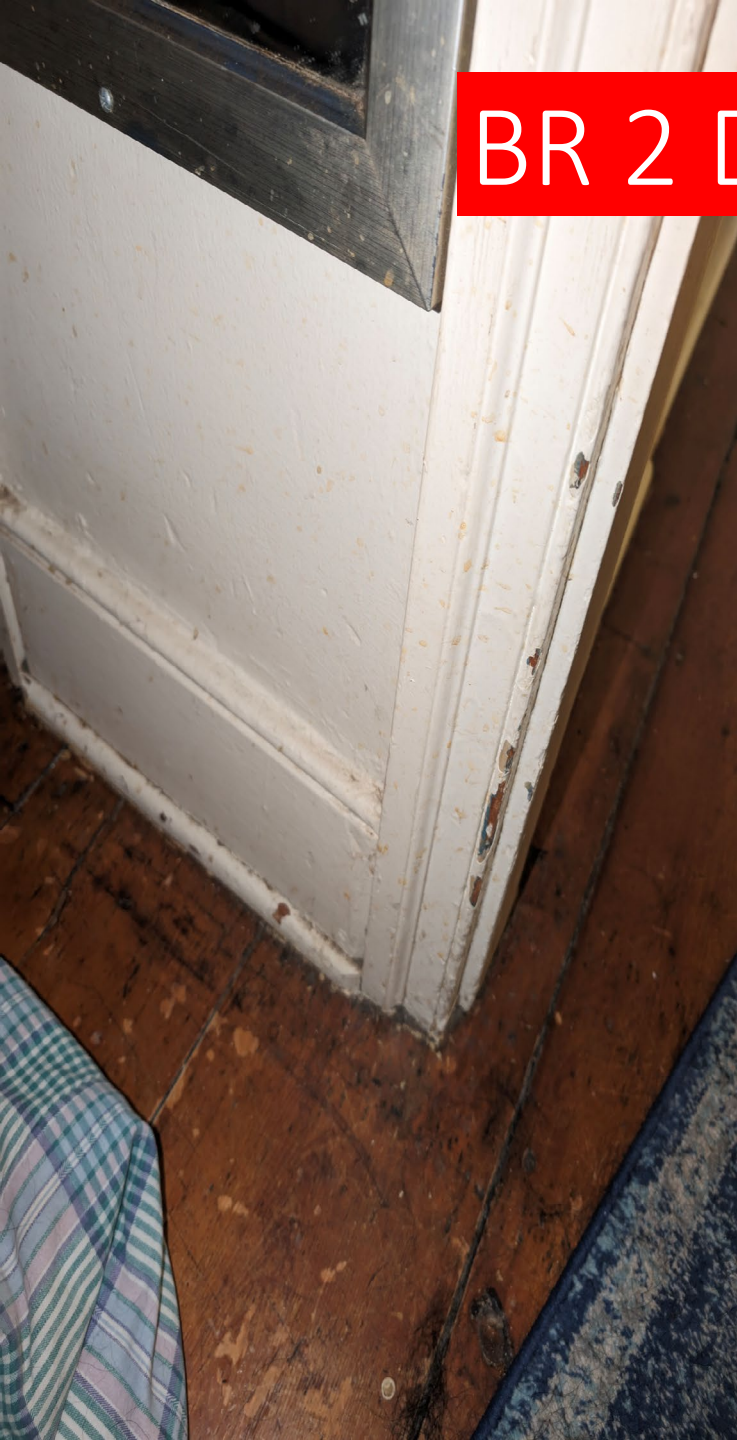
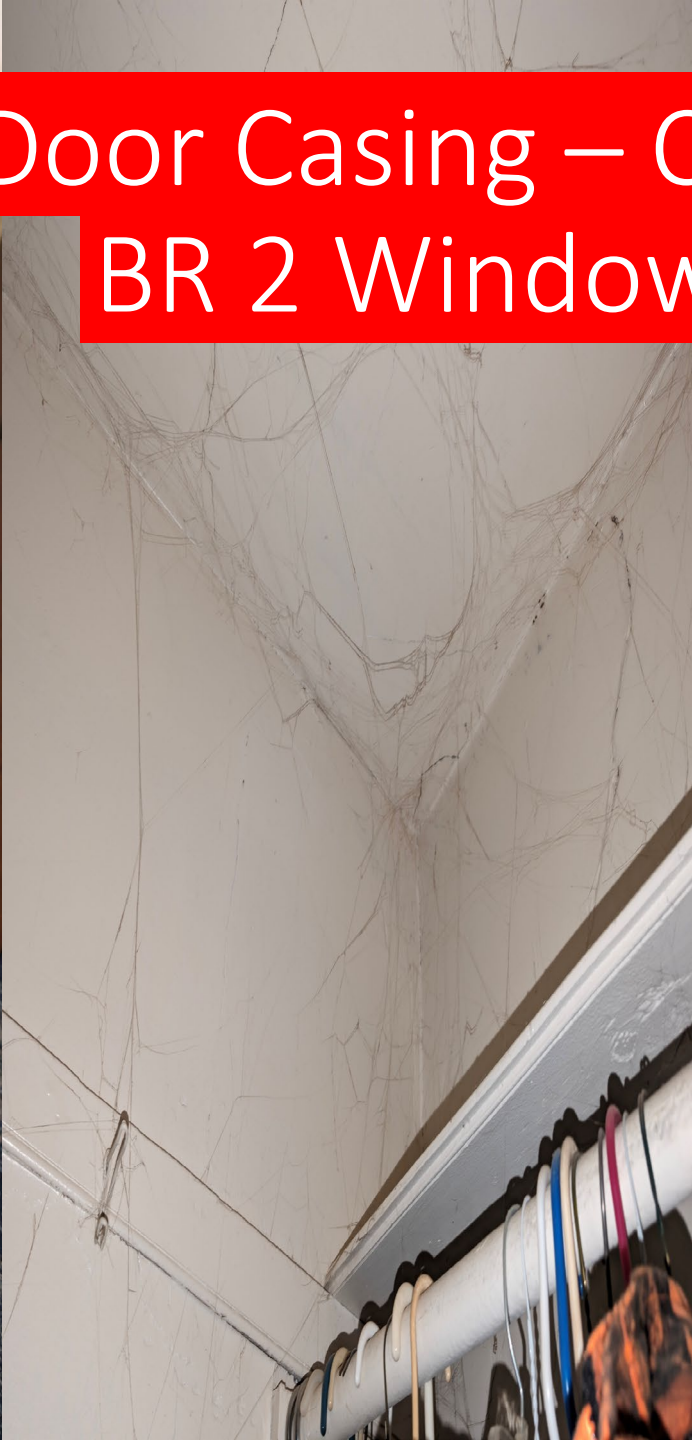
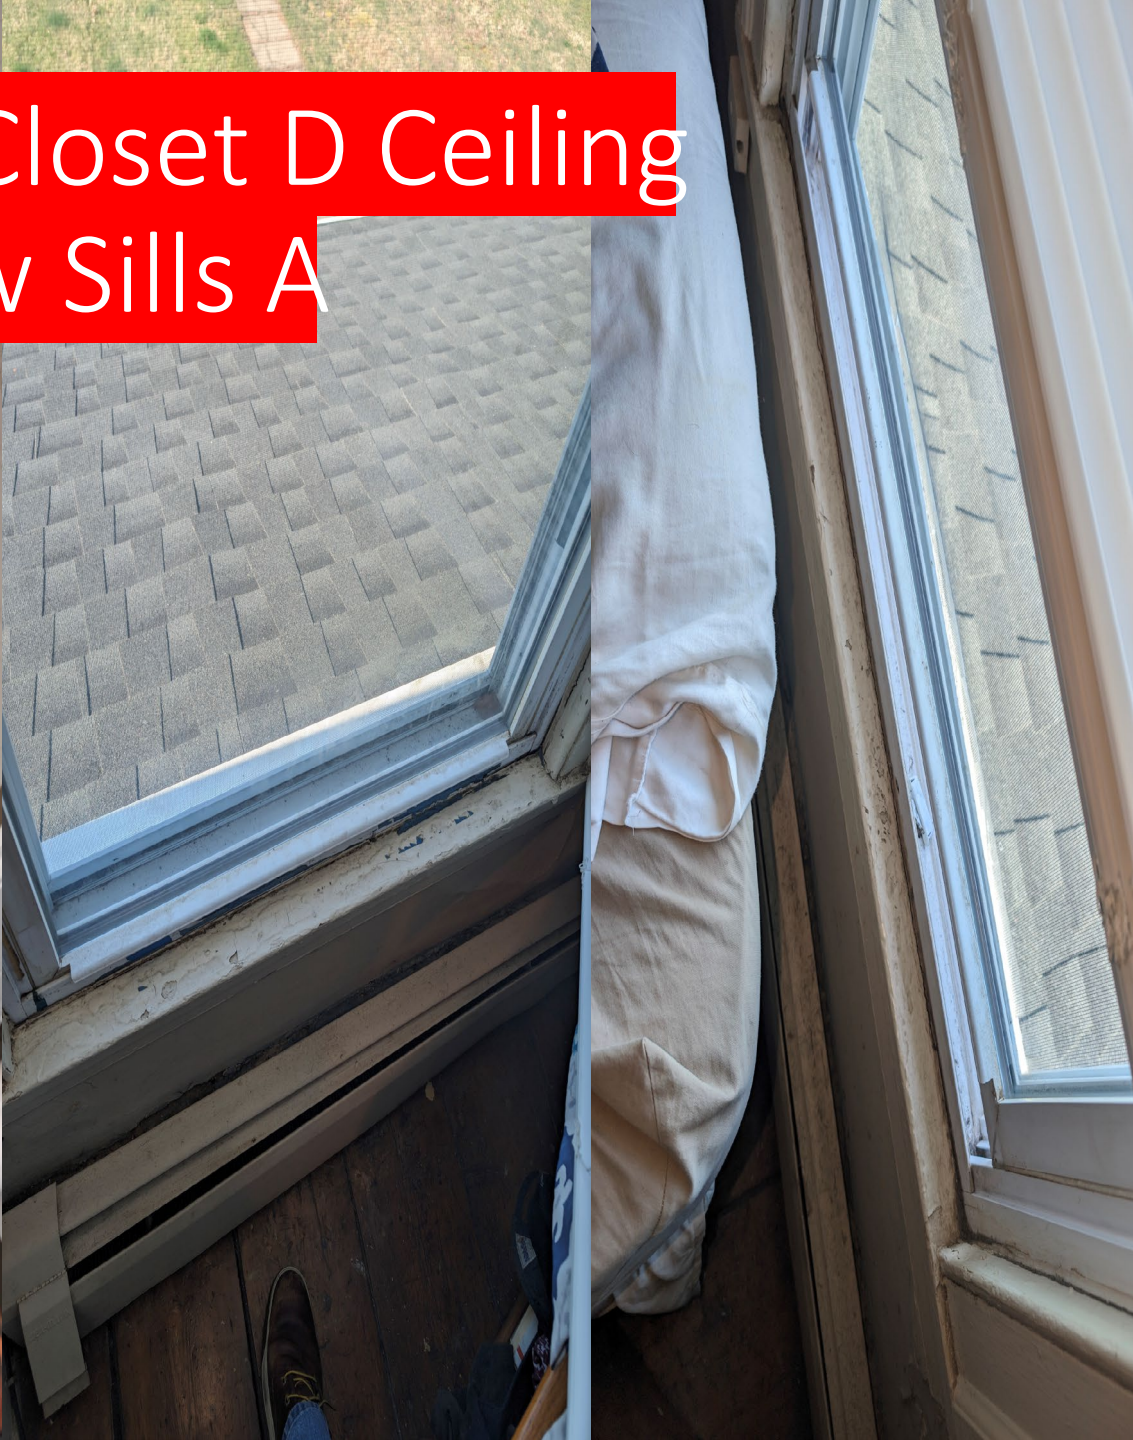
BR 2 Door Casing – Closet D Ceiling
BR 2 Window Sills A
