## LEAD-BASED PAINT EVALUATION REPORT DWELLING UNIT(S) INSPECTION

5 Ike Lane – Unit B, Netcong, NJ, 07857

Inspection Date: 03/12/2024  
Project Number: 1468

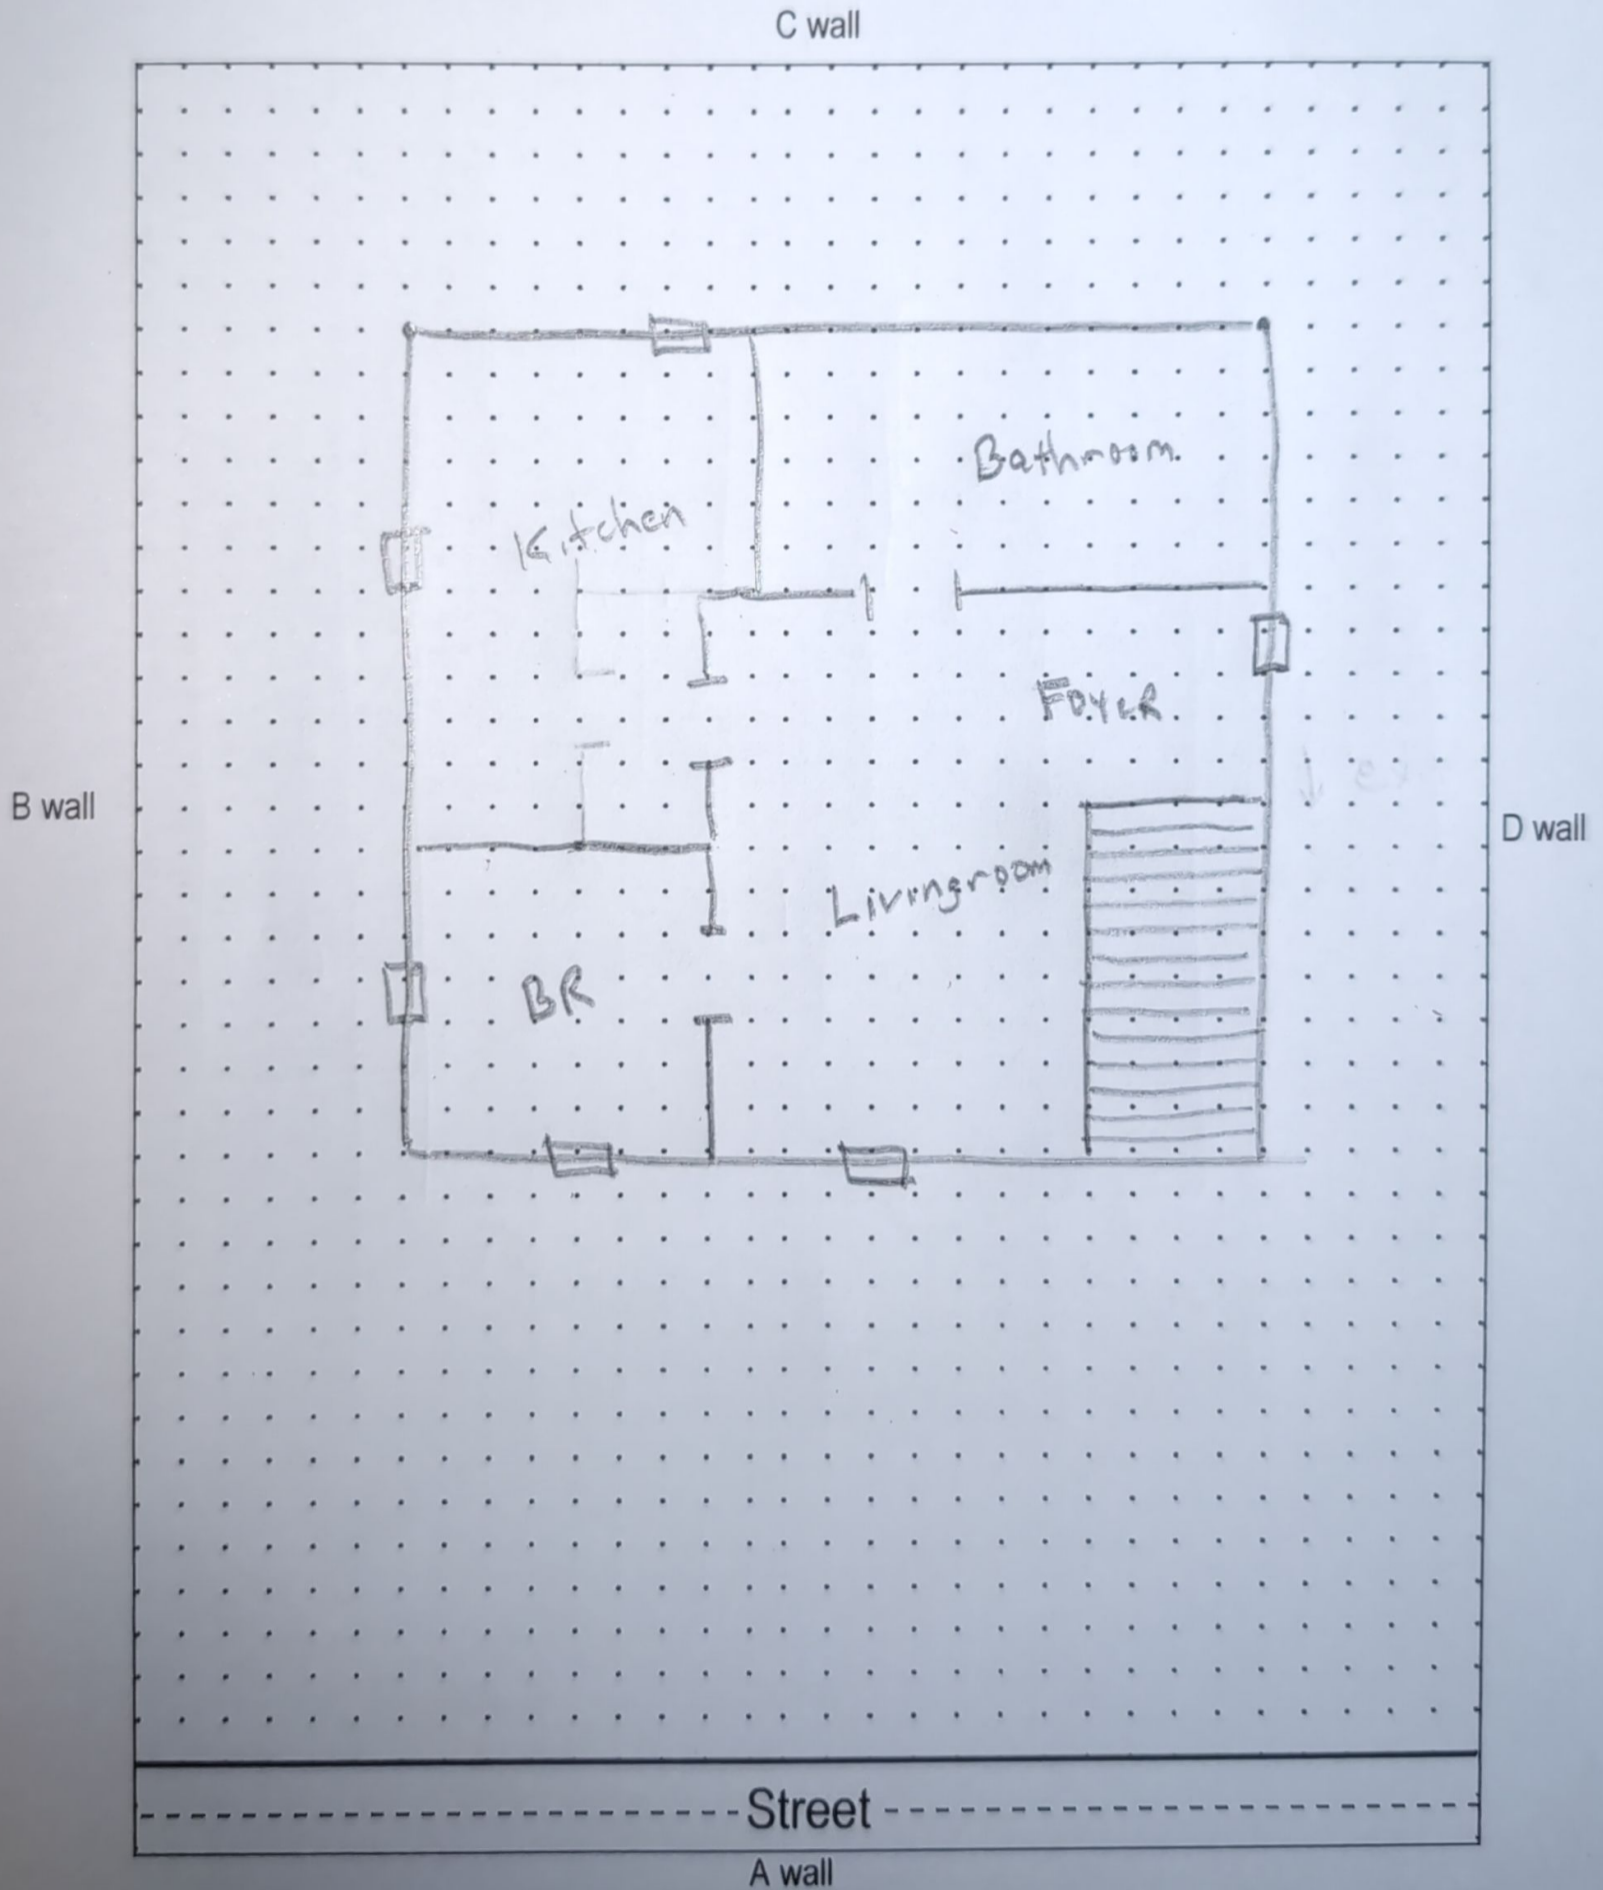
Floor Plan

When reviewing Appendix A "Floor Plan" and Appendix B "Lead-Based Paint Evaluation Report", you will notice that the letters A, B, C, and D are used to identify the location of specific components. The key to correct orientation is the location of the "A" wall, which is depicted on the floor plan or in the Executive Summary. The "B" wall, "C" wall, and "D" wall run clockwise from the "A" wall. The Lead-Based Paint Evaluation Report lists this information under the "Wall" column. The "Location" column uses numbering of replicated components starting with "1" at left and continuing sequentially to right respectively to describe the location of the component while facing the wall identified.

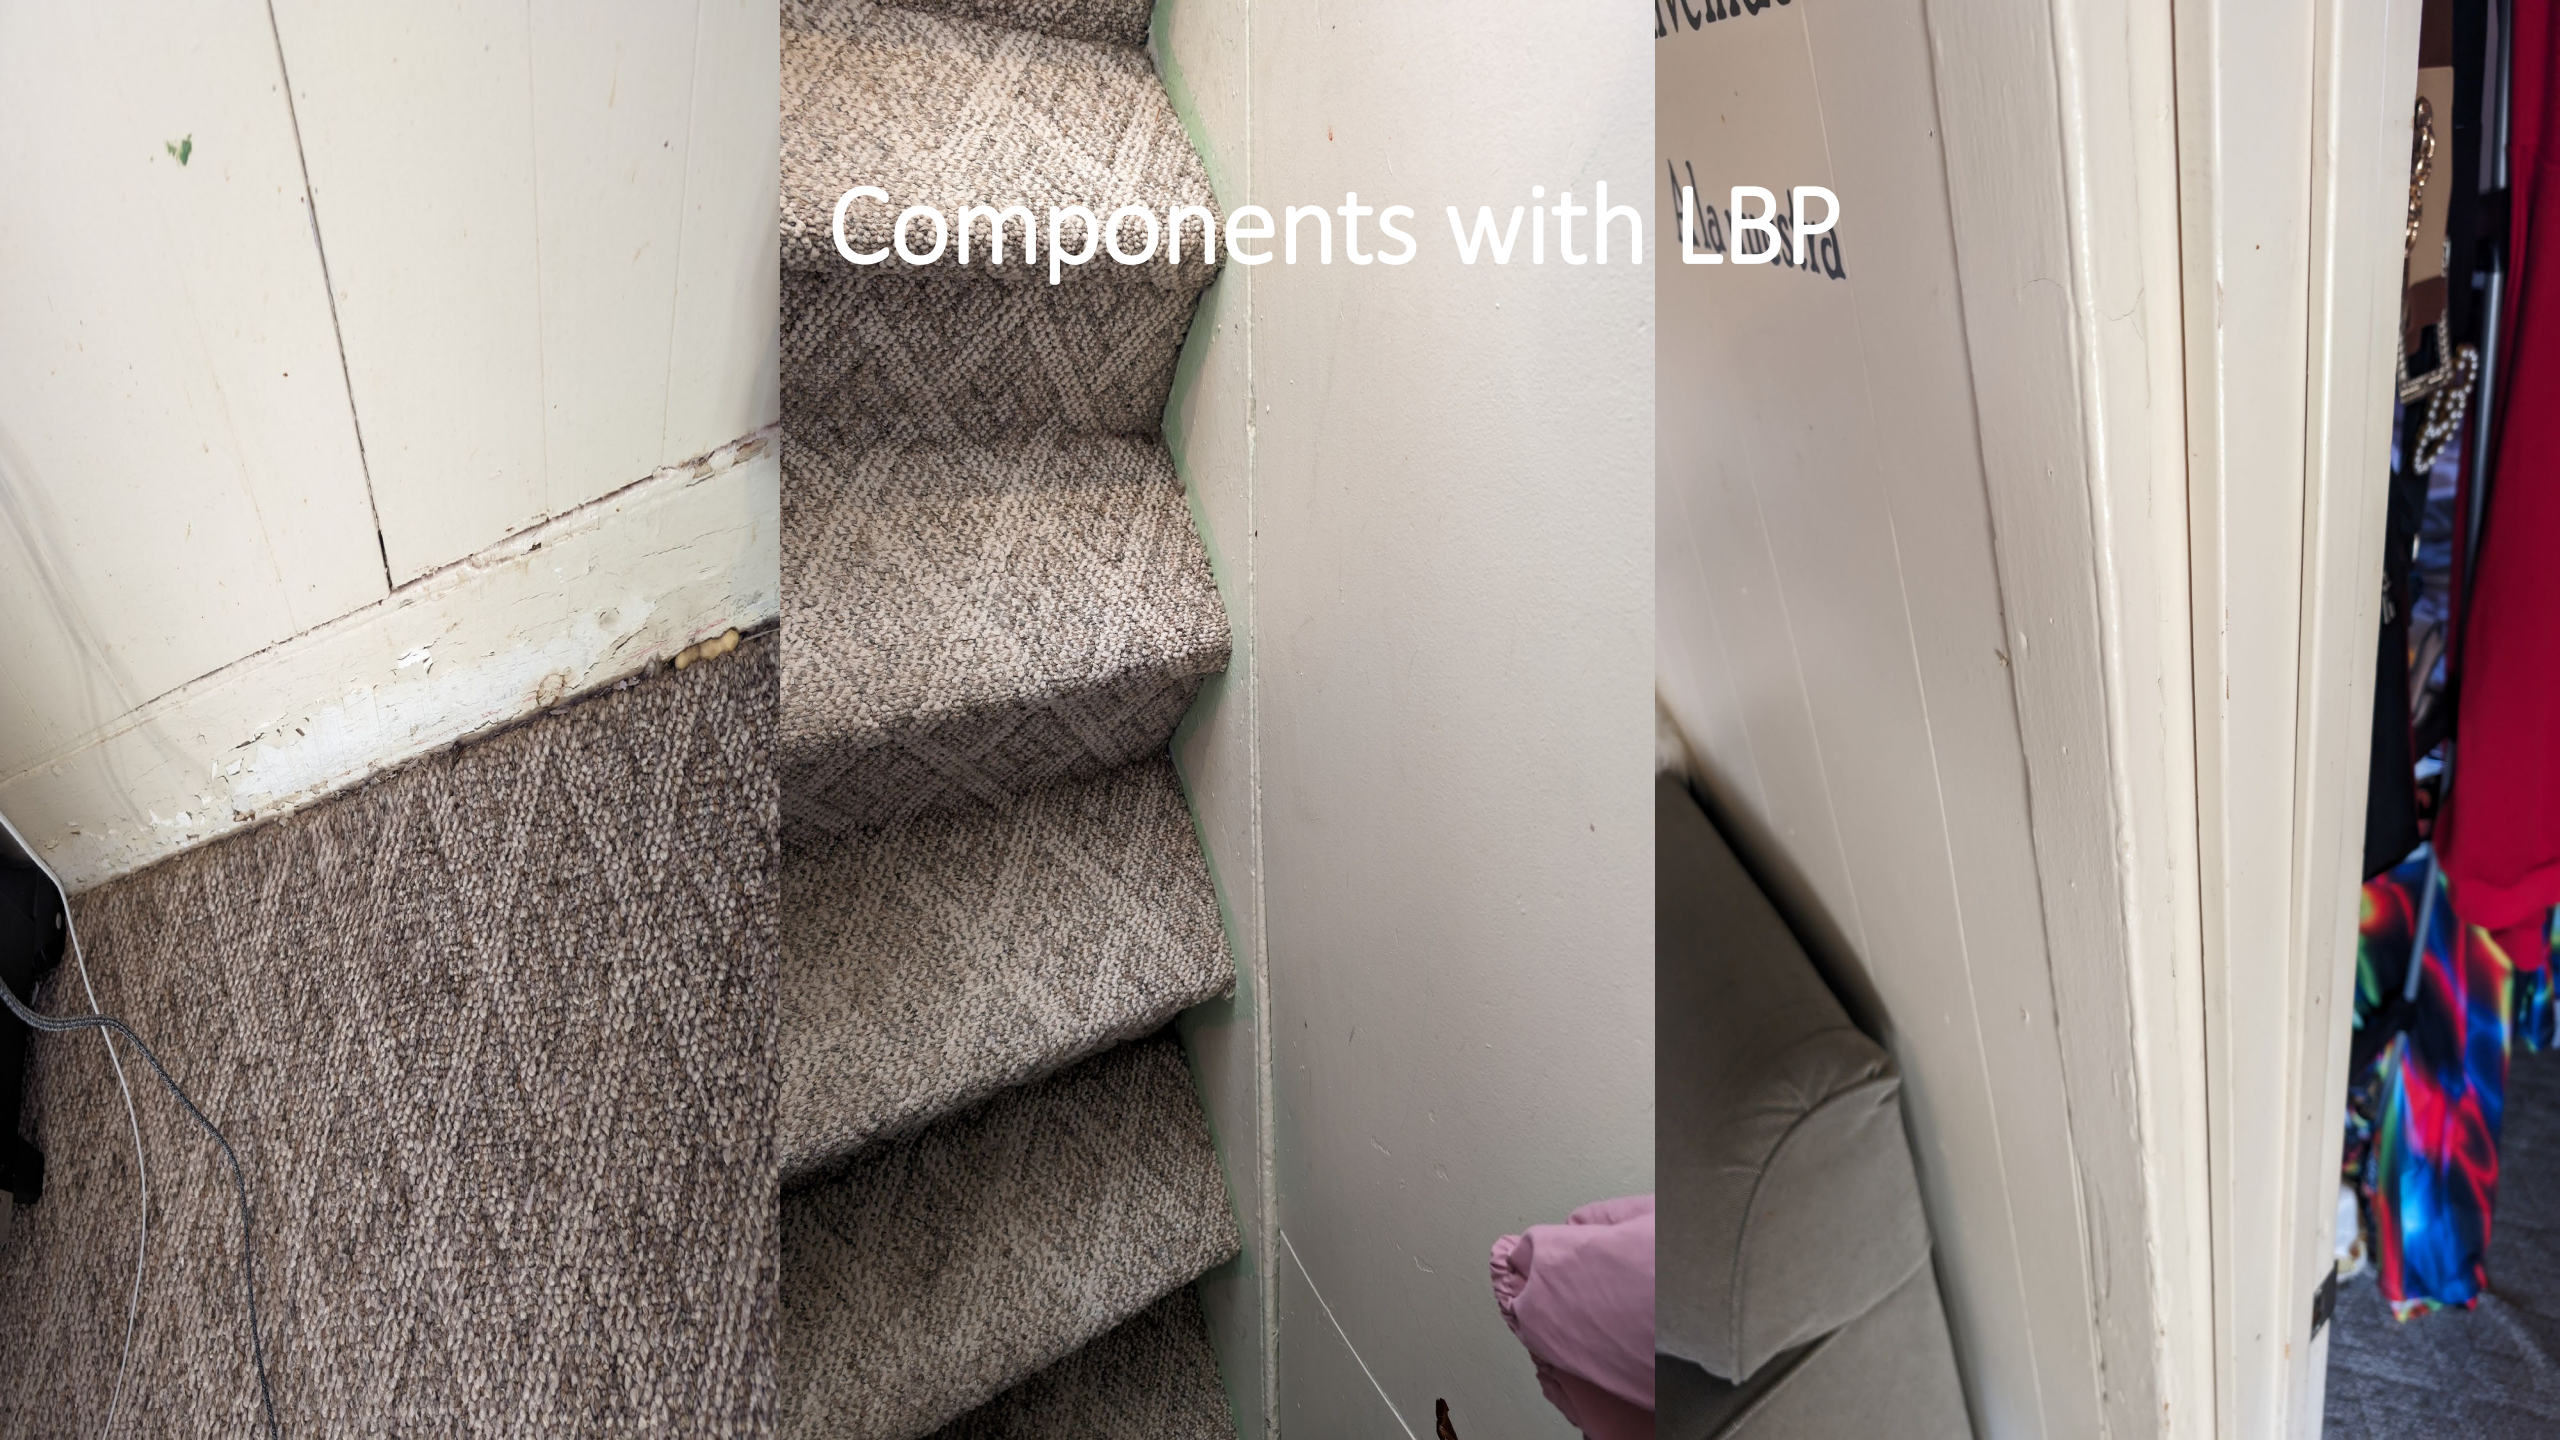
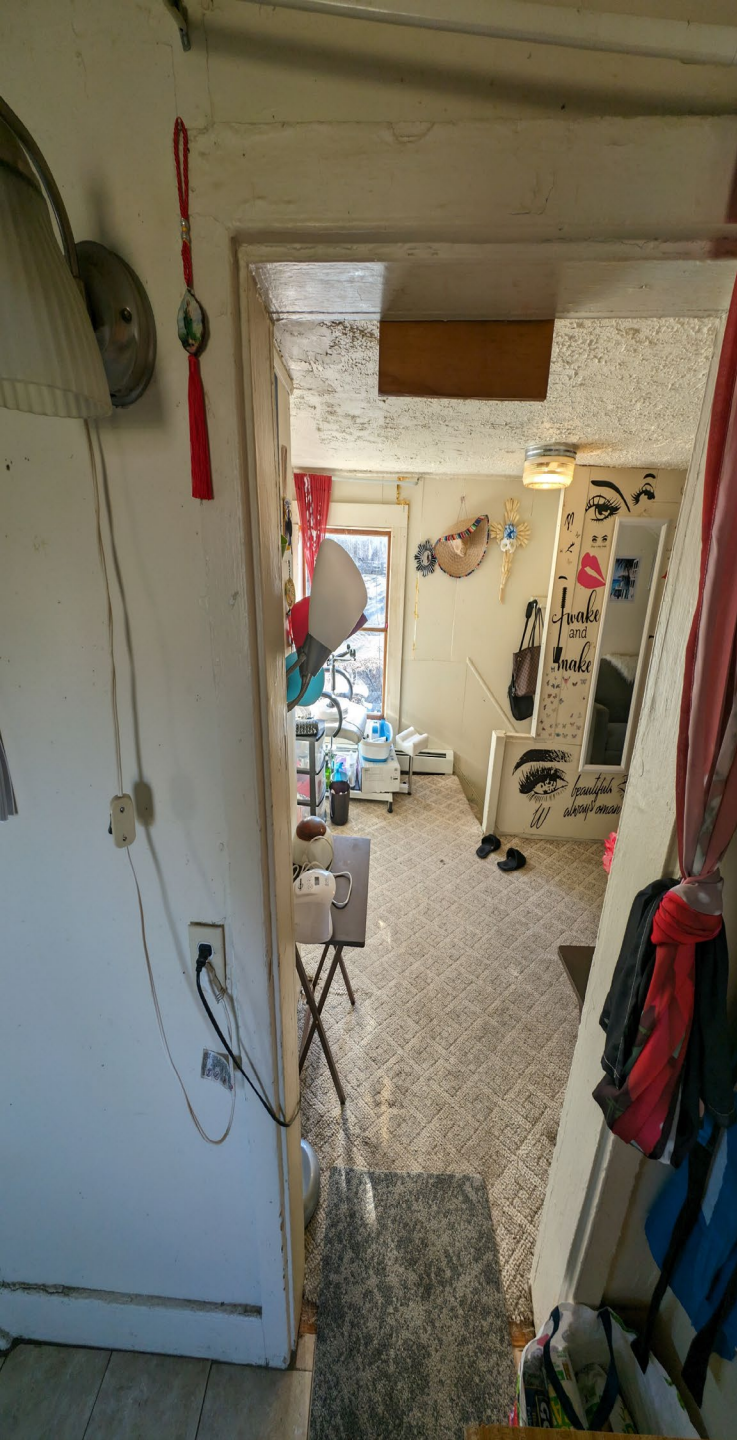
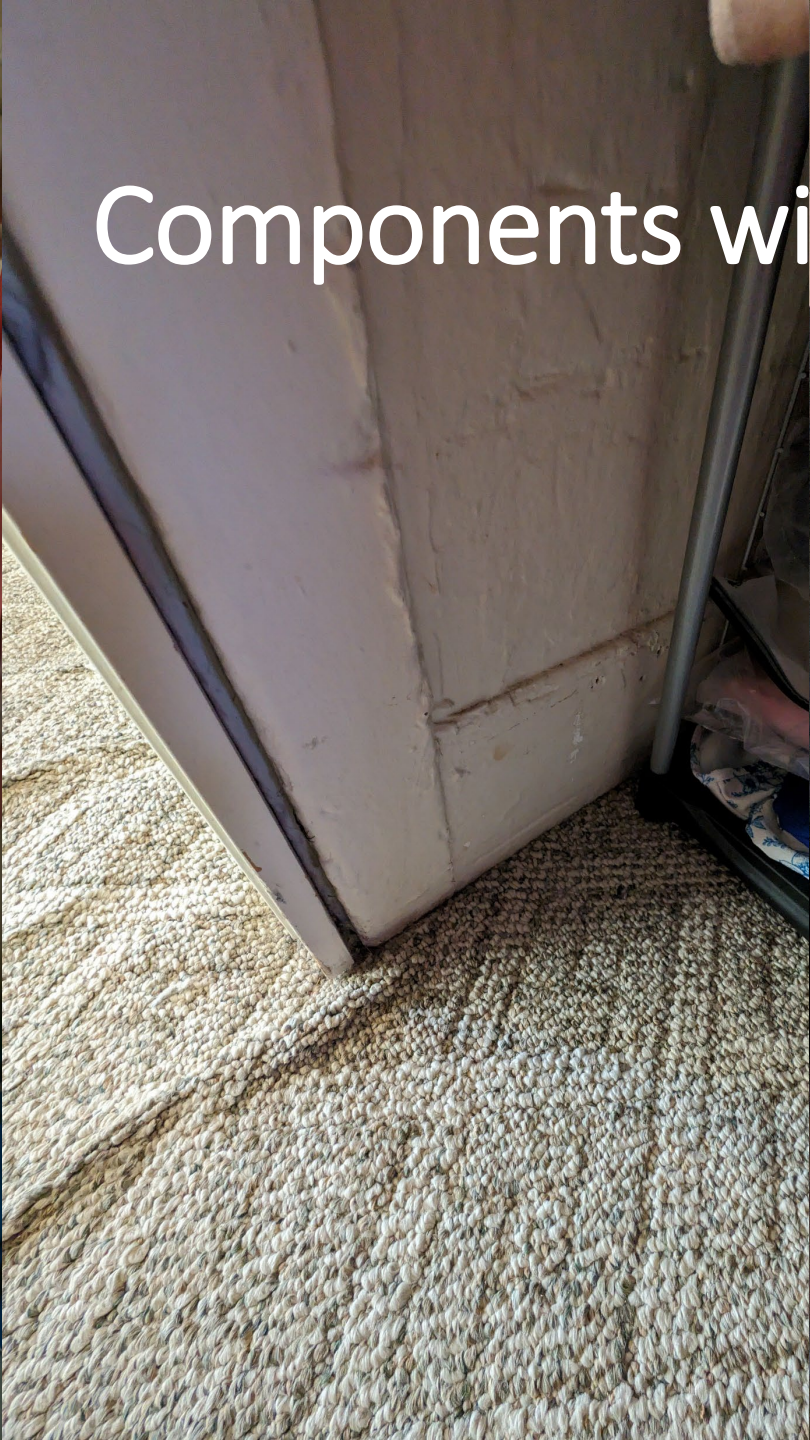
Unit #	Room	Structure	Member	Substrate	Wall
2	Stairwell	Stair	Stringer	Wood	D
2	Living Room	Room	Baseboard	Wood	A
2	Living Room	Door	Casing	Wood	B
2	Living Room	Door	Jamb	Wood	B
2	Bedroom	Door	Casing	Wood	D
2	Bedroom	Room	Baseboard	Wood	C
2	Kitchen	Room	Baseboard	Wood	D
2	Kitchen	Door	Casing	Wood	D
2	Kitchen	Door	Jamb	Wood	D
2	Bathroom	Door	Casing	Wood	A
2	Bathroom	Room	Baseboard	Wood	A

# Components with LBP

Components that are found to be positive for lead-based paint should be checked for deterioration. Lead-based paint in deteriorated condition is considered a paint-lead hazard. Those components should be address as soon as possible using lead safe work practices at a minimum. However, if any components are found to test positive for lead based paint, they should be considered for future component removal or paint stripping.
