Visual Paint Assessment Report

For: 43 Maple Ave – Netcong, NJ 07857
March 24, 2024

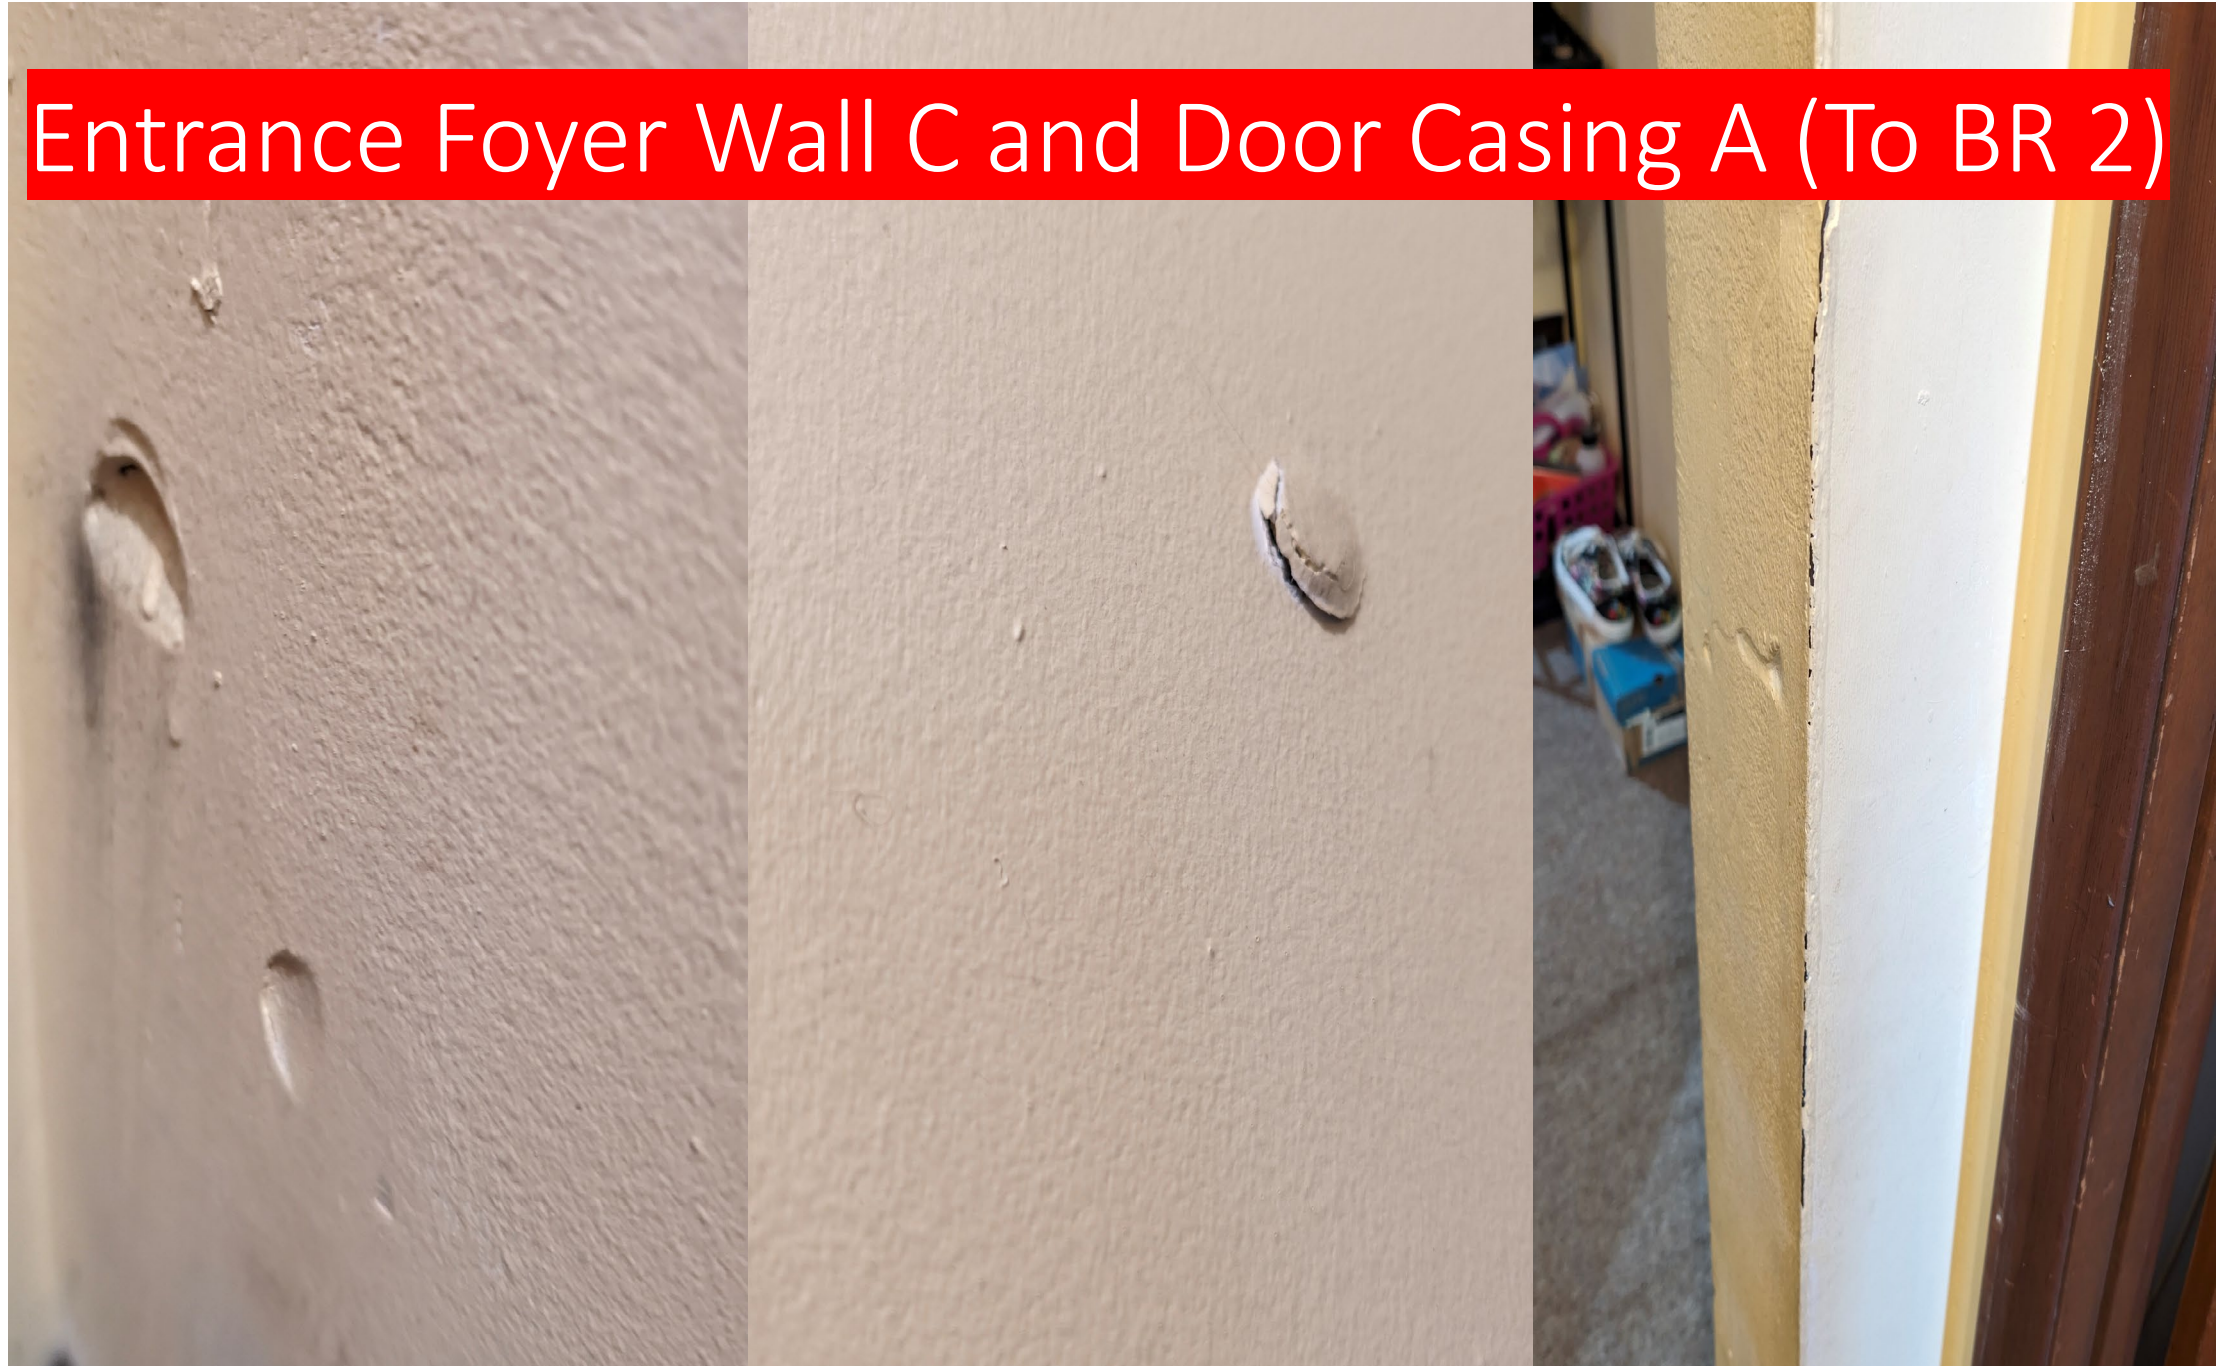
Entrance Foyer Wall C and Door Casing A (To BR 2)

Identified hazards shall be remediated using either abatement (permanent) or interim controls (temporary). Abatement shall be performed by a NJ Licensed lead abatement firm using licensed lead abatement supervisors and workers. Interim control work shall be performed by EPA RRP certified firms using an EPA certified RRP Renovator. After completion of interim control work, a lead-based paint post-remediation with dust wipes will be required. After completion of abatement work, a lead-based paint abatement clearance will be required.

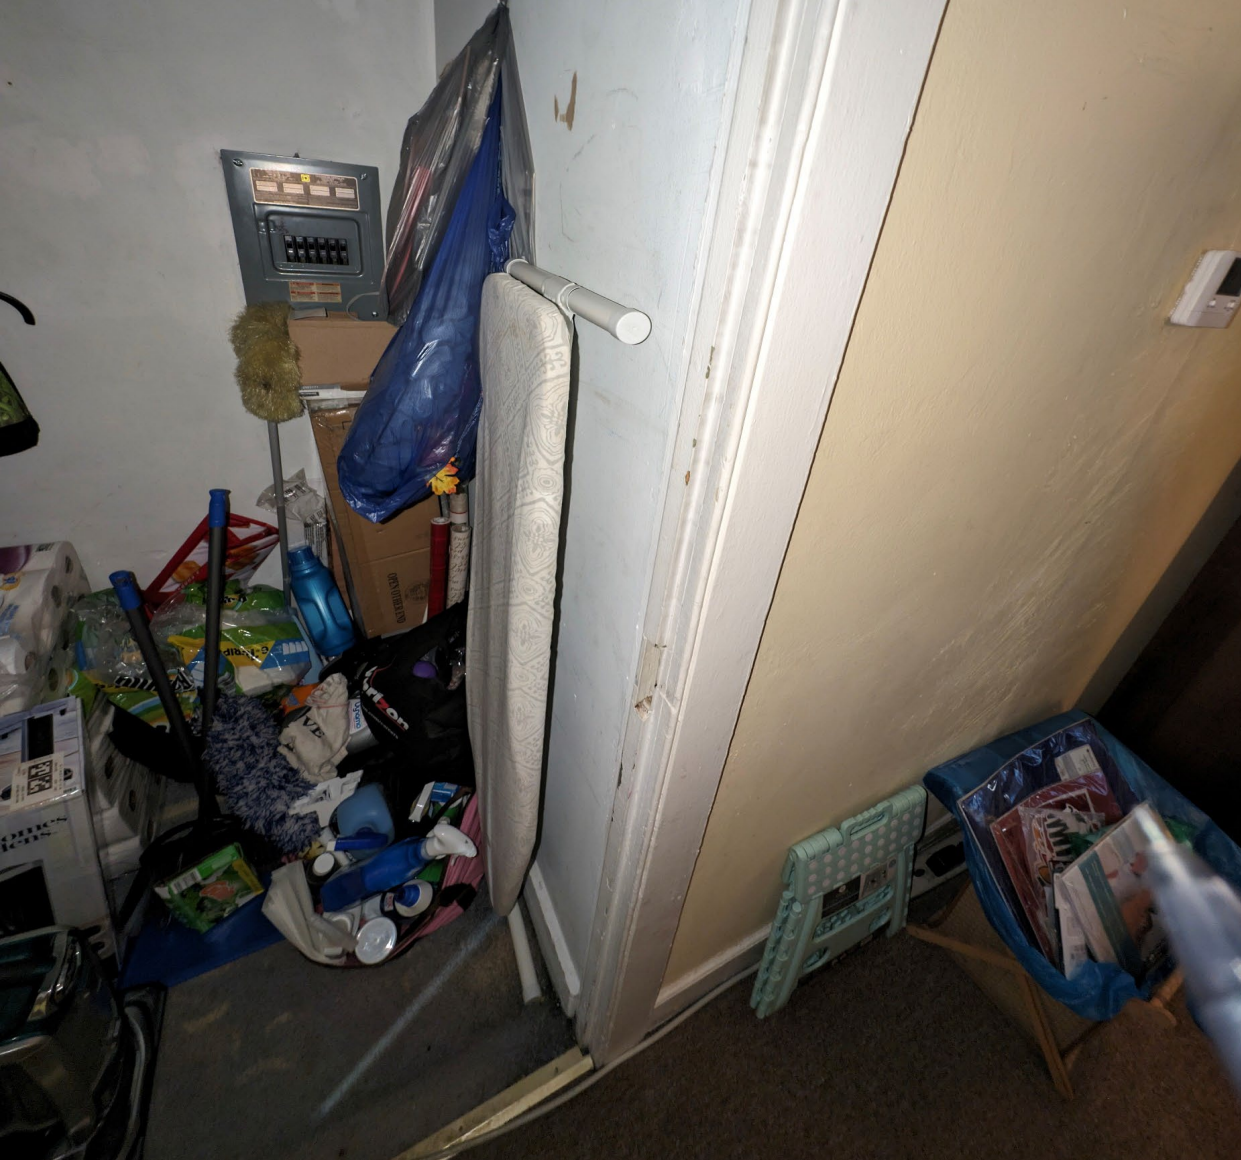
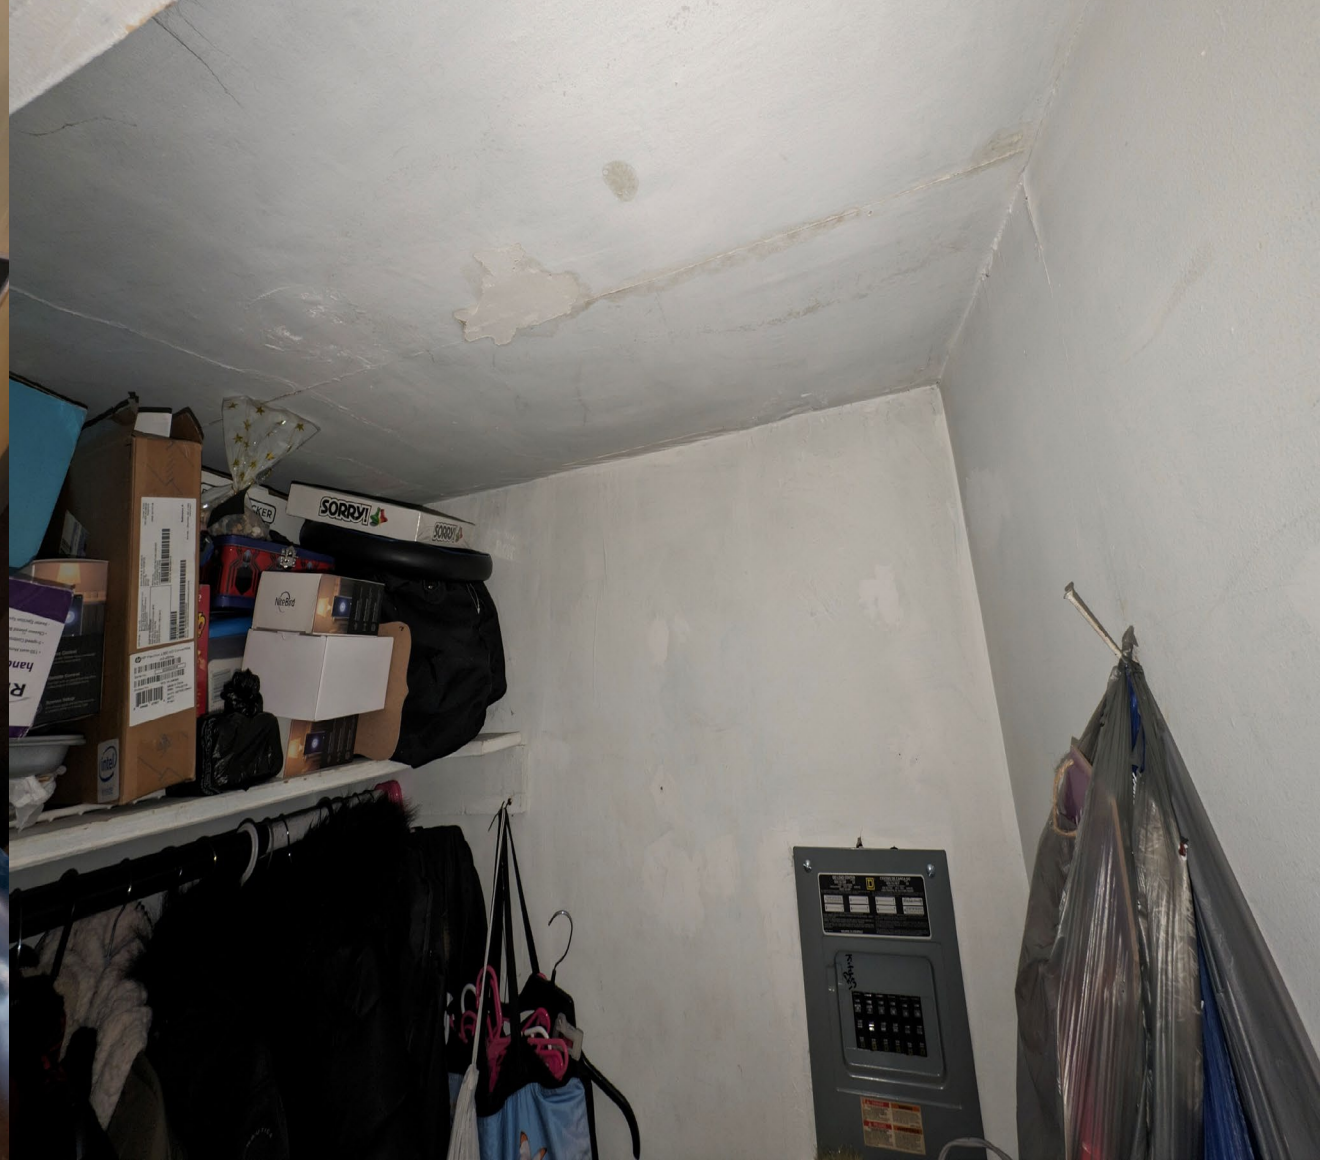
Closet Door Jamb/Wall A & Ceiling

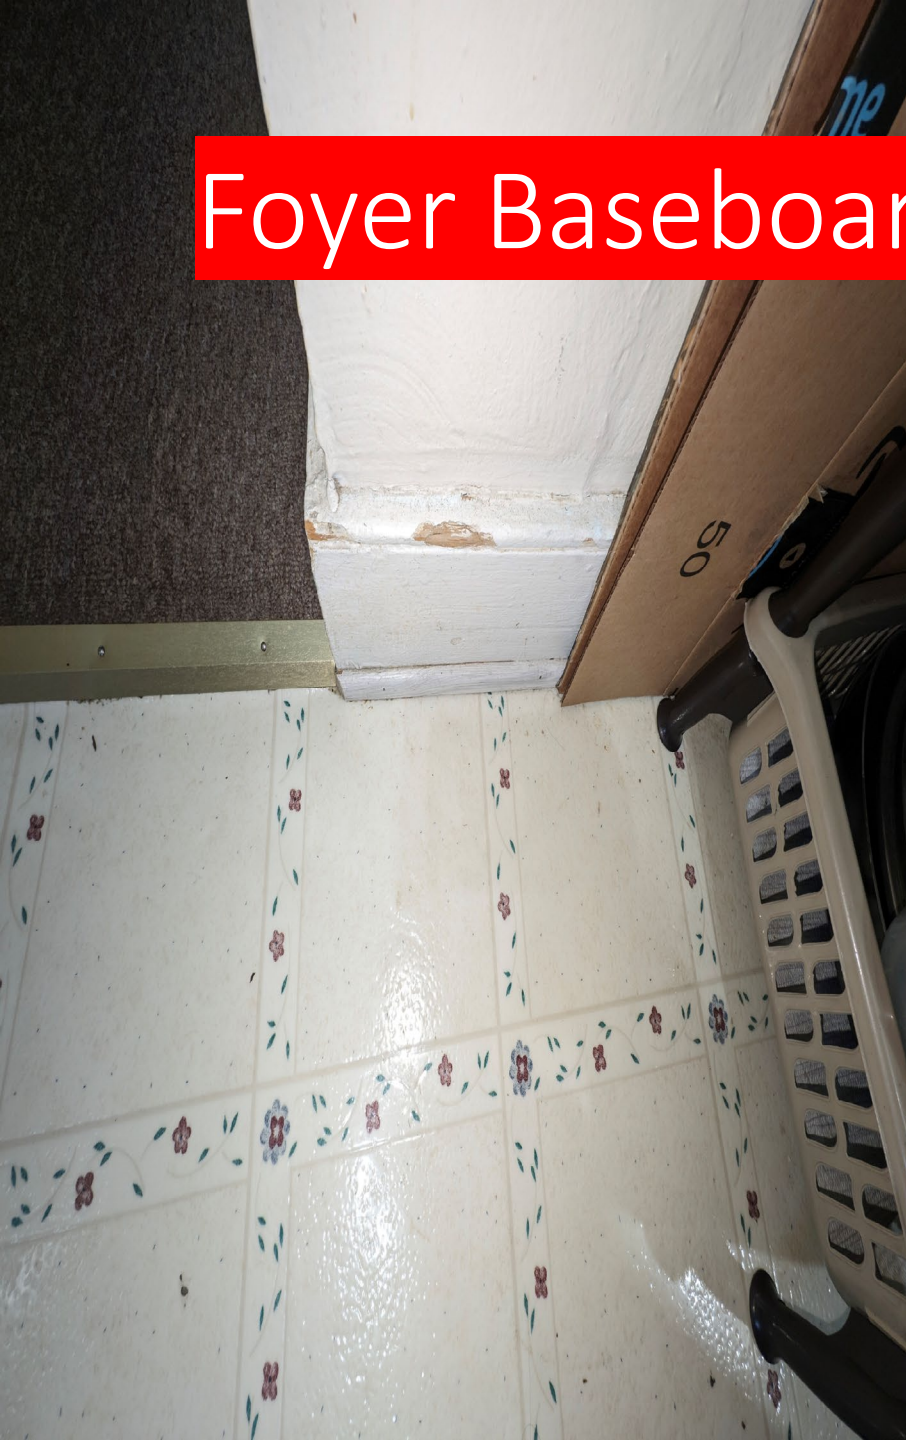
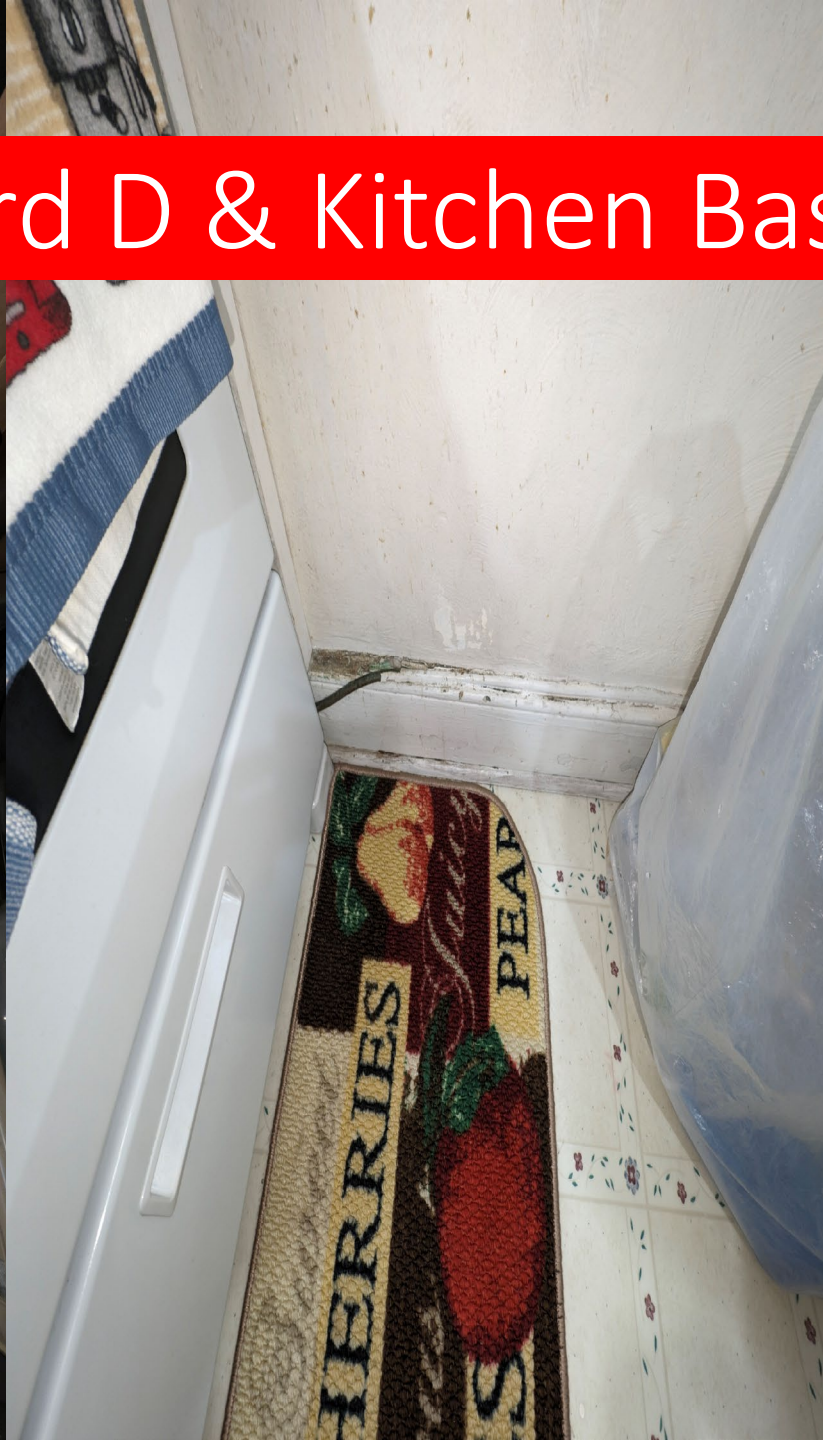
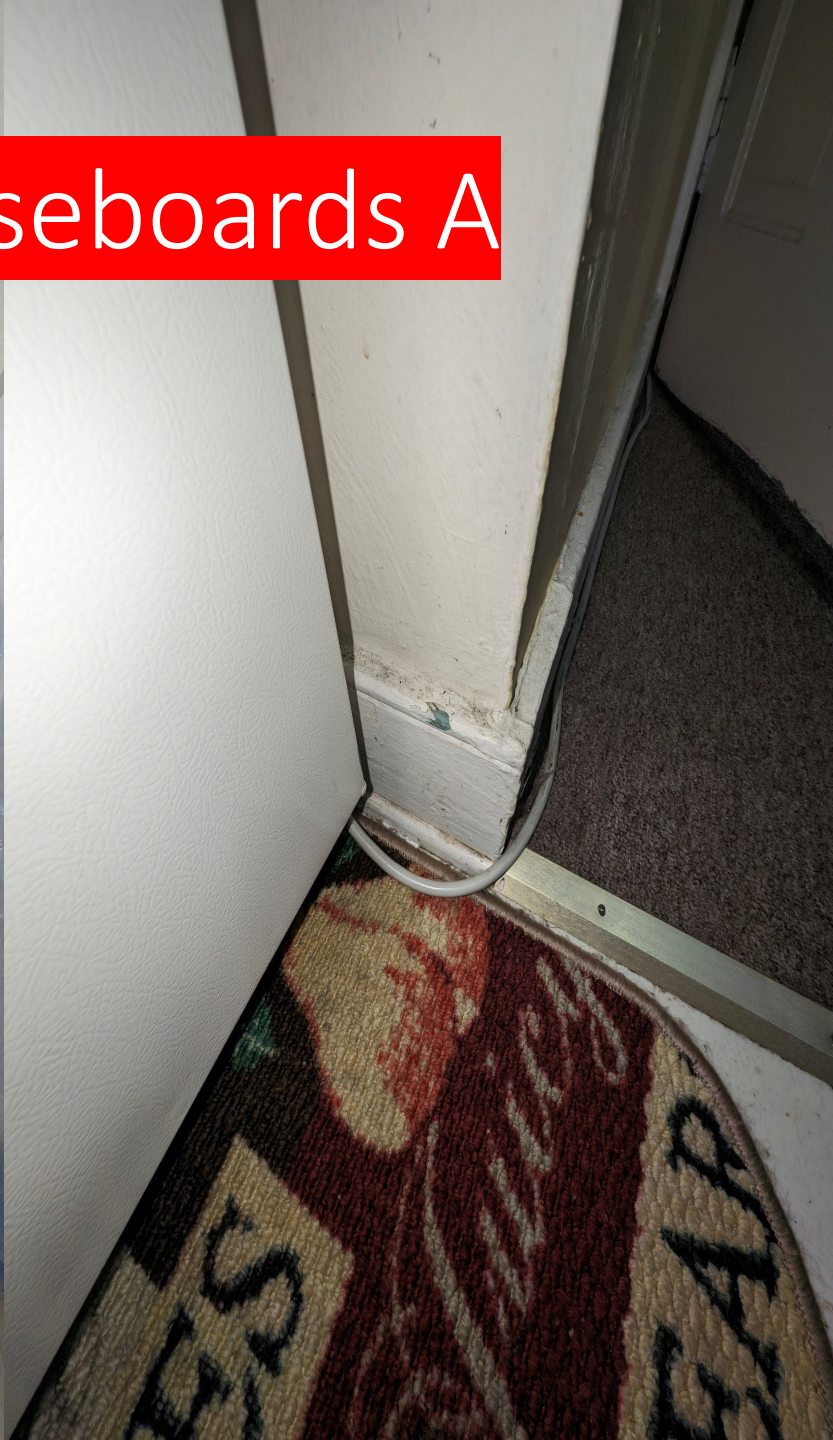
Foyer Baseboard D & Kitchen Baseboards A

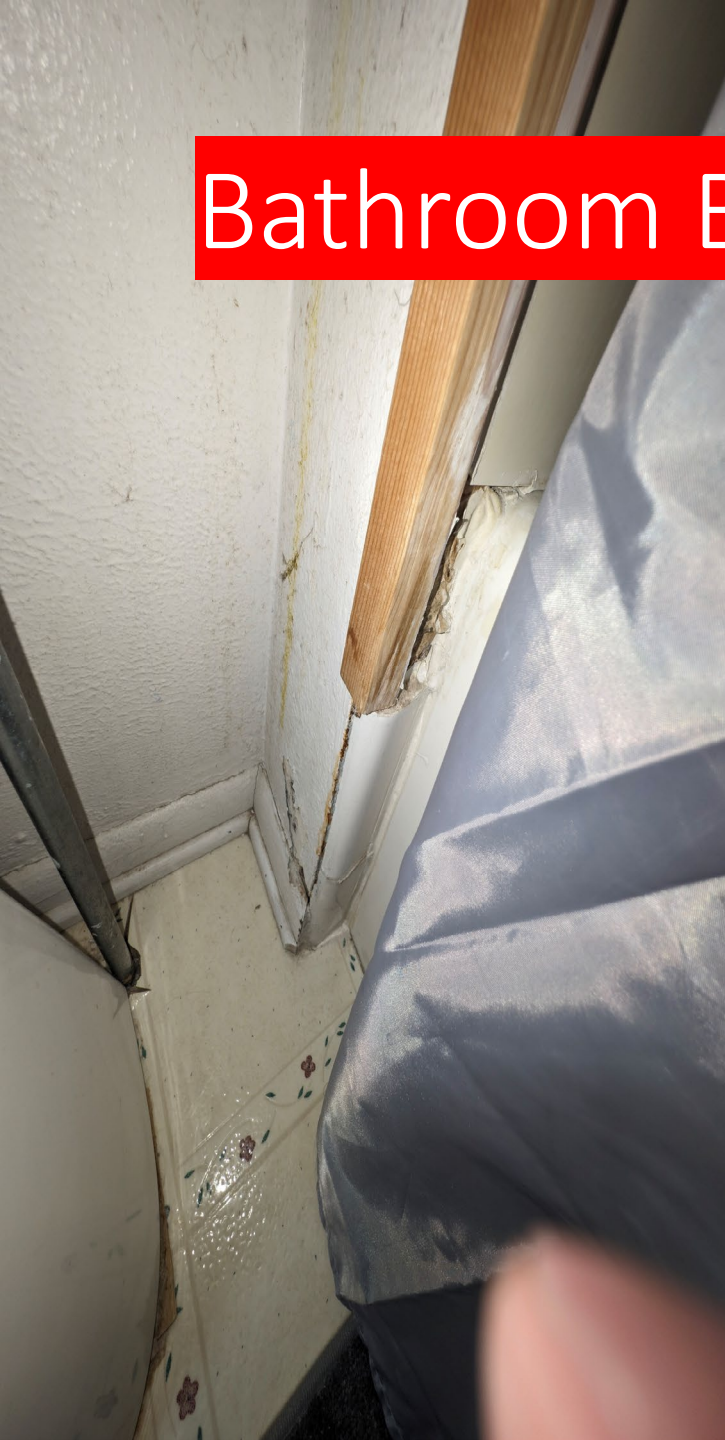
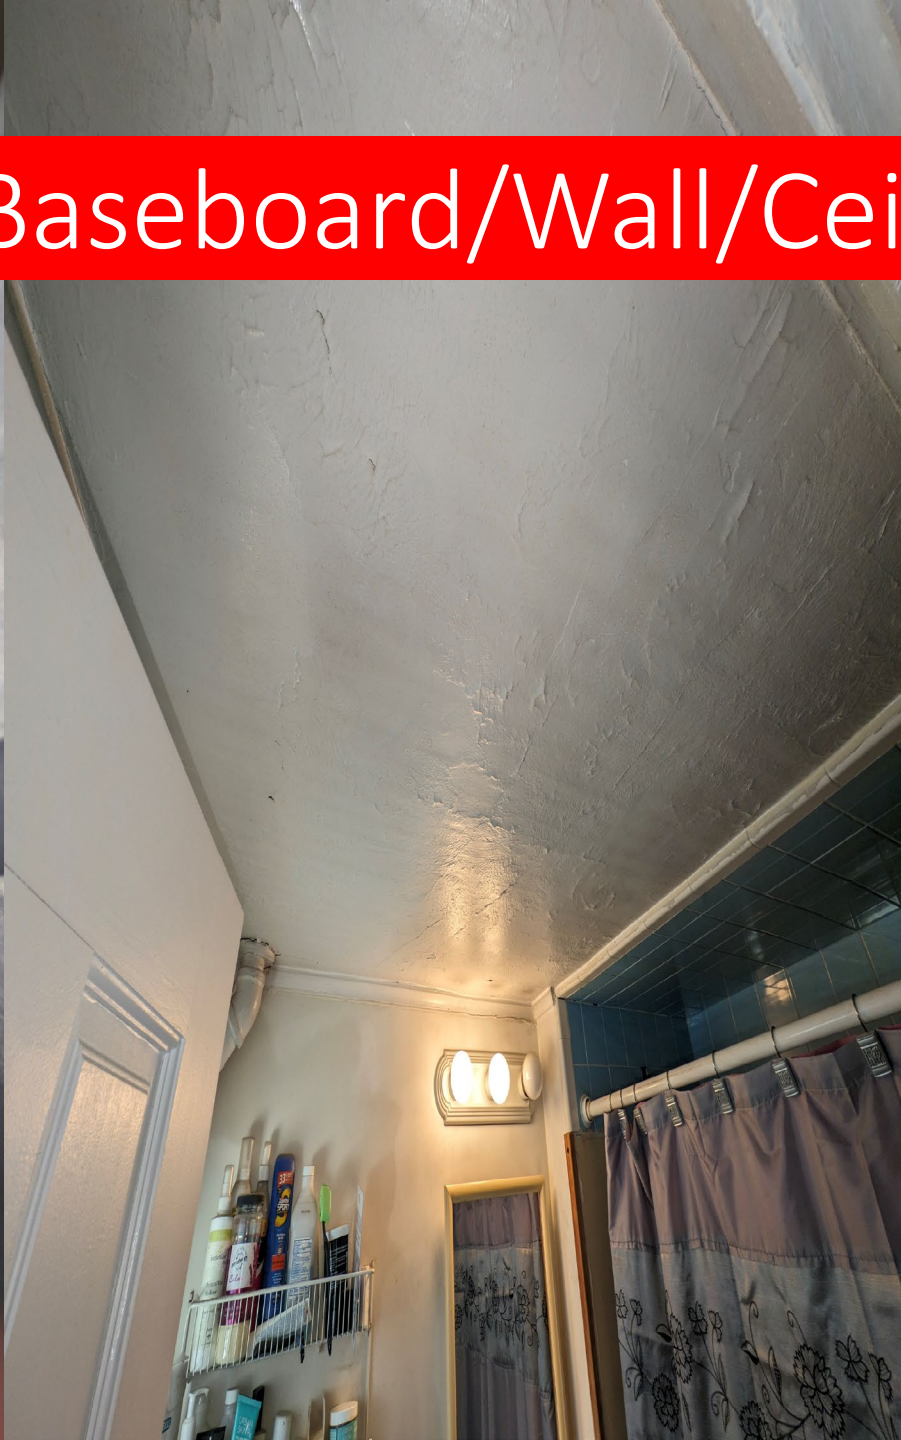
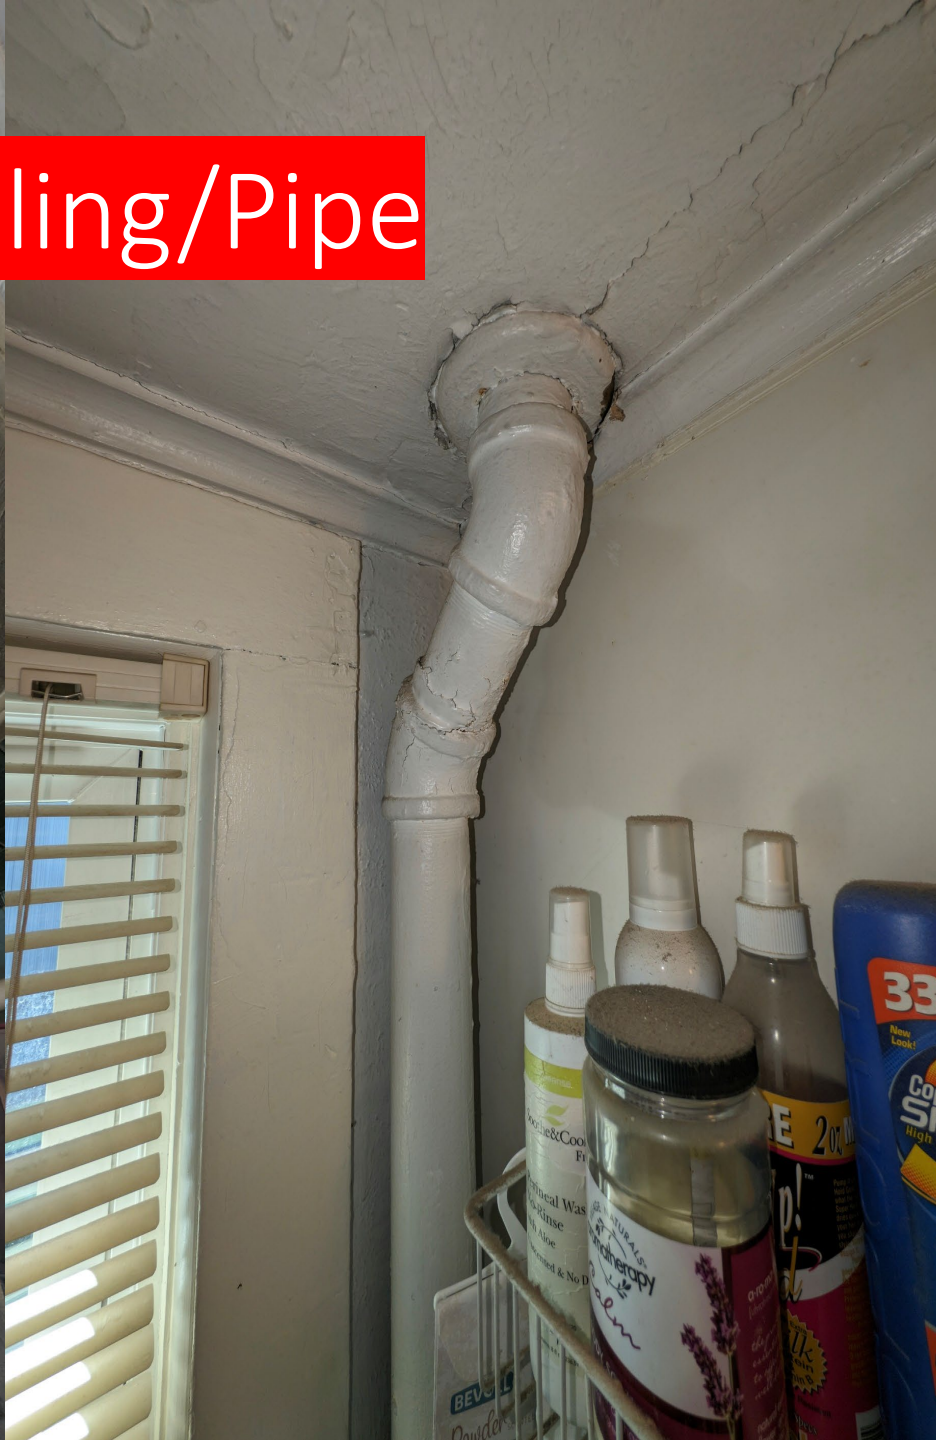
Bathroom Baseboard/Wall/Ceiling/Pipe

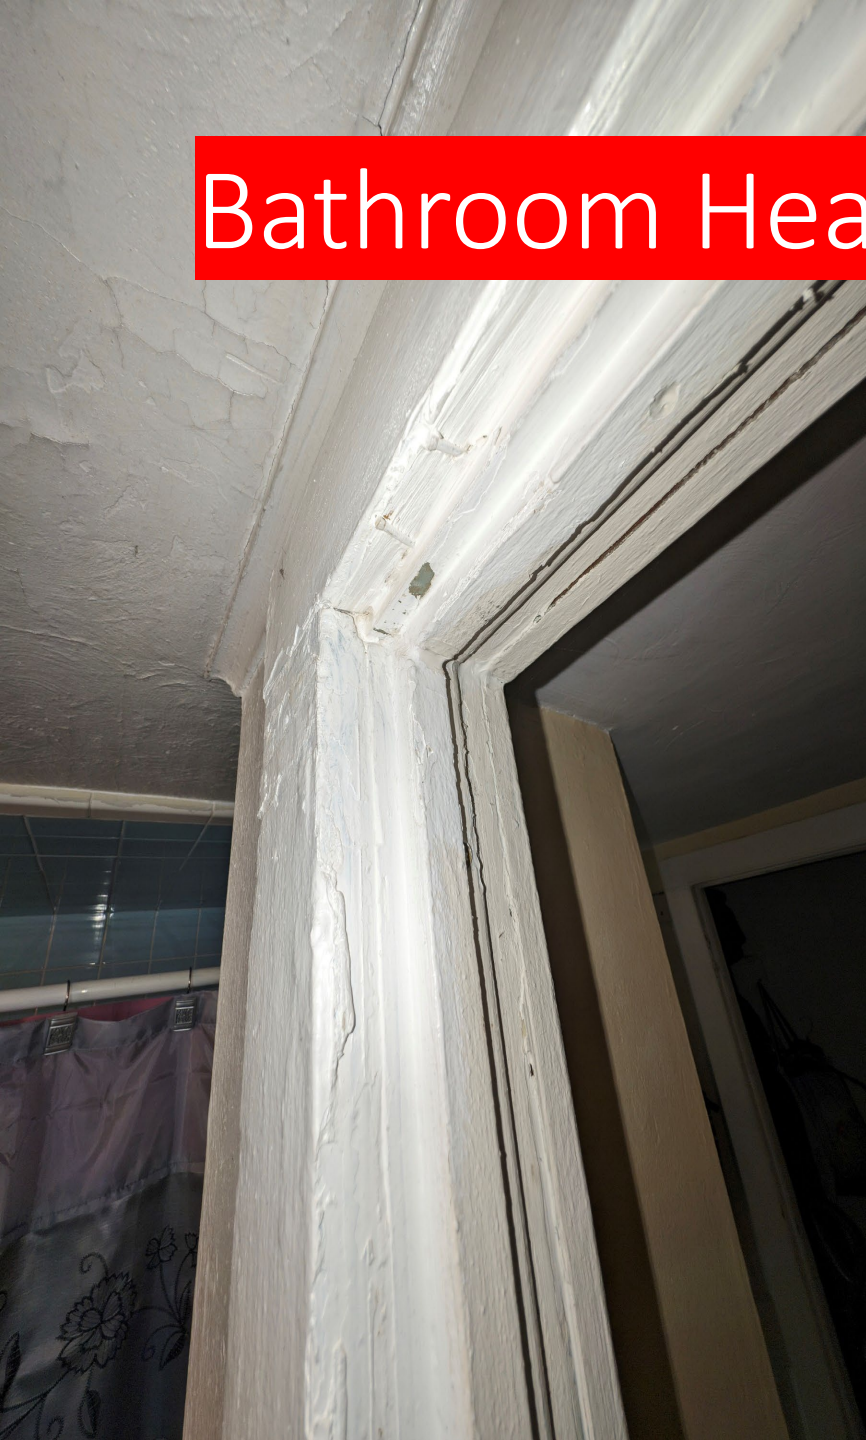
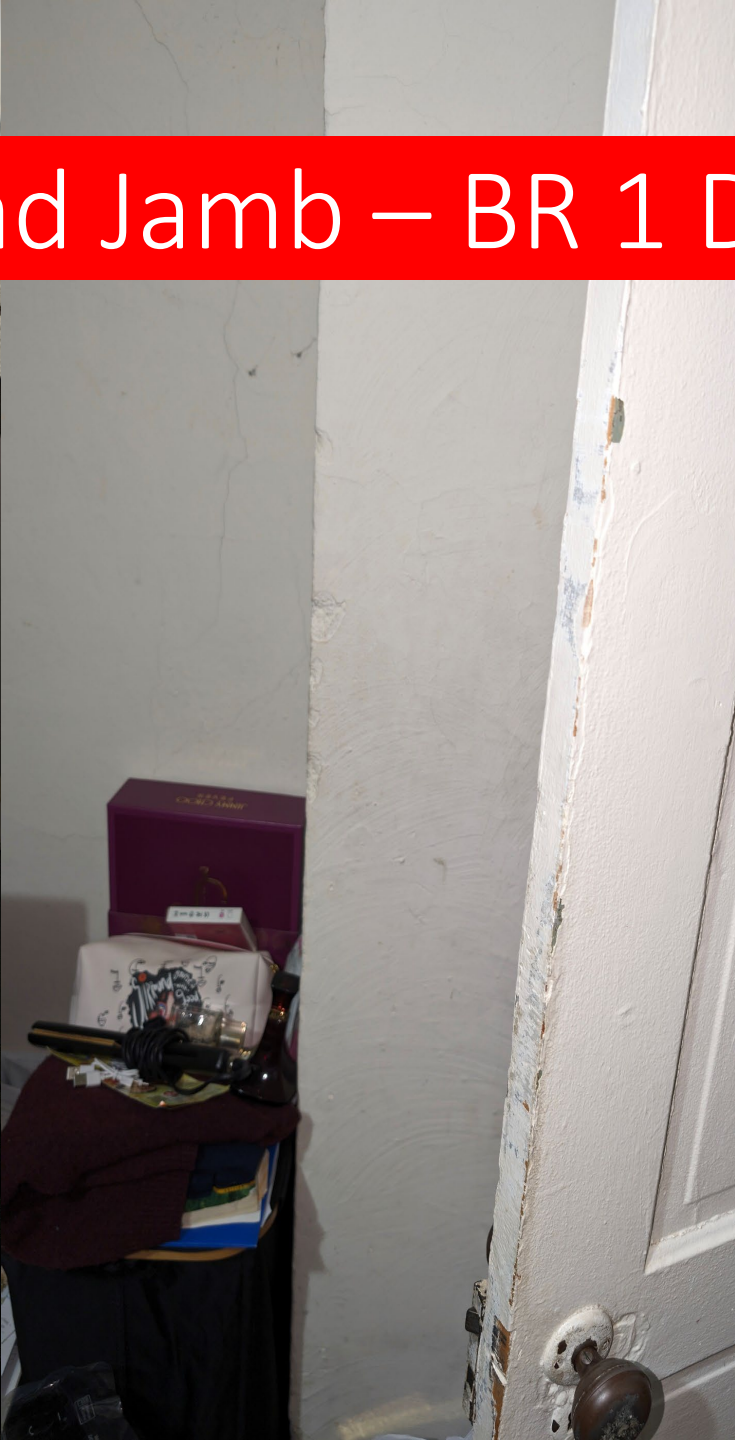
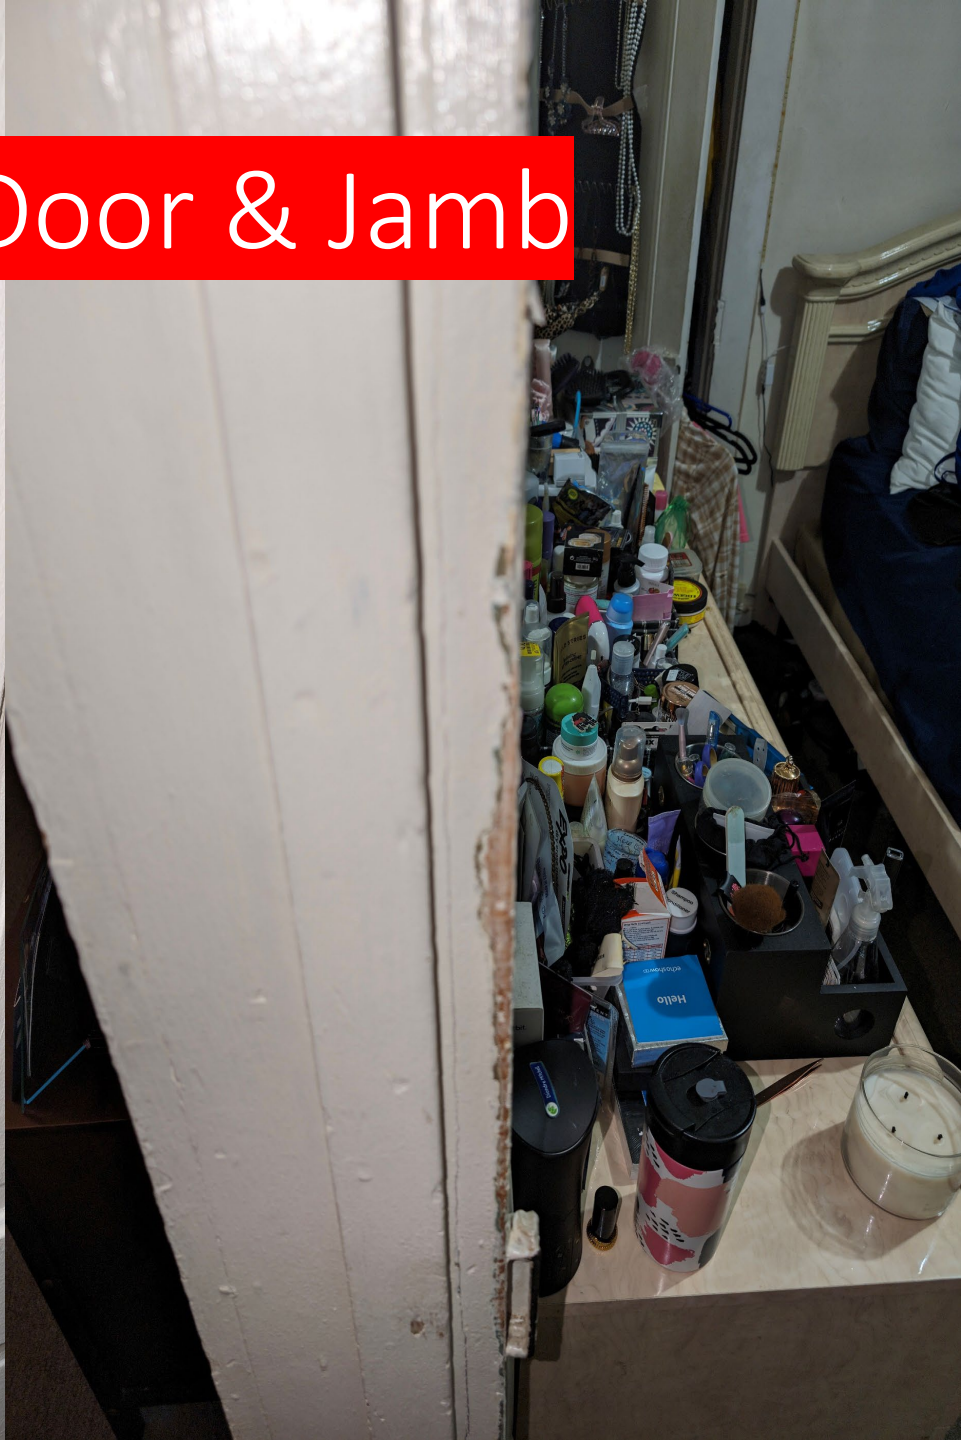
Bathroom Head Jamb – BR 1 Door & Jamb

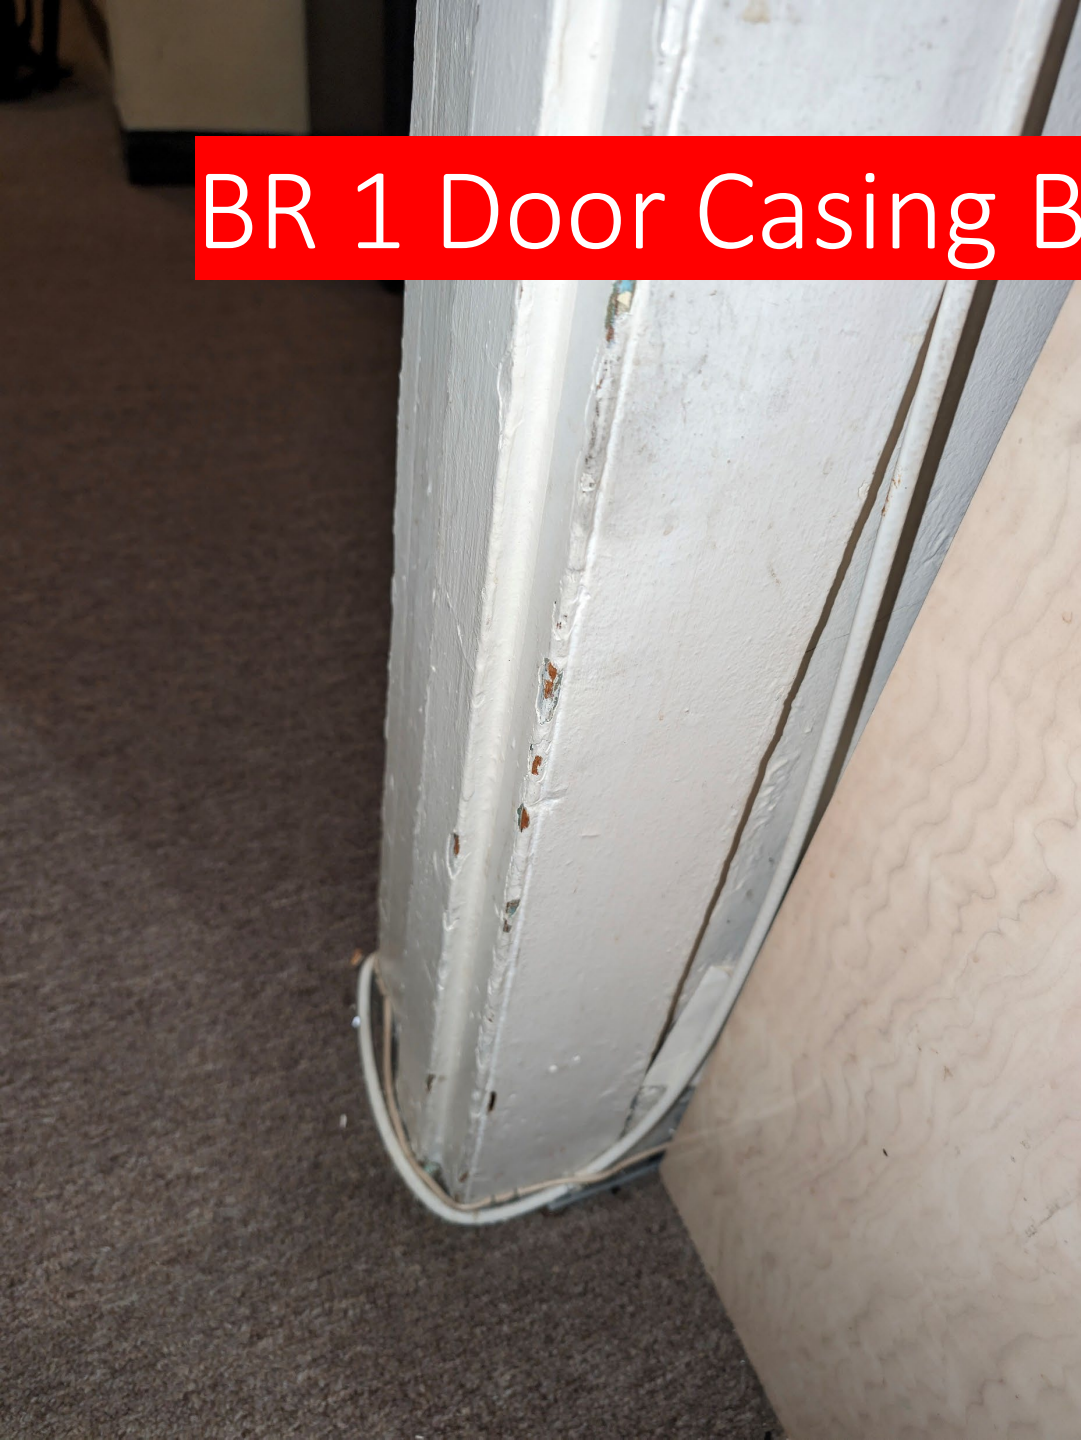
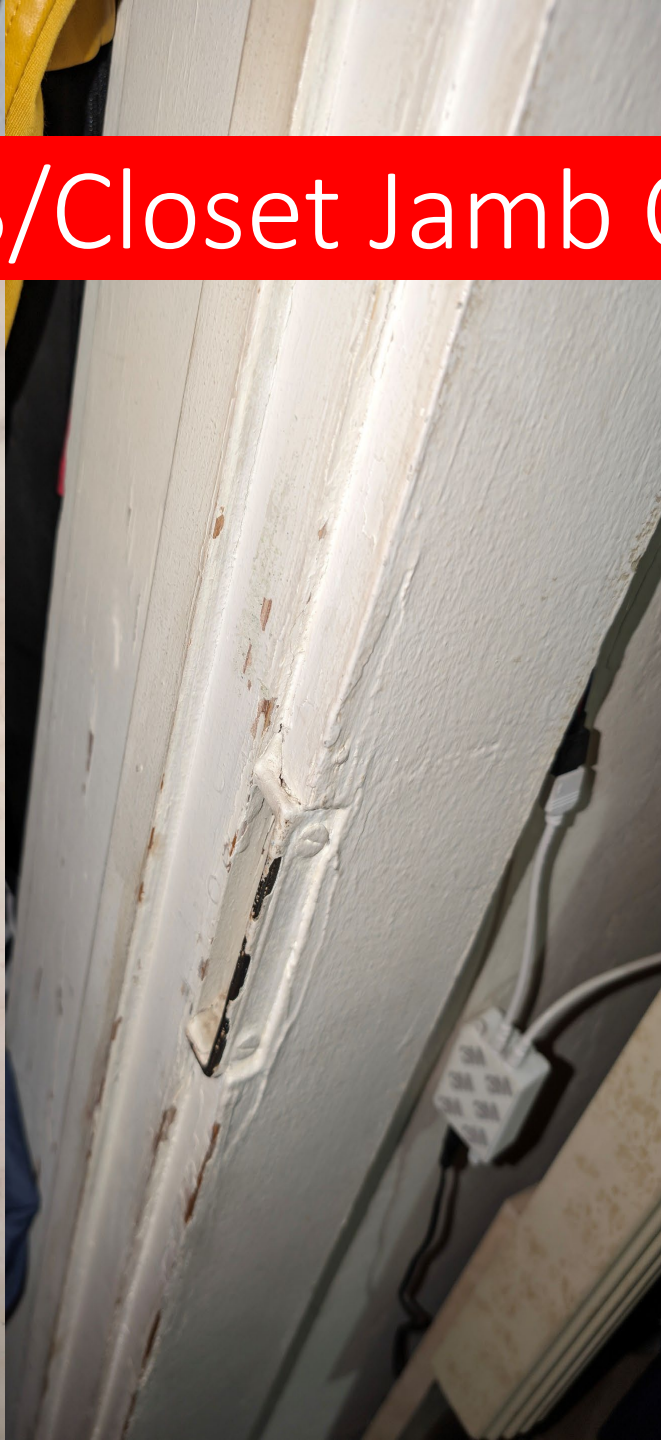
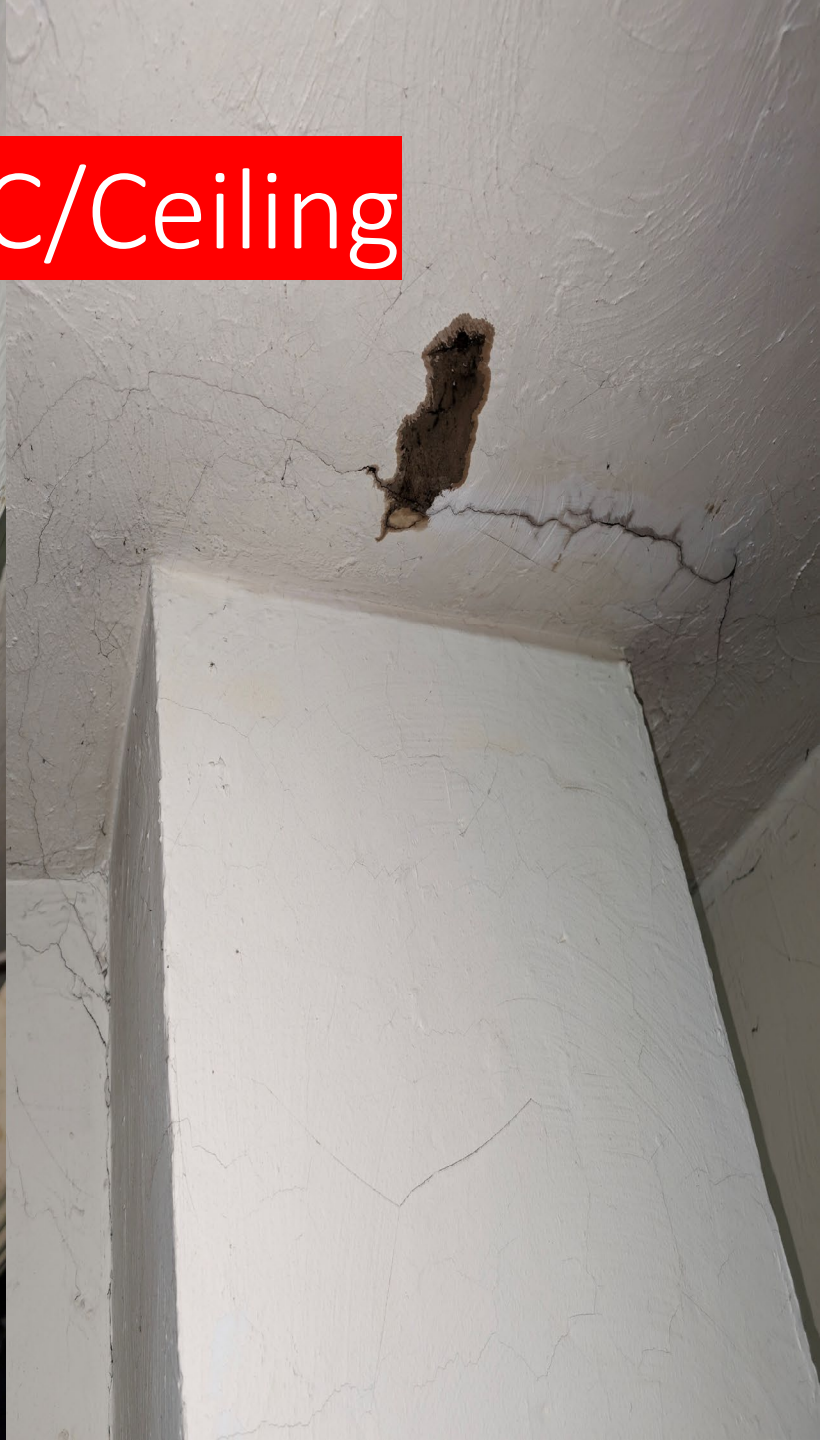
BR 1 Door Casing B/Closet Jamb C/Ceiling
