Visual Paint Assessment Report

For: 43 Maple Ave – Netcong, NJ 07857
March 24, 2024

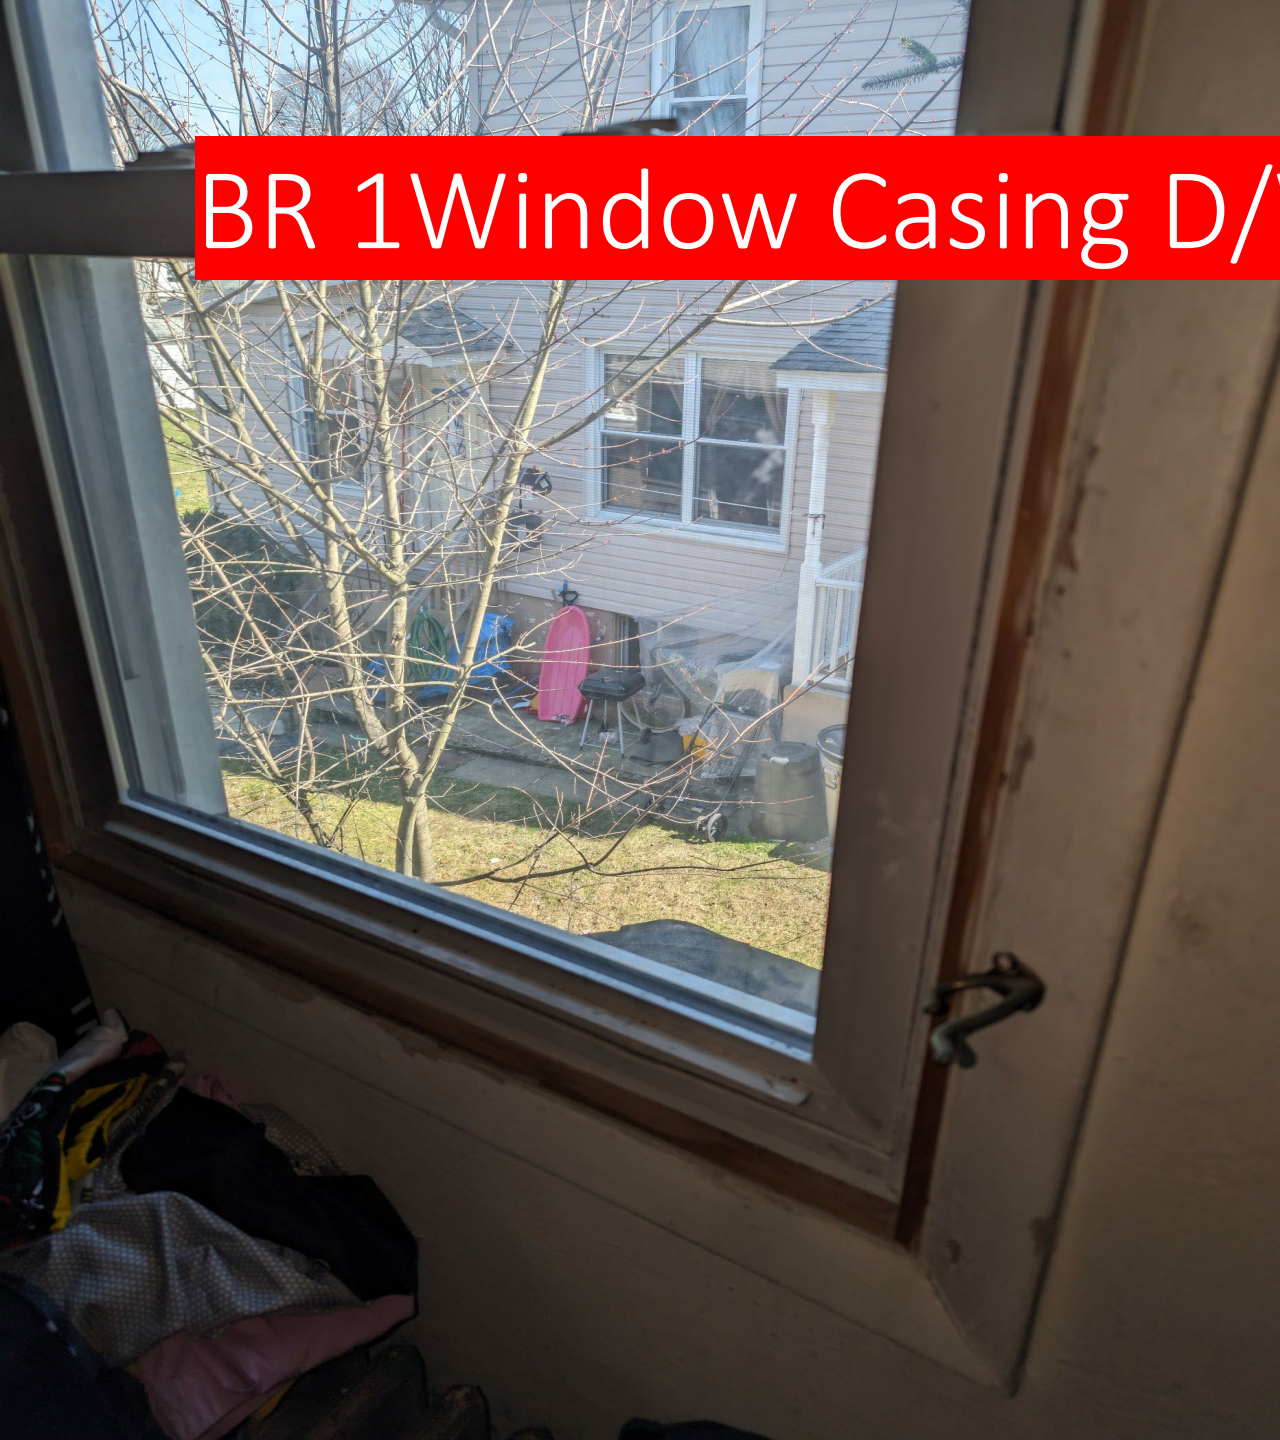
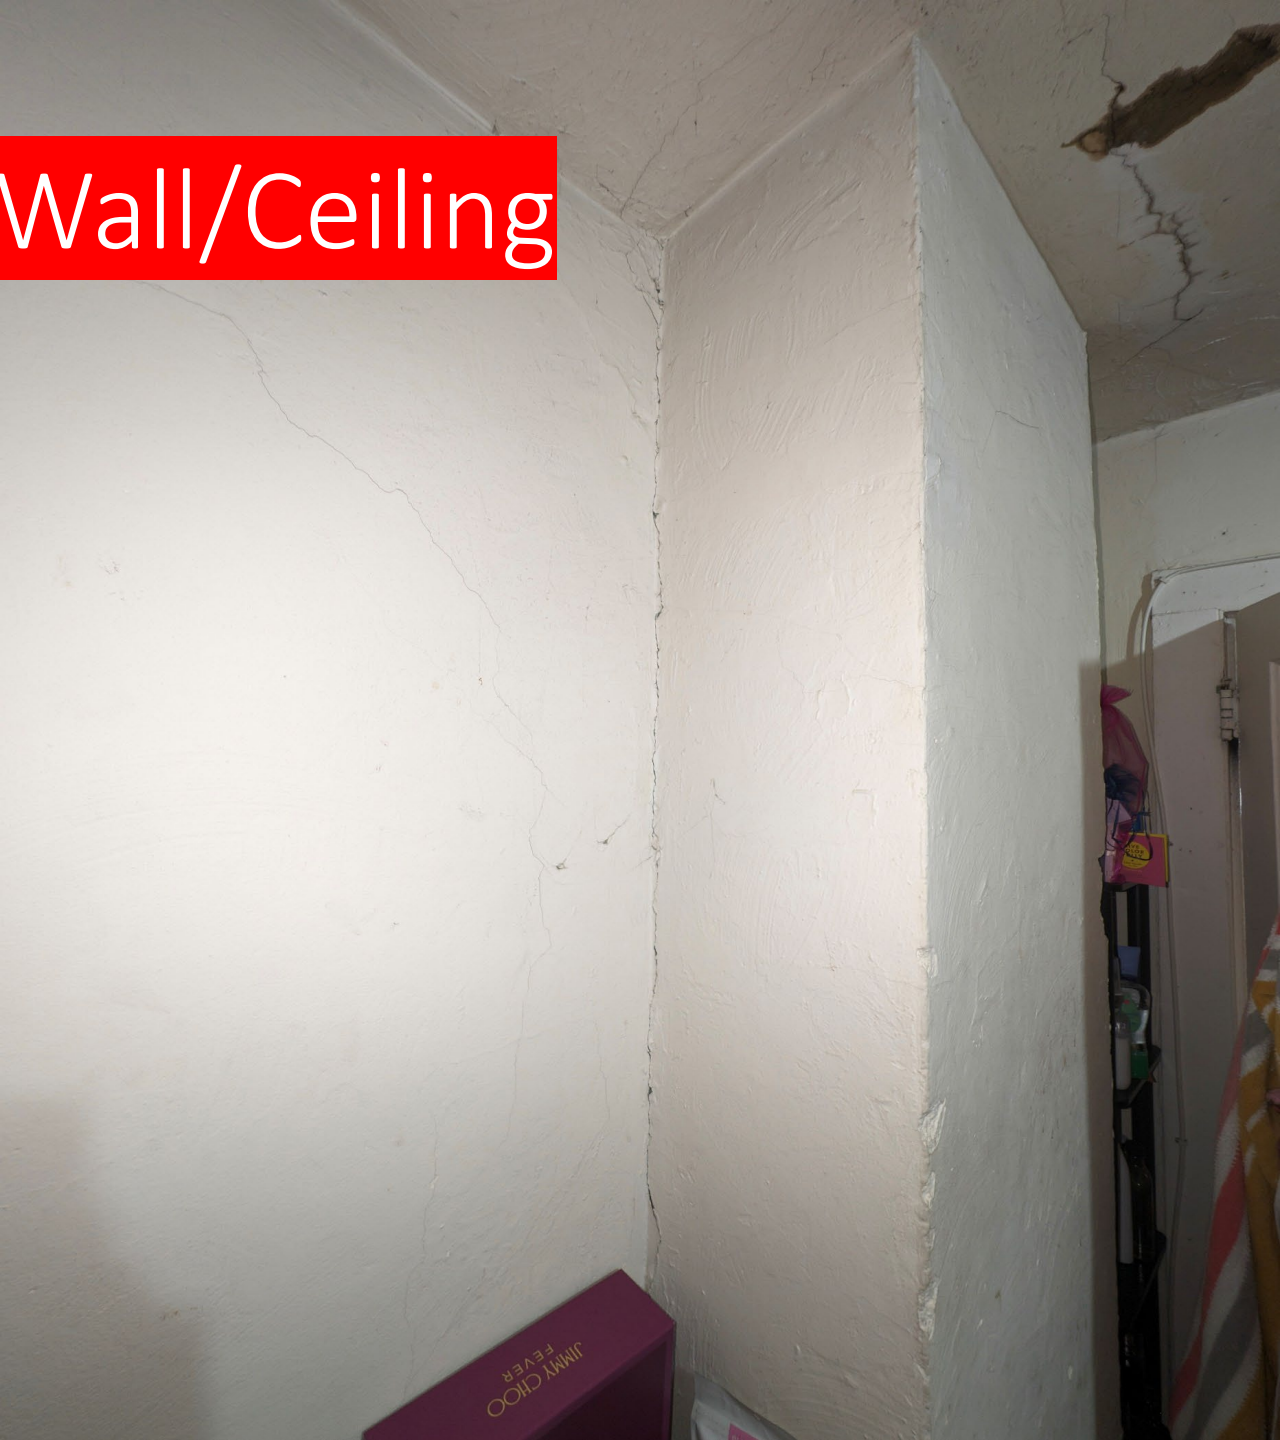
BR 1 Window Casing D/Wall/Ceiling

Identified hazards shall be remediated using either abatement (permanent) or interim controls (temporary). Abatement shall be performed by a NJ Licensed lead abatement firm using licensed lead abatement supervisors and workers. Interim control work shall be performed by EPA RRP certified firms using an EPA certified RRP Renovator. After completion of interim control work, a lead-based paint post-remediation with dust wipes will be required. After completion of abatement work, a lead-based paint abatement clearance will be required.

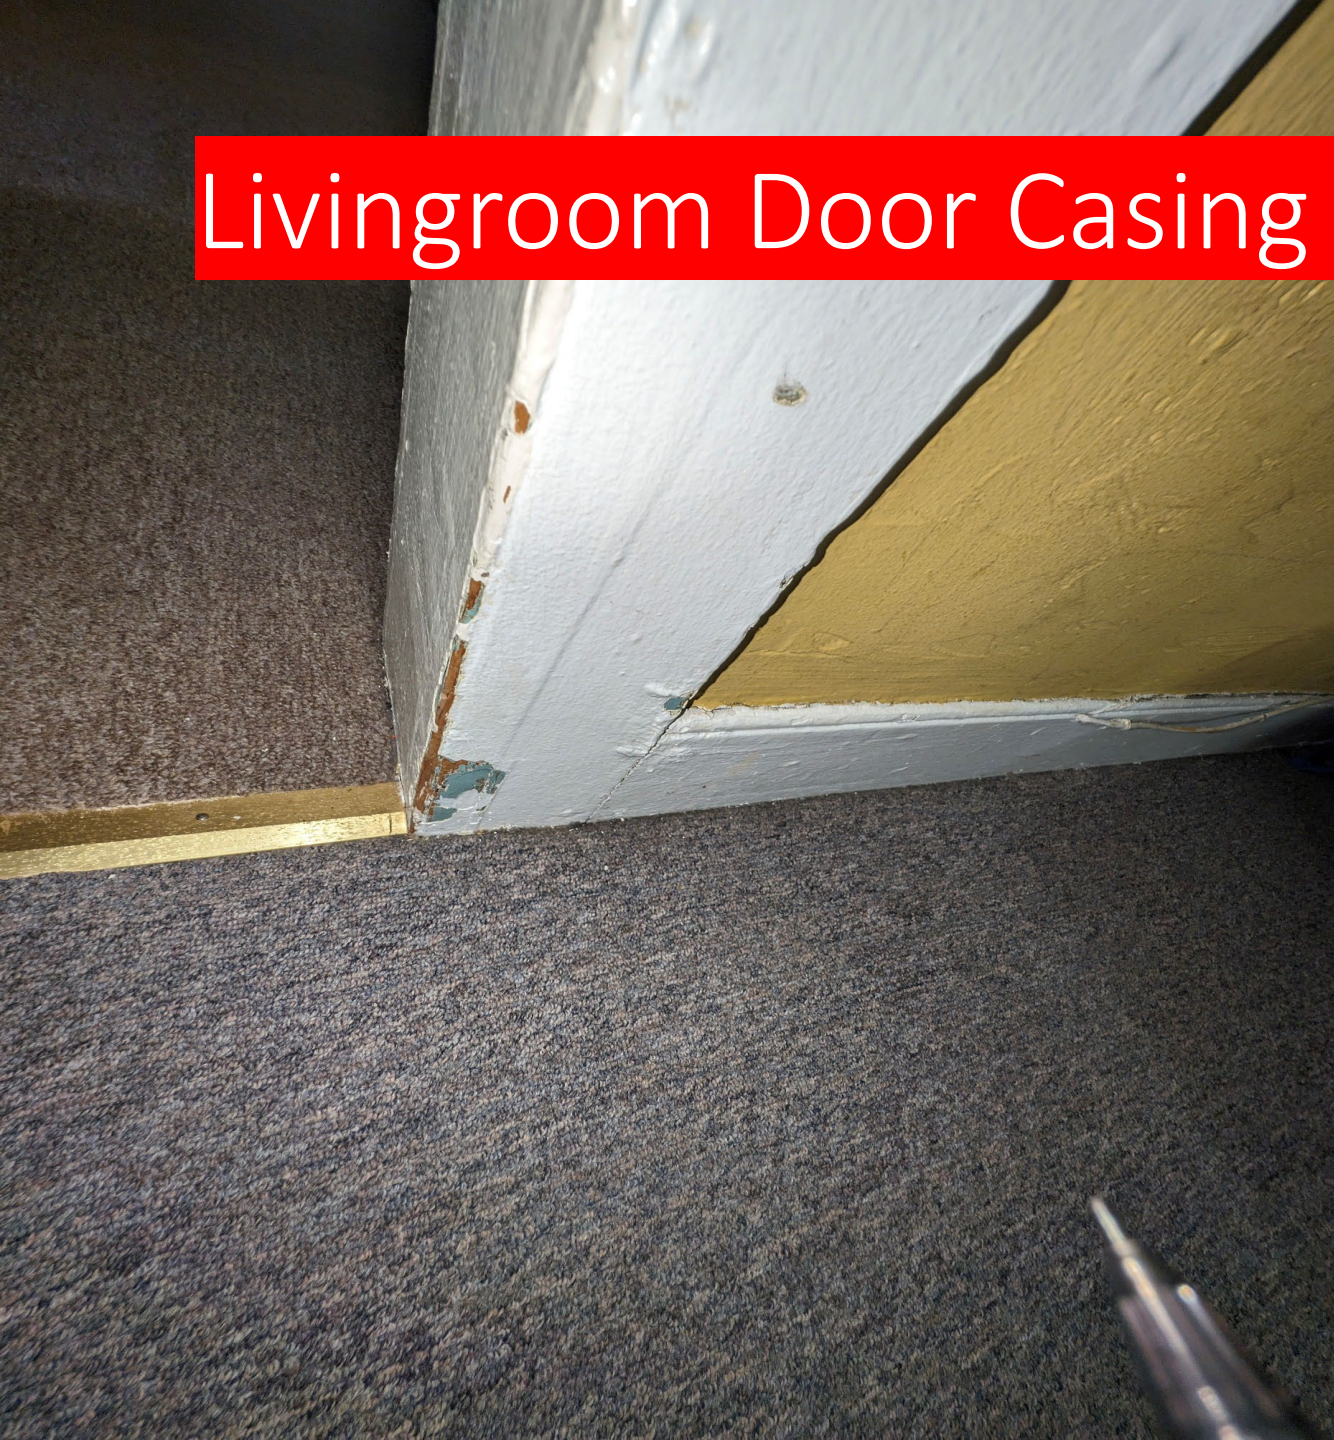
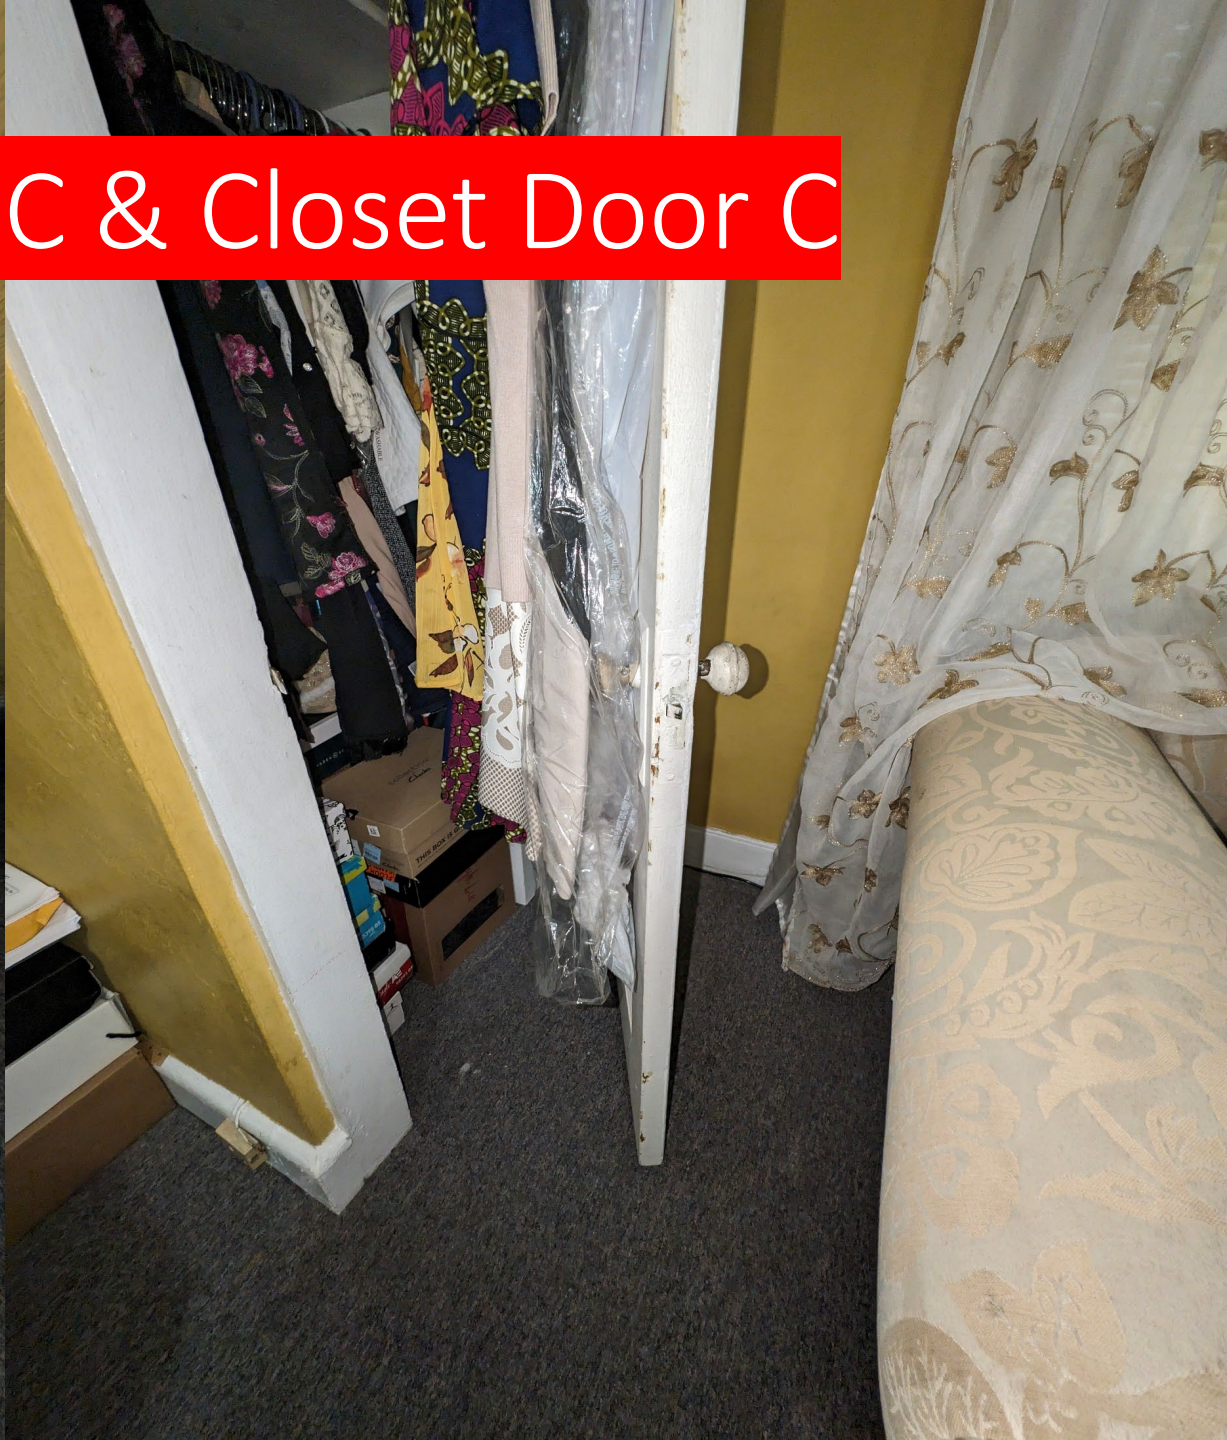
Livingroom Door Casing C & Closet Door C
