Visual Paint Assessment Report

For 301 Center Street Unit:Primary Roxbury Township, NJ 07850
09/05/2024

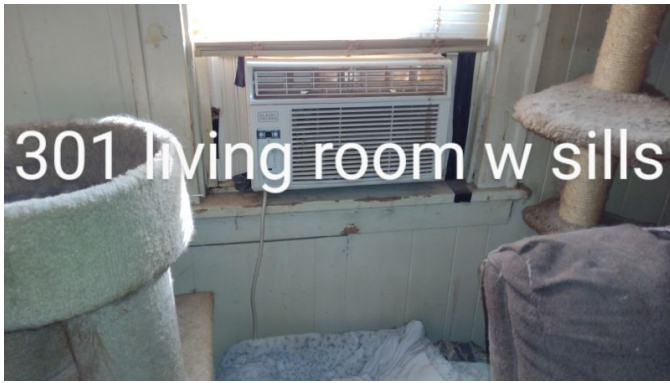
Hazard: Living Room | Window sills | Deteriorated Paint

Identified hazards shall be remediated using either abatement (permanent) or interim controls (temporary). Abatement is permanent but has a higher cost, as Interim controls are temporary but can be much more affordable. Abatement shall be performed by a NJ Licensed lead abatement firm using licensed lead abatement supervisors and workers. You can find the list of NJ licensed lead abatement contractors at https://www.nj.gov/dca/divisions/codes/publications/pdf_lead/ld_abat_c.pdf. Interim control work shall be performed by EPA RRP certified firms using an EPA certified RRP Renovator. You can find certified EPA RRP contractors at <https://cdxapps.epa.gov/ocspp-oppt-lead/firm-location-search>. Select RRP Contractor, then NJ, then enter your zip code to search for contractors. After completion of interim control work, a lead-based paint post-remediation with dust wipes will be required. After completion of abatement work, a lead-based paint abatement clearance will be required..

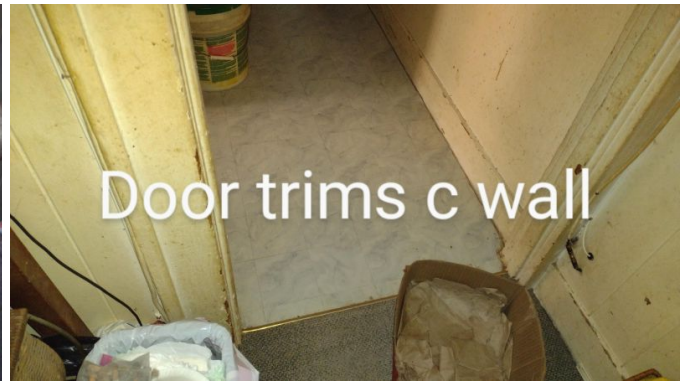
Hazard: Living Room | Door jamb and trims | Deteriorated Paint

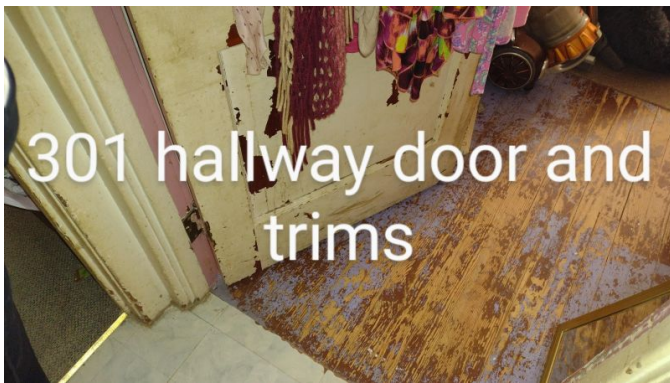
Hazard: Hallway | Door and trims | Deteriorated Paint

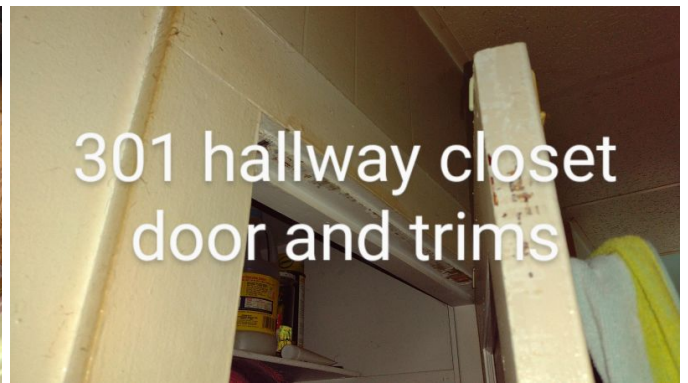
Hazard: Hallway | Closet door and trims | Deteriorated Paint

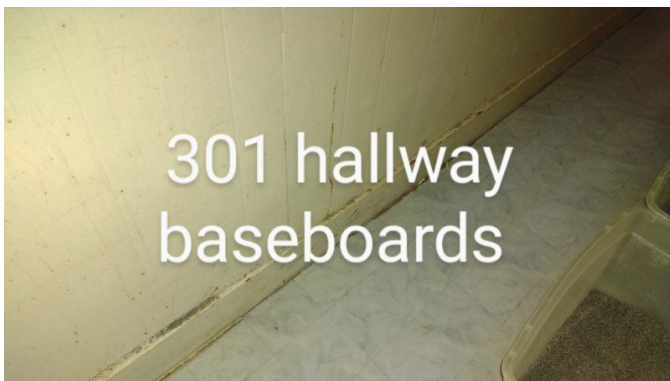
Hazard: Hallway | Baseboard | Deteriorated Paint

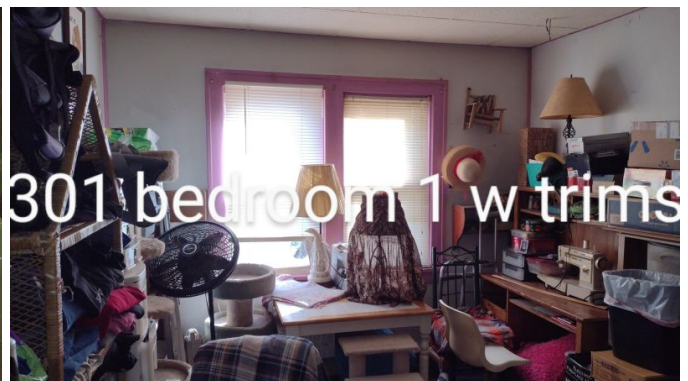
Hazard: Bedroom 1 | Window trims | Deteriorated Paint

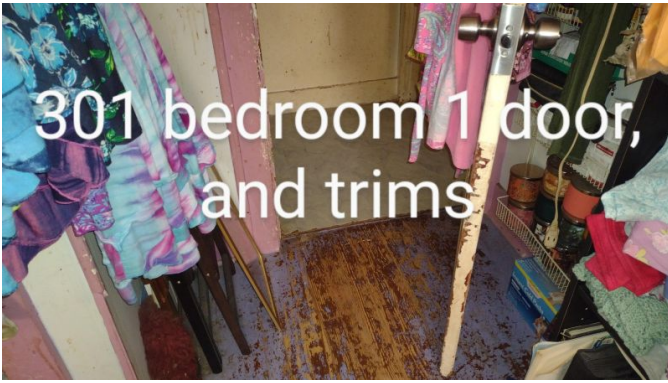
Hazard: Bedroom 1 | Door and trims | Deteriorated Paint

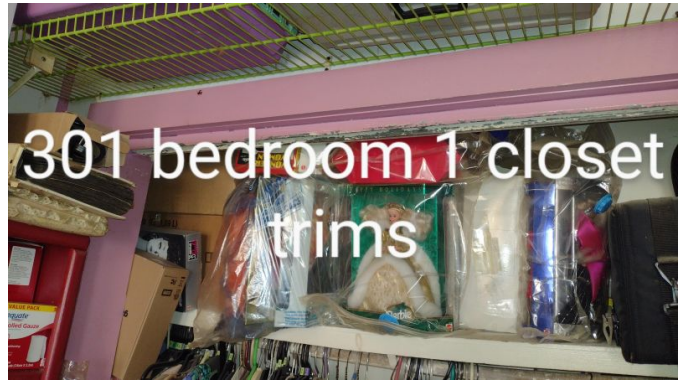
Hazard: Bedroom 1 | Closet door and trims | Deteriorated Paint

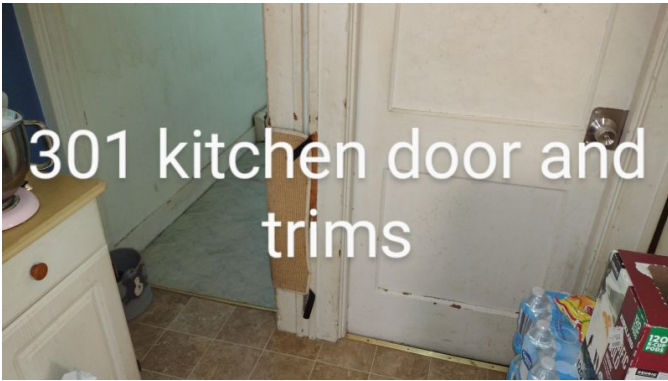
Hazard: Kitchen | Door and trims | Deteriorated Paint

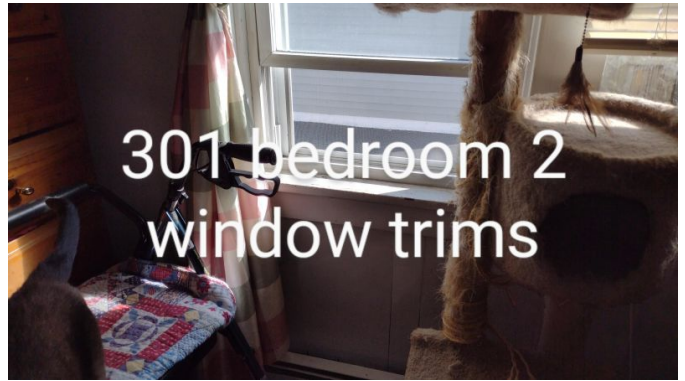
Hazard: Bedroom 2 | Window trims | Deteriorated Paint

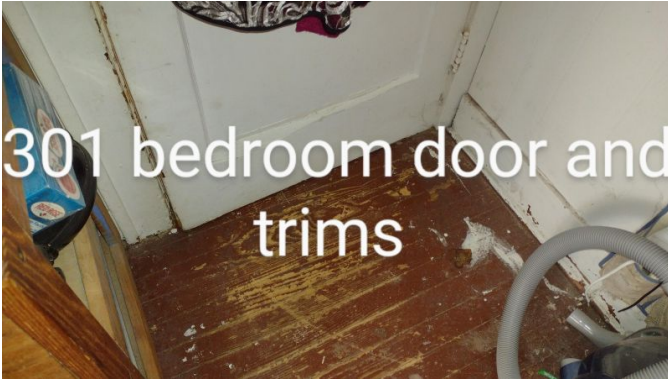
Hazard: Bedroom 2 | door and trims | Deteriorated Paint

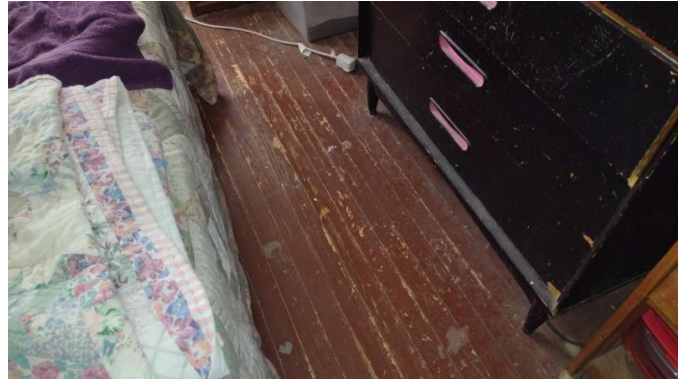
Hazard: Bedrooms 1-2 | Floors | Deteriorated Paint
