Visual Paint Assessment Report

For 158 Wilson st Boonton Town, NJ 07005 (Unit A)
 06/10/2024

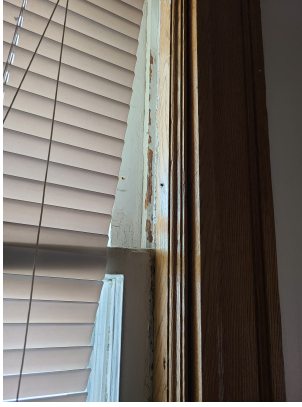
Hazard: Bedroom 1 | Window Sash and Jamb | Deteriorated Paint

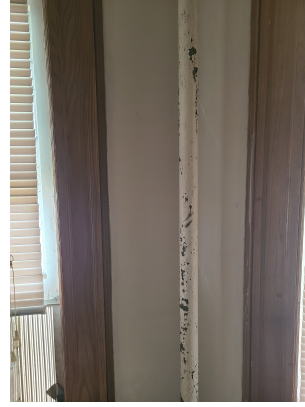
Hazard: Bedroom 1 | Pipe | Deteriorated Paint

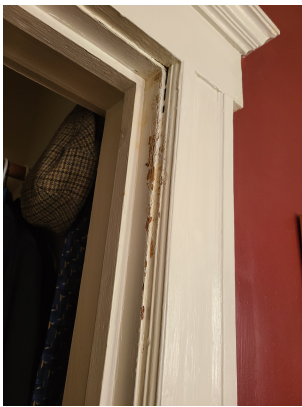
Hazard: Living Room | Closet Door Jamb | Deteriorated Paint

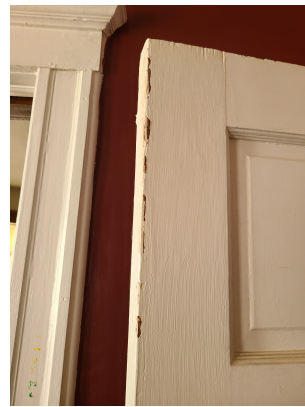
Hazard: Living Room | Door | Deteriorated Paint

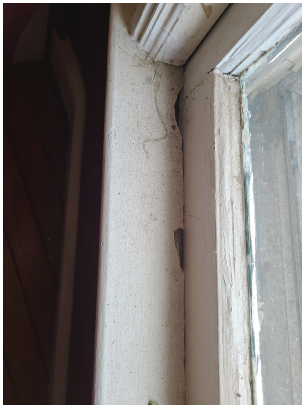
Hazard: Living Room | Window Sill | Deteriorated Paint

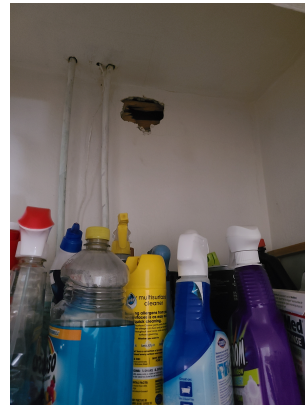
Hazard: Hall | Closet Wall | Deteriorated Paint

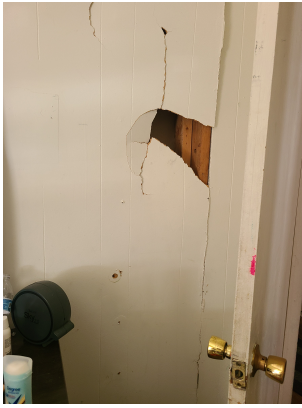
Hazard: Bedroom 2 | Wall C | Deteriorated Paint

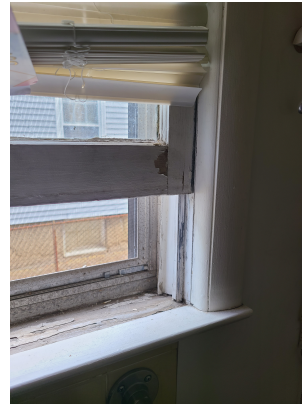
Hazard: Kitchen | Window Sill and Sash | Deteriorated Paint

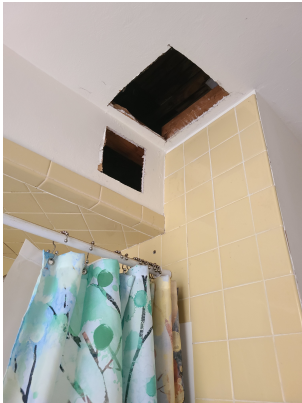
Hazard: Bathroom | Wall and Ceiling | Deteriorated Paint

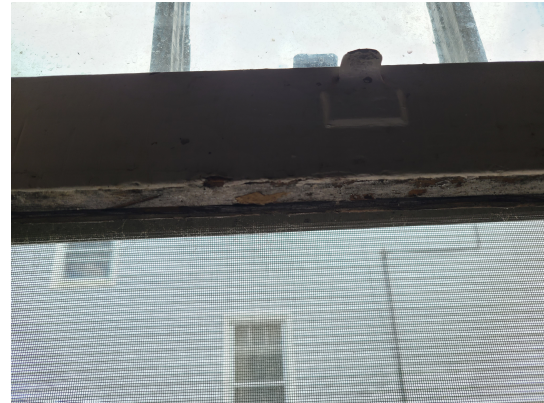
Hazard: Bathroom | Window Sash | Deteriorated Paint
