### Visual Paint Assessment Report

For 158 Wilson st Boonton Town, NJ 07005(Unit B)

06/10/2024

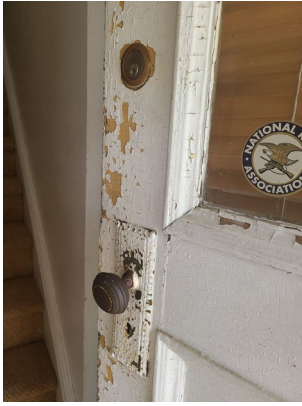
Hazard: Stairwell 1 | Door and Door Frame | Deteriorated Paint

Identified hazards shall be remediated using either abatement (permanent) or interim controls (temporary). Abatement is permanent but has a higher cost, as Interim controls are temporary but can be much more affordable. Abatement shall be performed by a NJ Licensed lead abatement firm using licensed lead abatement supervisors and workers. You can find the list of NJ licensed lead abatement contractors at [https://www.nj.gov/dca/divisions/codes/publications/pdf\\_lead/ld\\_abat\\_c.pdf](https://www.nj.gov/dca/divisions/codes/publications/pdf_lead/ld_abat_c.pdf). Interim control work shall be performed by EPA RRP certified firms using an EPA certified RRP Renovator. You can find certified EPA RRP contractors at <https://cdxappstest.epacdx.net/ocspp-oppt-leadhub/firm-location-search>. Select RRP Contractor, then NJ, then enter your zip code to search for contractors. After completion of interim

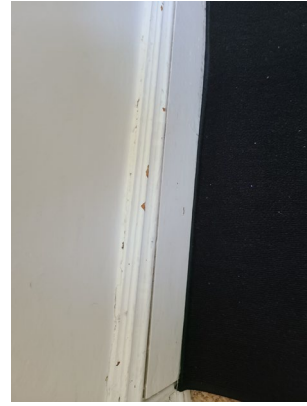
Hazard: Stairwell 1 | Baseboard | Deteriorated Paint

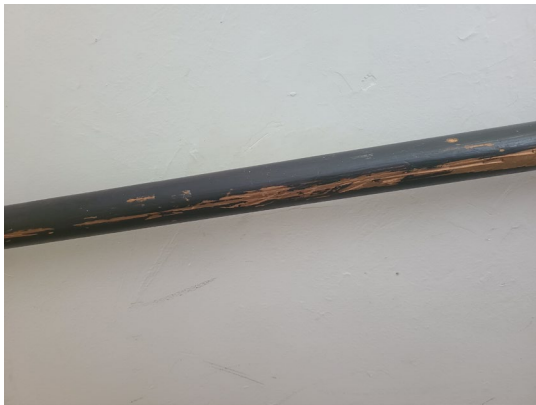
Hazard: Stairwell 1 | Stair Railing | Deteriorated Paint

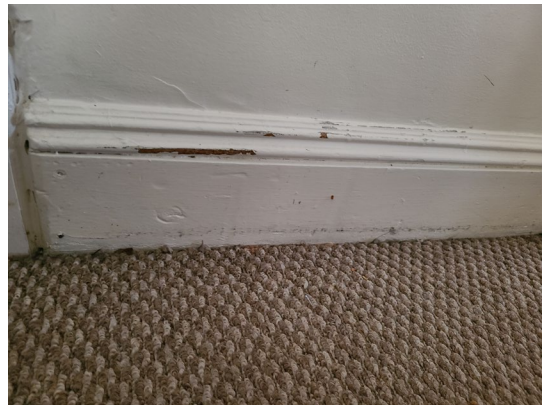
Hazard: Living Room | Baseboard | Deteriorated Paint

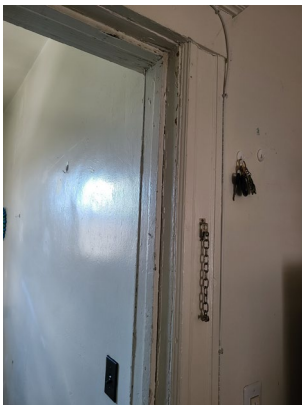
Hazard: Living Room | Door Jamb and Casing | Deteriorated Paint

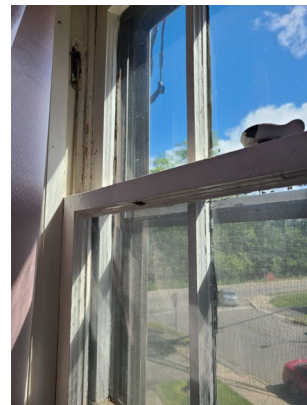
Hazard: Bedroom 1 | Window Sash and Jamb | Deteriorated Paint

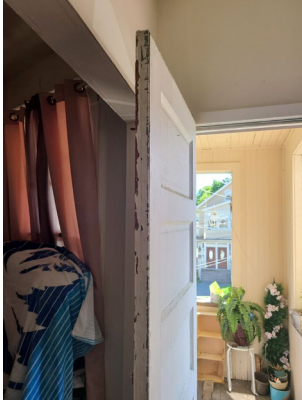
Hazard: Bedroom 1 | Door, Jamb and Casing | Deteriorated Paint

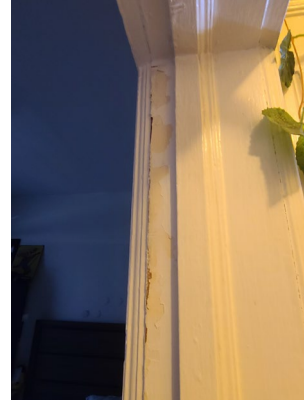
Hazard: Bedroom 2 | Door Jamb and Casing | Deteriorated Paint

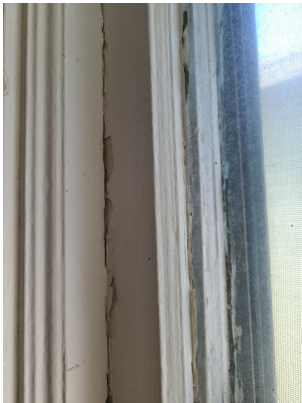
Hazard: Bedroom 2 | Window Sash | Deteriorated Paint

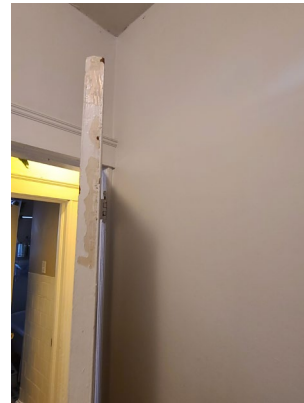
Hazard: Bedroom 3 | Door, Door Jamb and Casing | Deteriorated Paint

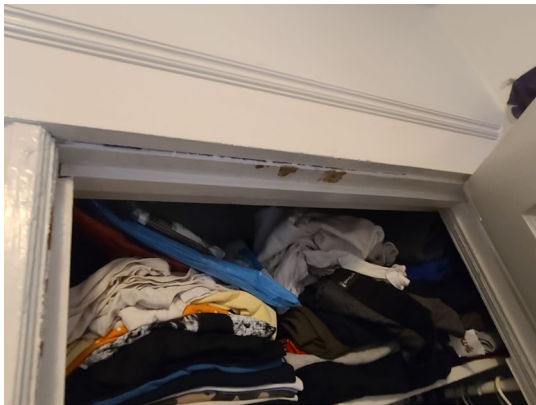
Hazard: Bedroom 3 | Closet Door Jamb and Casing | Deteriorated Paint

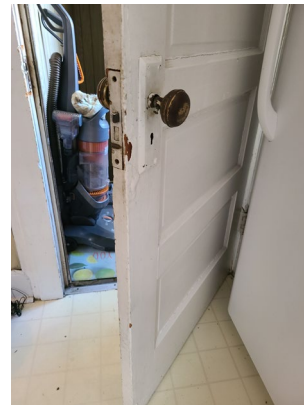
Hazard: Kitchen Door and Casing | Deteriorated Paint

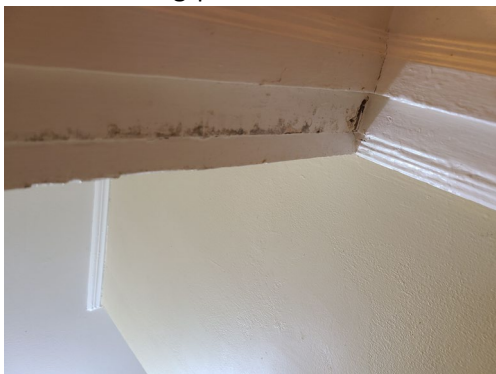
Hazard: Bathroom | Door Jamb | Deteriorated Paint
