## Visual Paint Assessment Report

For 42 SUNRISE TERRACE Unit:Primary Cedar Grove Township, NJ 07009  
10/31/2024

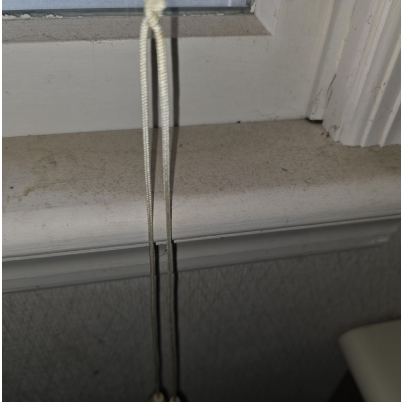
Hazard: All Rooms | Window Sill | Dust

Identified hazards shall be remediated using either abatement (permanent) or interim controls (temporary). Abatement is permanent but has a higher cost, as Interim controls are temporary but can be much more affordable. Abatement shall be performed by a NJ Licensed lead abatement firm using licensed lead abatement supervisors and workers. You can find the list of NJ licensed lead abatement contractors at [https://www.nj.gov/dca/divisions/codes/publications/pdf\\_lead/ld\\_abat\\_c.pdf](https://www.nj.gov/dca/divisions/codes/publications/pdf_lead/ld_abat_c.pdf). Interim control work shall be performed by EPA RRP certified firms using an EPA certified RRP Renovator. You can find certified EPA RRP contractors at <https://cdxapps.epa.gov/ocspp-oppt-lead/firm-location-search>. Select RRP Contractor, then NJ, then enter your zip code to search for contractors. After completion of interim control work, a lead-based paint post-remediation with dust wipes will be required. After completion of abatement work, a lead-based paint abatement clearance will be required.

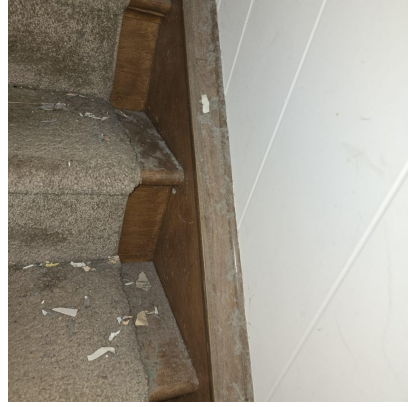
Hazard: Living Room | Steps | Dust
