Visual Paint Assessment Report

For 439 Boonton Ave Boonton Town, NJ 07005
 12/19/2023

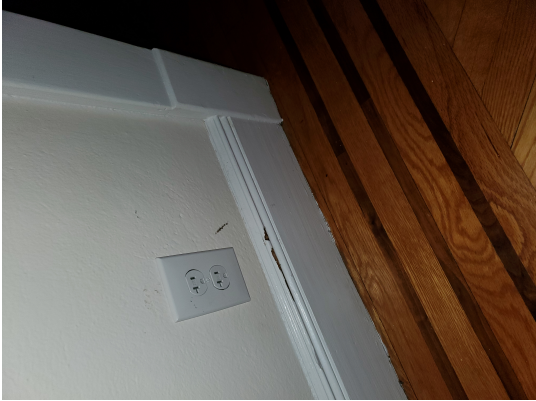
Hazard: Dining Room | Baseboard | Deteriorated Paint

Identified hazards shall be remediated using either abatement (permanent) or interim controls (temporary). Abatement shall be performed by a NJ Licensed lead abatement firm using licensed lead abatement supervisors and workers. Interim control work shall be performed by EPA RRP certified firms using an EPA certified RRP Renovator. After completion of interim control work, a lead-based paint post-remediation with dust wipes will be required. After completion of abatement work, a lead-based paint abatement clearance will be required.

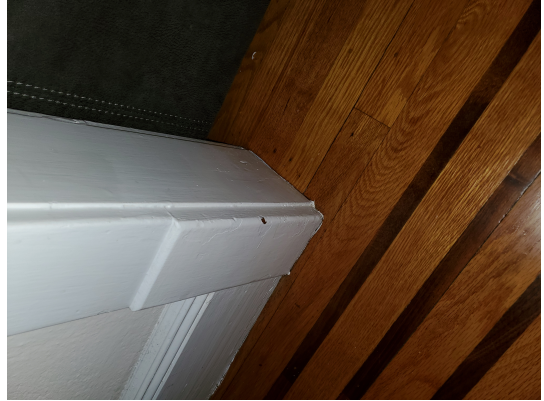
Hazard: Dining Room | Door Casing | Deteriorated Paint

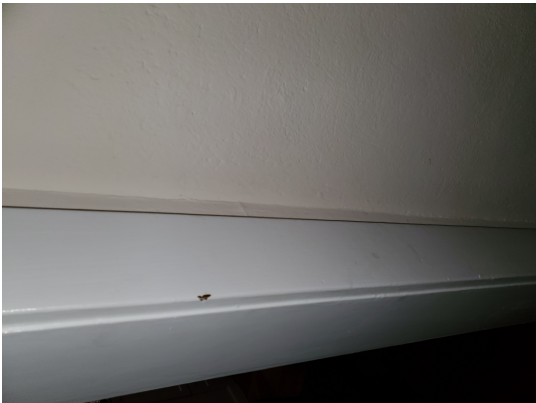
Hazard: Dining Room | Door Casing | Deteriorated Paint

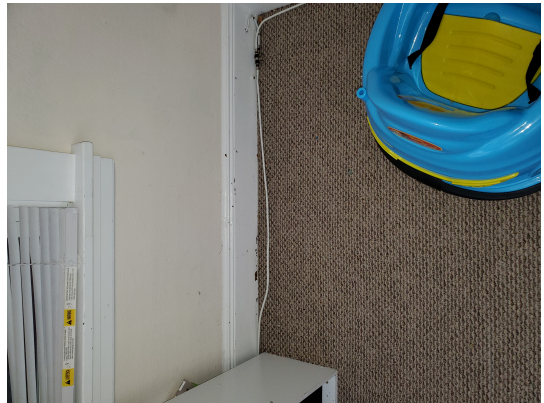
Hazard: Sun Room | Baseboard | Deteriorated Paint

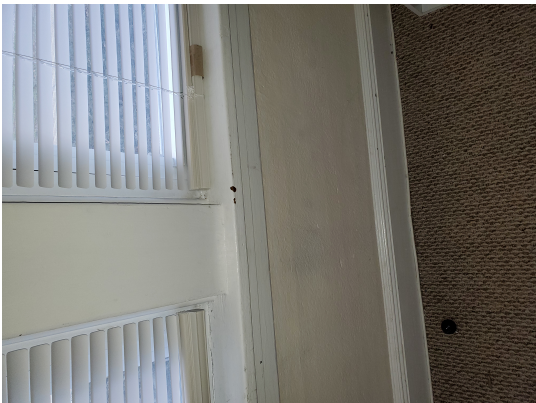
Hazard: Sun Room | Window Sill | Deteriorated Paint

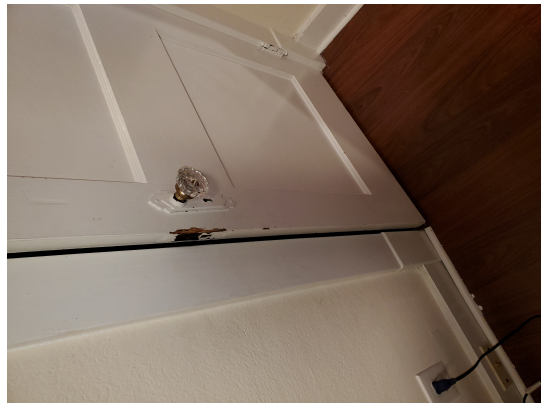
Hazard: Bedroom 3 | Door Casing | Deteriorated Paint

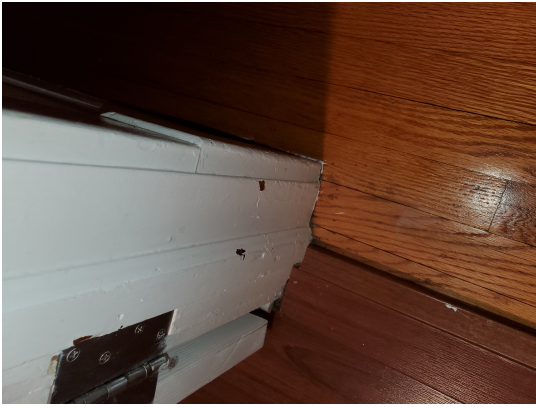
Hazard: Hallway 1 | Door Casing | Deteriorated
Paint
