Visual Paint Assessment Report

For 439 Boonton Ave Boonton Town, NJ 07005
 12/19/2023

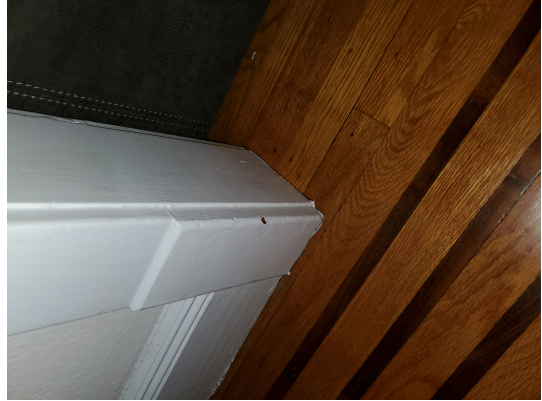
Hazard: Dining Room | Door Casing | Deteriorated Paint

Identified hazards shall be remediated using either abatement (permanent) or interim controls (temporary). Abatement shall be performed by a NJ Licensed lead abatement firm using licensed lead abatement supervisors and workers. Interim control work shall be performed by EPA RRP certified firms using an EPA certified RRP Renovator. After completion of interim control work, a lead-based paint post-remediation with dust wipes will be required. After completion of abatement work, a lead-based paint abatement clearance will be required.

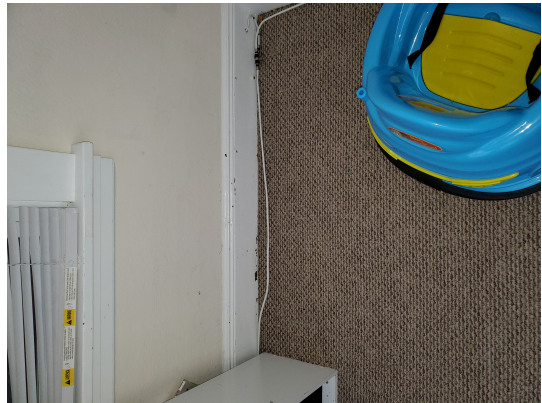
Hazard: Sun Room | Baseboard | Deteriorated Paint

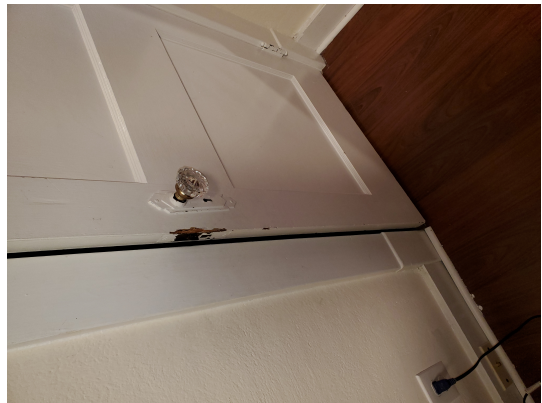
Hazard: Bedroom 3 | Door Casing | Deteriorated Paint

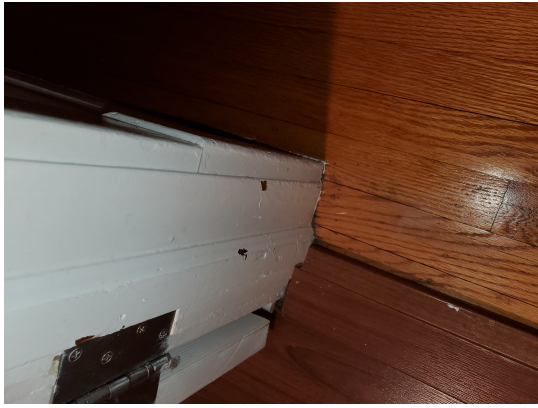
Hazard: Hallway 1 | Door Casing | Deteriorated
Paint
