## Visual Paint Assessment Report

For 4 walnut rd Sparta Township, NJ 07871  
07/03/2024

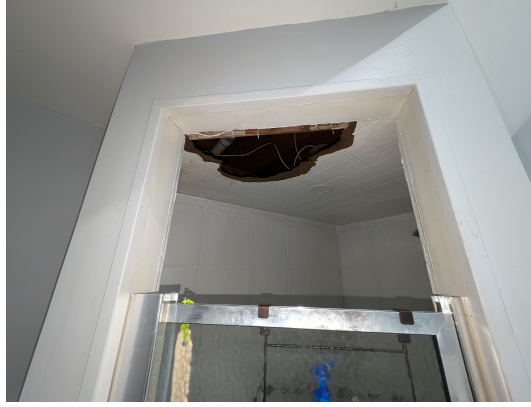
Room	Component	Hazard
Bathroom	Ceiling	Deteriorated Paint

Hazard: Bathroom | Ceiling | Deteriorated Paint

Identified hazards shall be remediated using either abatement (permanent) or interim controls (temporary). Abatement is permanent but has a higher cost, as Interim controls are temporary but can be much more affordable. Abatement shall be performed by a NJ Licensed lead abatement firm using licensed lead abatement supervisors and workers. You can find the list of NJ licensed lead abatement contractors at [https://www.nj.gov/dca/divisions/codes/publications/pdf\\_lead/ld\\_abat\\_c.pdf](https://www.nj.gov/dca/divisions/codes/publications/pdf_lead/ld_abat_c.pdf). Interim control work shall be performed by EPA RRP certified firms using an EPA certified RRP Renovator. You can find certified EPA RRP contractors at <https://cdxappstest.epacdx.net/ocspp-oppt-leadhub/firm-location-search>. Select RRP Contractor, then NJ, then enter your zip code to search for contractors. After completion of interim control work, a lead-based paint post-remediation with dust wipes will be required. After completion of abatement work, a lead-based paint abatement clearance will be required..
