Visual Paint Assessment Report

For 716 Nassau Street North Brunswick Township, NJ 08902
 12/22/2023

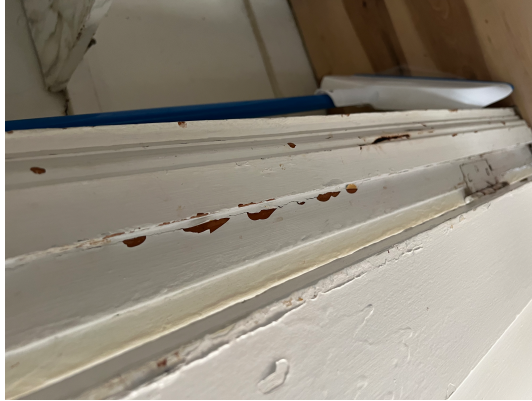
Room	Component	Hazard
Kitchen	Closet Door Frame	Deteriorated Paint

Hazard: Kitchen | Closet Door Frame | Deteriorated Paint

Identified hazards shall be remediated using either abatement (permanent) or interim controls (temporary). Abatement shall be performed by a NJ Licensed lead abatement firm using licensed lead abatement supervisors and workers. Interim control work shall be performed by EPA RRP certified firms using an EPA certified RRP Renovator. After completion of interim control work, a lead-based paint post-remediation with dust wipes will be required. After completion of abatement work, a lead-based paint abatement clearance will be required.
