## Visual Paint Assessment Report

For 73 Main Street Roxbury Township, NJ 07876  
07/03/2024

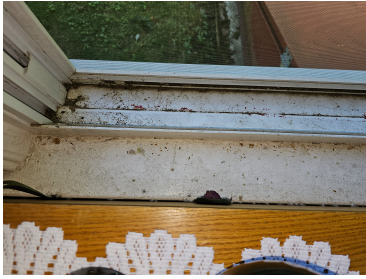
Hazard: All Rooms | All Windows | Dust

Identified hazards shall be remediated using either abatement (permanent) or interim controls (temporary). Abatement is permanent but has a higher cost, as Interim controls are temporary but can be much more affordable. Abatement shall be performed by a NJ Licensed lead abatement firm using licensed lead abatement supervisors and workers. You can find the list of NJ licensed lead abatement contractors at [https://www.nj.gov/dca/divisions/codes/publications/pdf\\_lead/ld\\_abat\\_c.pdf](https://www.nj.gov/dca/divisions/codes/publications/pdf_lead/ld_abat_c.pdf). Interim control work shall be performed by EPA RRP certified firms using an EPA certified RRP Renovator. You can find certified EPA RRP contractors at <https://cdxappstest.epacdx.net/ocspp-oppt-leadhub/firm-location-search>. Select RRP Contractor, then NJ, then enter your zip code to search for contractors. After completion of interim control work, a lead-based paint post-remediation with dust wipes will be required. After completion of abatement work, a lead-based paint abatement clearance will be required..

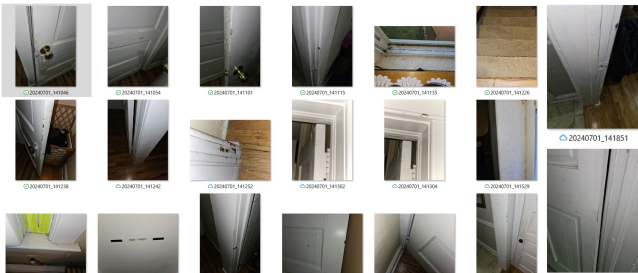
Hazard: Enclosed Porch, Bedrooms, Closets | Doors and Door Trims | Deteriorated Paint

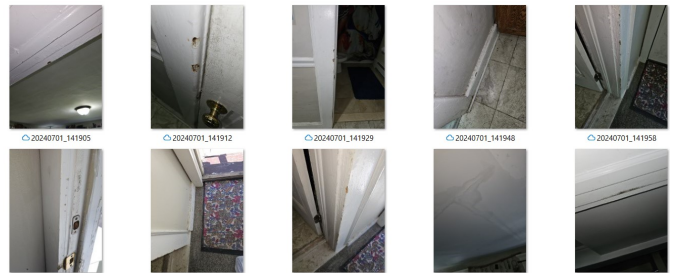
Hazard: Foyer | Baseboard | Deteriorated Paint
