Visual Paint Assessment Report

For 775 Route 15 South Jefferson Township, NJ 07849
 06/09/2024

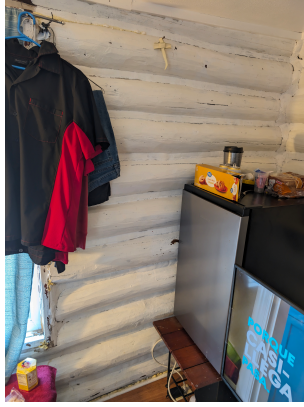
Hazard: Bedroom 1 | Wall | Deteriorated Paint

Identified hazards shall be remediated using either abatement (permanent) or interim controls (temporary). Abatement is permanent but has a higher cost, as Interim controls are temporary but can be much more affordable. Abatement shall be performed by a NJ Licensed lead abatement firm using licensed lead abatement supervisors and workers. You can find the list of NJ licensed lead abatement contractors at https://www.nj.gov/dca/divisions/codes/publications/pdf_lead/ld_abat_c.pdf. Interim control work shall be performed by EPA RRP certified firms using an EPA certified RRP Renovator. You can find certified EPA RRP contractors at <https://cdxappstest.epacdx.net/ocspp-oppt-leadhub/firm-location-search>. Select RRP Contractor, then NJ, then enter your zip code to search for contractors. After completion of interim control work, a lead-based paint post-remediation with dust wipes will be required. After completion of abatement work, a lead-based paint abatement clearance will be required..

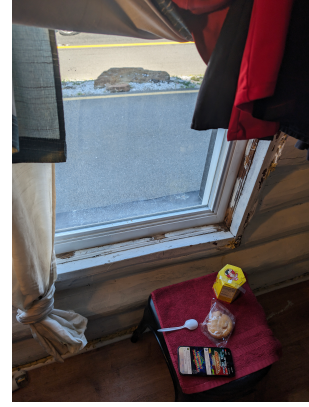
Hazard: Bedroom 1 | Window Casing/Stop | Deteriorated Paint

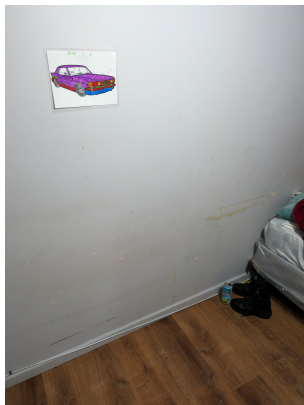
Hazard: Bedroom 3 | Wall | Deteriorated Paint

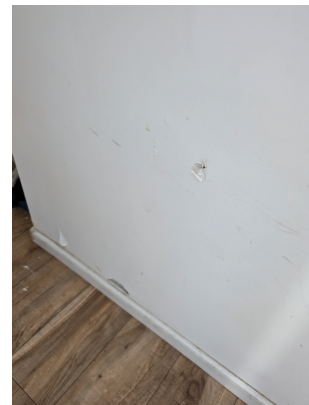
Hazard: Foyer | Wall | Deteriorated Paint

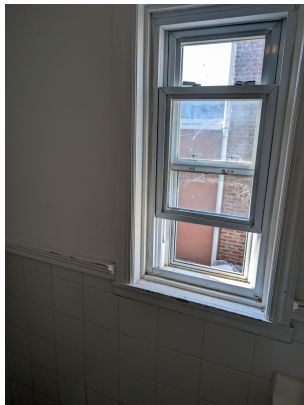
Hazard: Bathroom | Window Casing & Chair Rail
Wall Trim | Deteriorated Paint

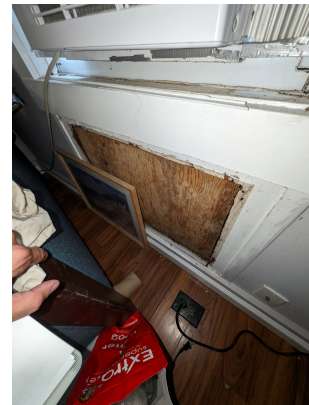
Hazard: Bedroom 5 | Wall underneath Window | Deteriorated Paint
