Visual Paint Assessment Report

For 7 Murray St. Freehold Borough, NJ 07728
04/19/2024

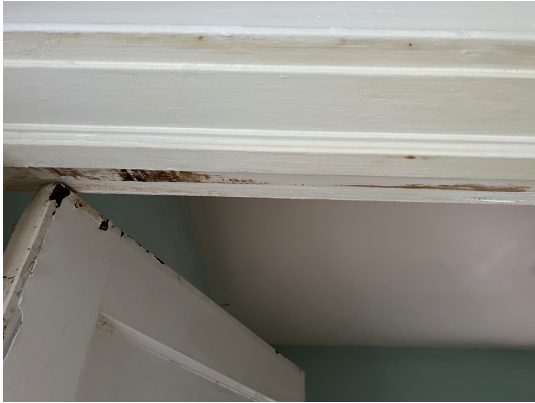
Hazard: Bedroom 1 | Door Casing | Deteriorated Paint

Identified hazards shall be remediated using either abatement (permanent) or interim controls (temporary). Abatement is permanent but has a higher cost, as Interim controls are temporary but can be much more affordable. Abatement shall be performed by a NJ Licensed lead abatement firm using licensed lead abatement supervisors and workers. You can find the list of NJ licensed lead abatement contractors at https://www.nj.gov/dca/divisions/codes/publications/pdf_lead/ld_abat_c.pdf. Interim control work shall be performed by EPA RRP certified firms using an EPA certified RRP Renovator. You can find certified EPA RRP contractors at <https://cdxappstest.epacdx.net/ocspp-oppt-leadhub/firm-location-search>. Select RRP Contractor, then NJ, then enter your zip code to search for contractors. After completion of interim control work, a lead-based paint post-remediation with dust wipes will be required. After completion of abatement work, a lead-based paint abatement clearance will be required..

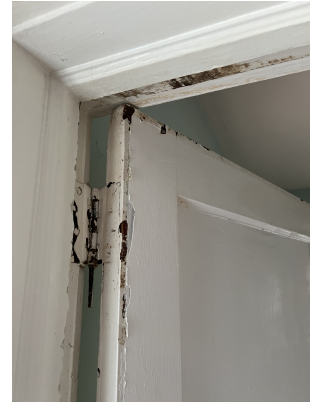
Hazard: Bedroom 1 | Door | Deteriorated Paint

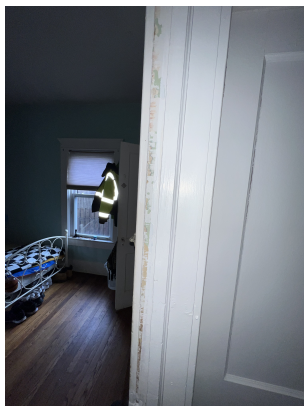
Hazard: bedroom 2 closet | Door Casing | Deteriorated Paint

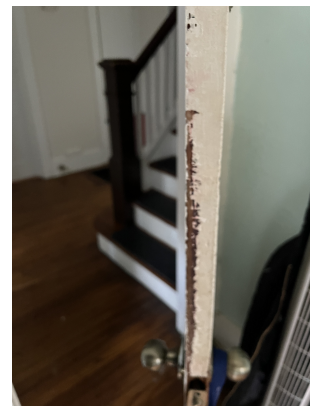
Hazard: Bedroom 1 | Door | Deteriorated Paint

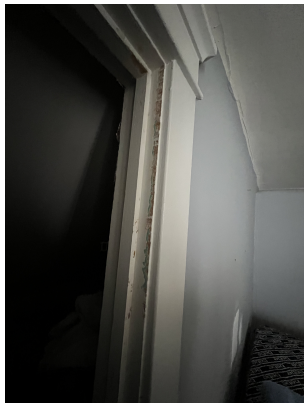
Hazard: Bedroom 3 Closet Wall A | Door Casing | Deteriorated Paint

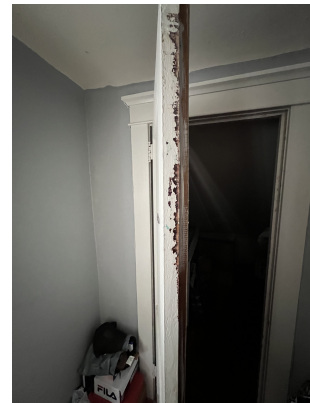
Hazard: Bedroom 3 Closet wall A | Door | Deteriorated Paint
