## Visual Paint Assessment Report

For 807 Eves Drive Hillsborough Township, NJ  
02/12/2024

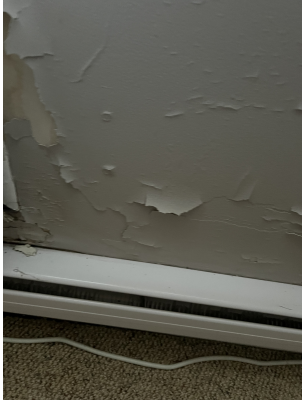
Hazard: Bedroom 1 | Wall | Deteriorated Paint

Identified hazards shall be remediated using either abatement (permanent) or interim controls (temporary). Abatement is permanent but has a higher cost, as Interim controls are temporary but can be much more affordable. Abatement shall be performed by a NJ Licensed lead abatement firm using licensed lead abatement supervisors and workers. You can find the list of NJ licensed lead abatement contractors at [https://www.nj.gov/dca/divisions/codes/publications/pdf\\_lead/ld\\_abat\\_c.pdf](https://www.nj.gov/dca/divisions/codes/publications/pdf_lead/ld_abat_c.pdf). Interim control work shall be performed by EPA RRP certified firms using an EPA certified RRP Renovator. You can find certified EPA RRP contractors at <https://cdxappstest.epacdx.net/ocspp-oppt-leadhub/firm-location-search>. Select RRP Contractor, then NJ, then enter your zip code to search for contractors. After completion of interim control work, a lead-based paint post-remediation with dust wipes will be required. After completion of abatement work, a lead-based paint abatement clearance will be required..

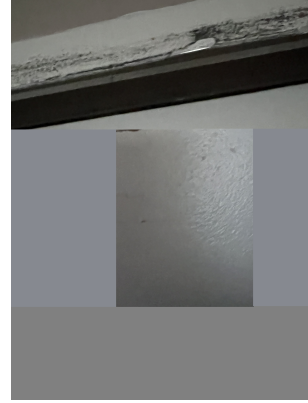
Hazard: Bedroom 1 | closet door |  
Deteriorated Paint

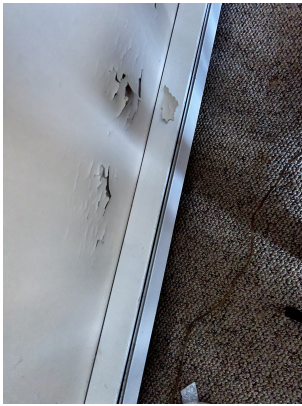
Hazard: Living Room | Wall | Deteriorated Paint
