Visual Paint Assessment Report

For 900 G Merritt Drive, Hillsborough Township, NJ
 12/07/2023

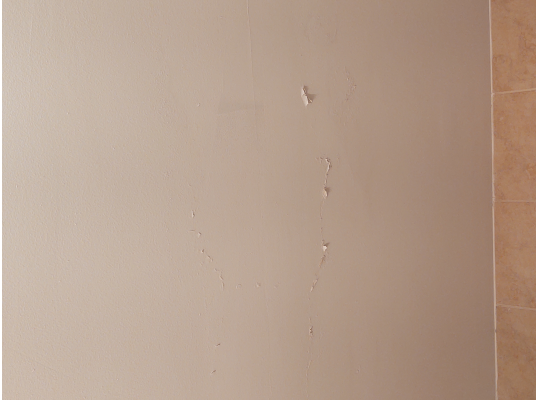
Room	Component	Hazard
Bathroom 2	Ceiling	Deteriorated Paint
Bathroom 2	Wall	Deteriorated Paint

Hazard: Bathroom 2 | Ceiling | Deteriorated Paint Hazard: Bathroom 2 | Wall | Deteriorated Paint

Identified hazards shall be remediated using either abatement (permanent) or interim controls (temporary). Abatement shall be performed by a NJ Licensed lead abatement firm using licensed lead abatement supervisors and workers. Interim control work shall be performed by EPA RRP certified firms using an EPA certified RRP Renovator. After completion of interim control work, a lead-based paint post-remediation with dust wipes will be required. After completion of abatement work, a lead-based paint abatement clearance will be required.
