Lead-Based Paint Evaluation Report Inspection

936_938_WEST_3RD_STREET Unit:938
938
Plainfield City, NJ 07062

LEW Environmental Services, LLC.
181 US Hwy 46
Mine Hill, NJ 07803
Phone (908) 654-8068
Fax (908) 654-8069
Inspection Date: 11/22/2024
Order Number: 84117

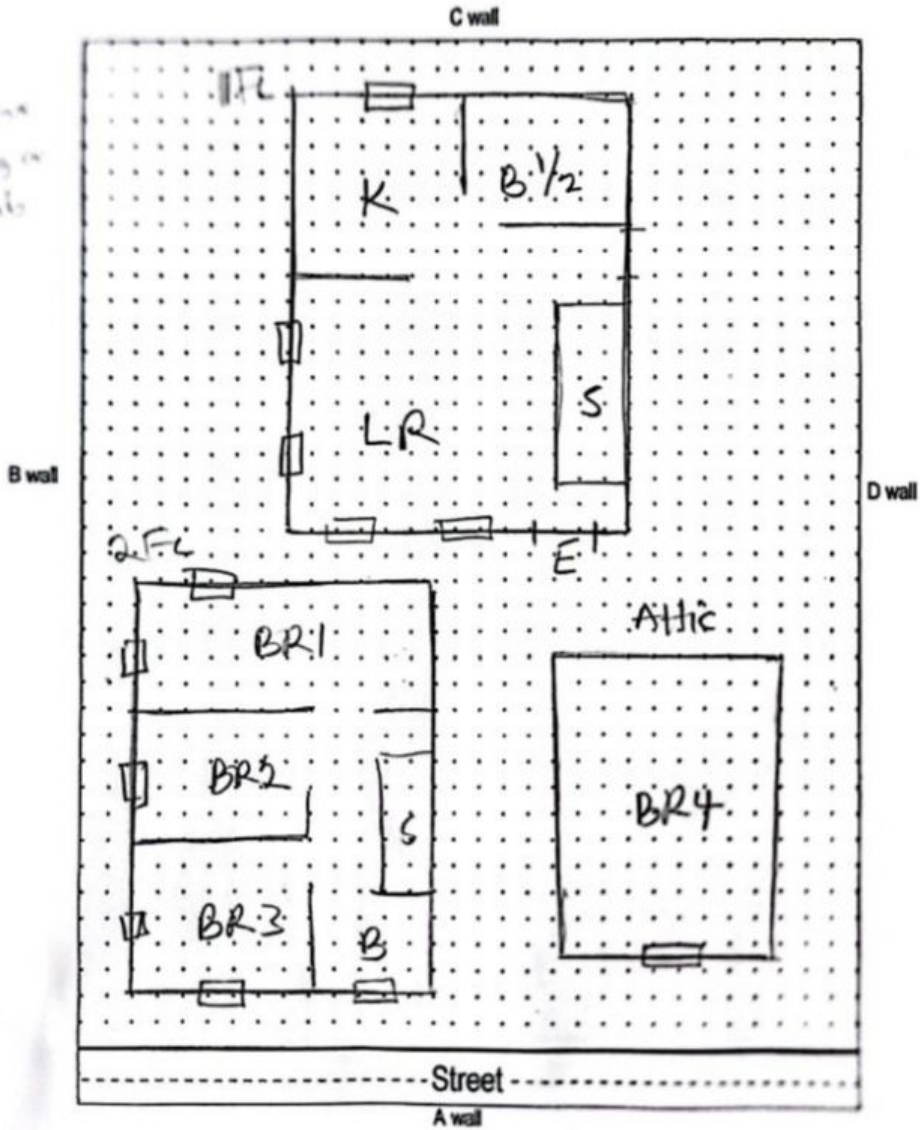
Site: 938 W 3rd Street

No windows
existing on
front
