Visual Paint Assessment Report

For 1004 Victoria Court Hillsborough Township, NJ
 03/25/2024

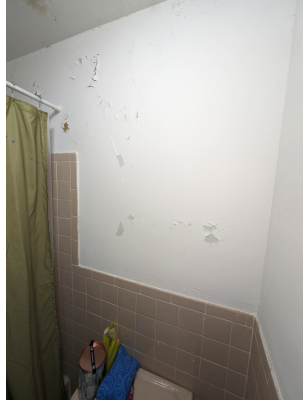
Room	Component	Hazard
Bathroom 1	Wall	Deteriorated Paint

Hazard: Bathroom 1 | Wall | Deteriorated Paint

Identified hazards shall be remediated using either abatement (permanent) or interim controls (temporary). Abatement is permanent but has a higher cost, as Interim controls are temporary but can be much more affordable. Abatement shall be performed by a NJ Licensed lead abatement firm using licensed lead abatement supervisors and workers. You can find the list of NJ licensed lead abatement contractors at https://www.nj.gov/dca/divisions/codes/publications/pdf_lead/ld_abat_c.pdf. Interim control work shall be performed by EPA RRP certified firms using an EPA certified RRP Renovator. You can find certified EPA RRP contractors at <https://cdxappstest.epacdx.net/ocspp-oppt-leadhub/firm-location-search>. Select RRP Contractor, then NJ, then enter your zip code to search for contractors. After completion of interim control work, a lead-based paint post-remediation with dust wipes will be required. After completion of abatement work, a lead-based paint abatement clearance will be required..
