Visual Paint Assessment Report

For Auten Rd. Hillsborough Township, NJ 08844
 01/24/2024

Site: 579-4 Auten Rd, Hillsborough, NJ Floor 1

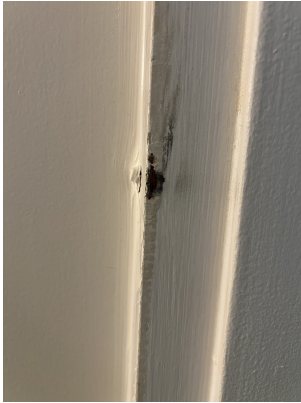
Room	Component	Hazard
Bathroom 1	Door Casing	Deteriorated Paint
Bathroom 1	Door	Deteriorated Paint

Hazard: Bathroom 1 | Door Casing |
Deteriorated Paint

Identified hazards shall be remediated using either abatement (permanent) or interim controls (temporary). Abatement shall be performed by a NJ Licensed lead abatement firm using licensed lead abatement supervisors and workers. Interim control work shall be performed by EPA RRP certified firms using an EPA certified RRP Renovator. After completion of interim control work, a lead-based paint post-remediation with dust wipes will be required. After completion of abatement work, a lead-based paint abatement clearance will be required.
