Visual Paint Assessment Report

For 716 Nassau Street North Brunswick Township, NJ 08902
 12/22/2023

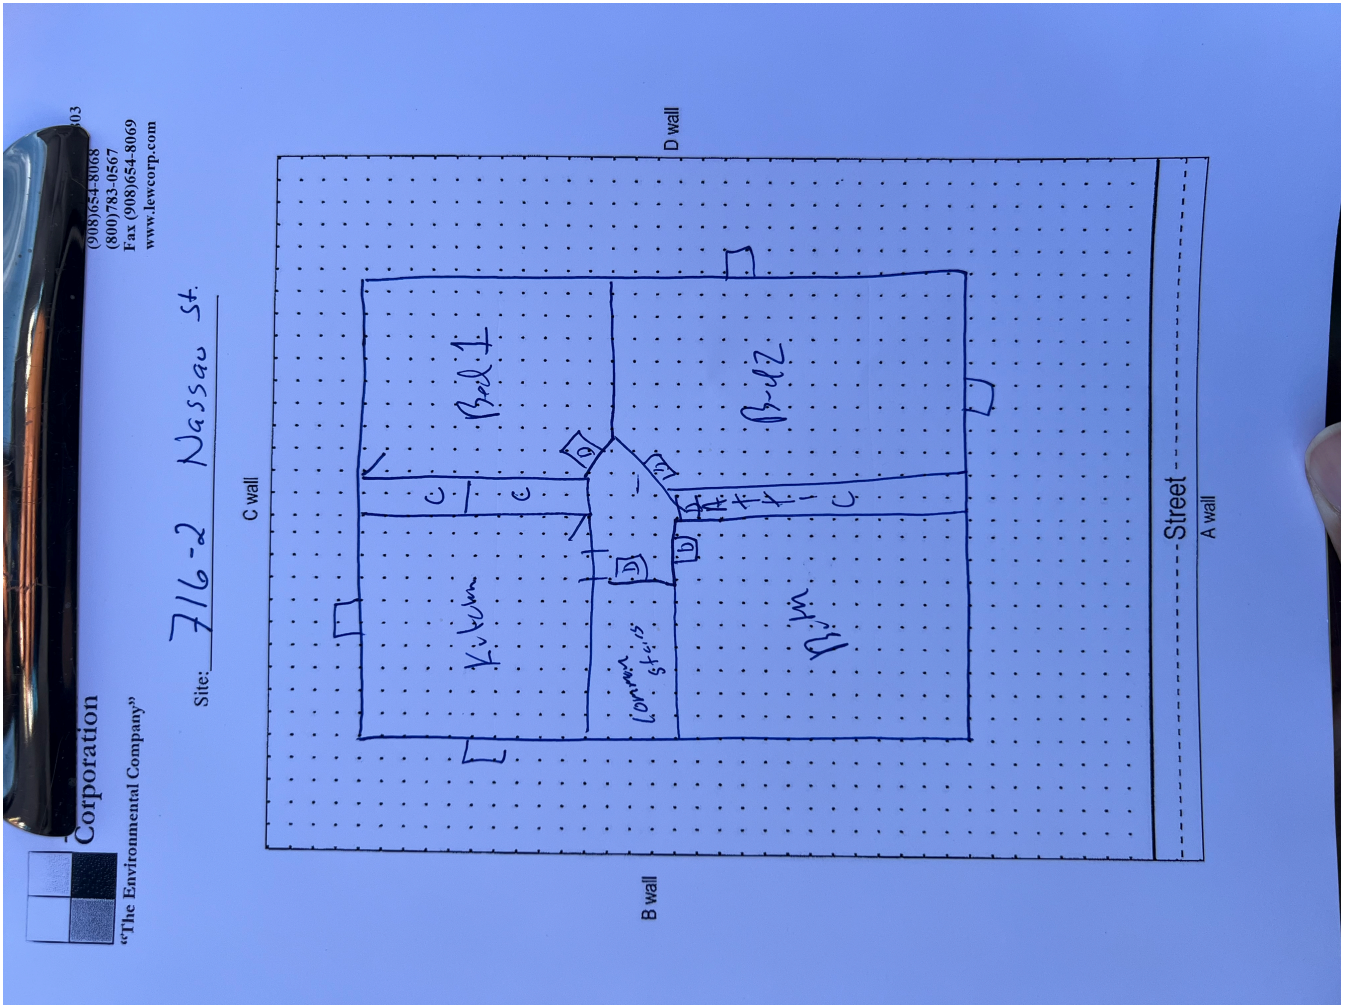
Floor 1

Room	Component	Hazard
Kitchen	Closet Door Frame	Deteriorated Paint

Identified hazards shall be remediated using either abatement (permanent) or interim controls (temporary). Abatement shall be performed by a NJ Licensed lead abatement firm using licensed lead abatement supervisors and workers. Interim control work shall be performed by EPA RRP certified firms using an EPA certified RRP Renovator. After completion of interim control work, a lead-based paint post-remediation with dust wipes will be required. After completion of abatement work, a lead-based paint abatement clearance will be required.
