Visual Paint Assessment Report

For 900 G Merritt Drive, Hillsborough Township, NJ
 12/07/2023

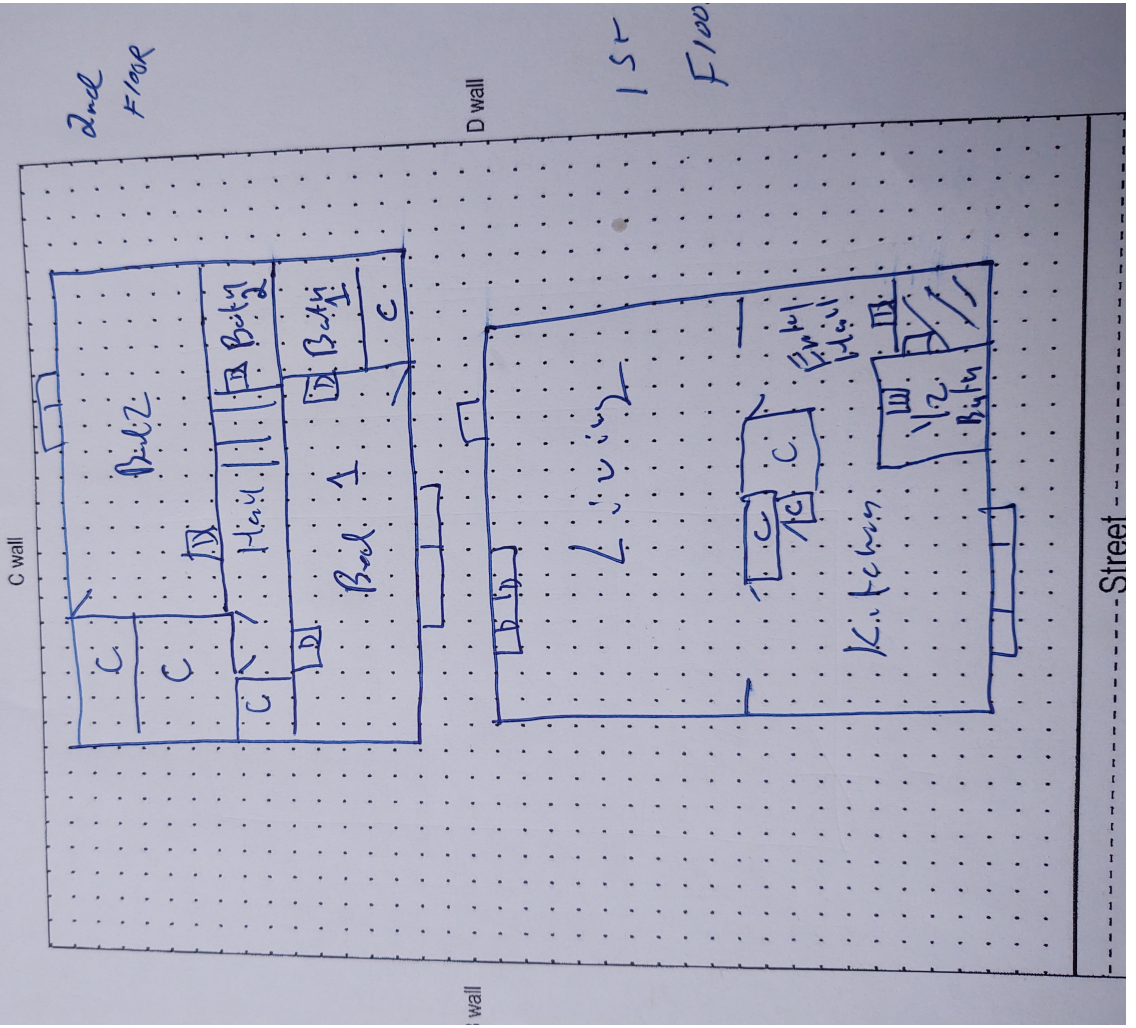
Floor Plan

Room	Component	Hazard
Bathroom 2	Ceiling	Deteriorated Paint
Bathroom 2	Wall	Deteriorated Paint

Identified hazards shall be remediated using either abatement (permanent) or interim controls (temporary). Abatement shall be performed by a NJ Licensed lead abatement firm using licensed lead abatement supervisors and workers. Interim control work shall be performed by EPA RRP certified firms using an EPA certified RRP Renovator. After completion of interim control work, a lead-based paint post-remediation with dust wipes will be required. After completion of abatement work, a lead-based paint abatement clearance will be required.
