LEAD-BASED PAINT EVALUATION REPORT DWELLING UNIT(S) INSPECTION

10 Oak Street
Morristown NJ

Inspection Date: 7/24/24

Project Number: 53874

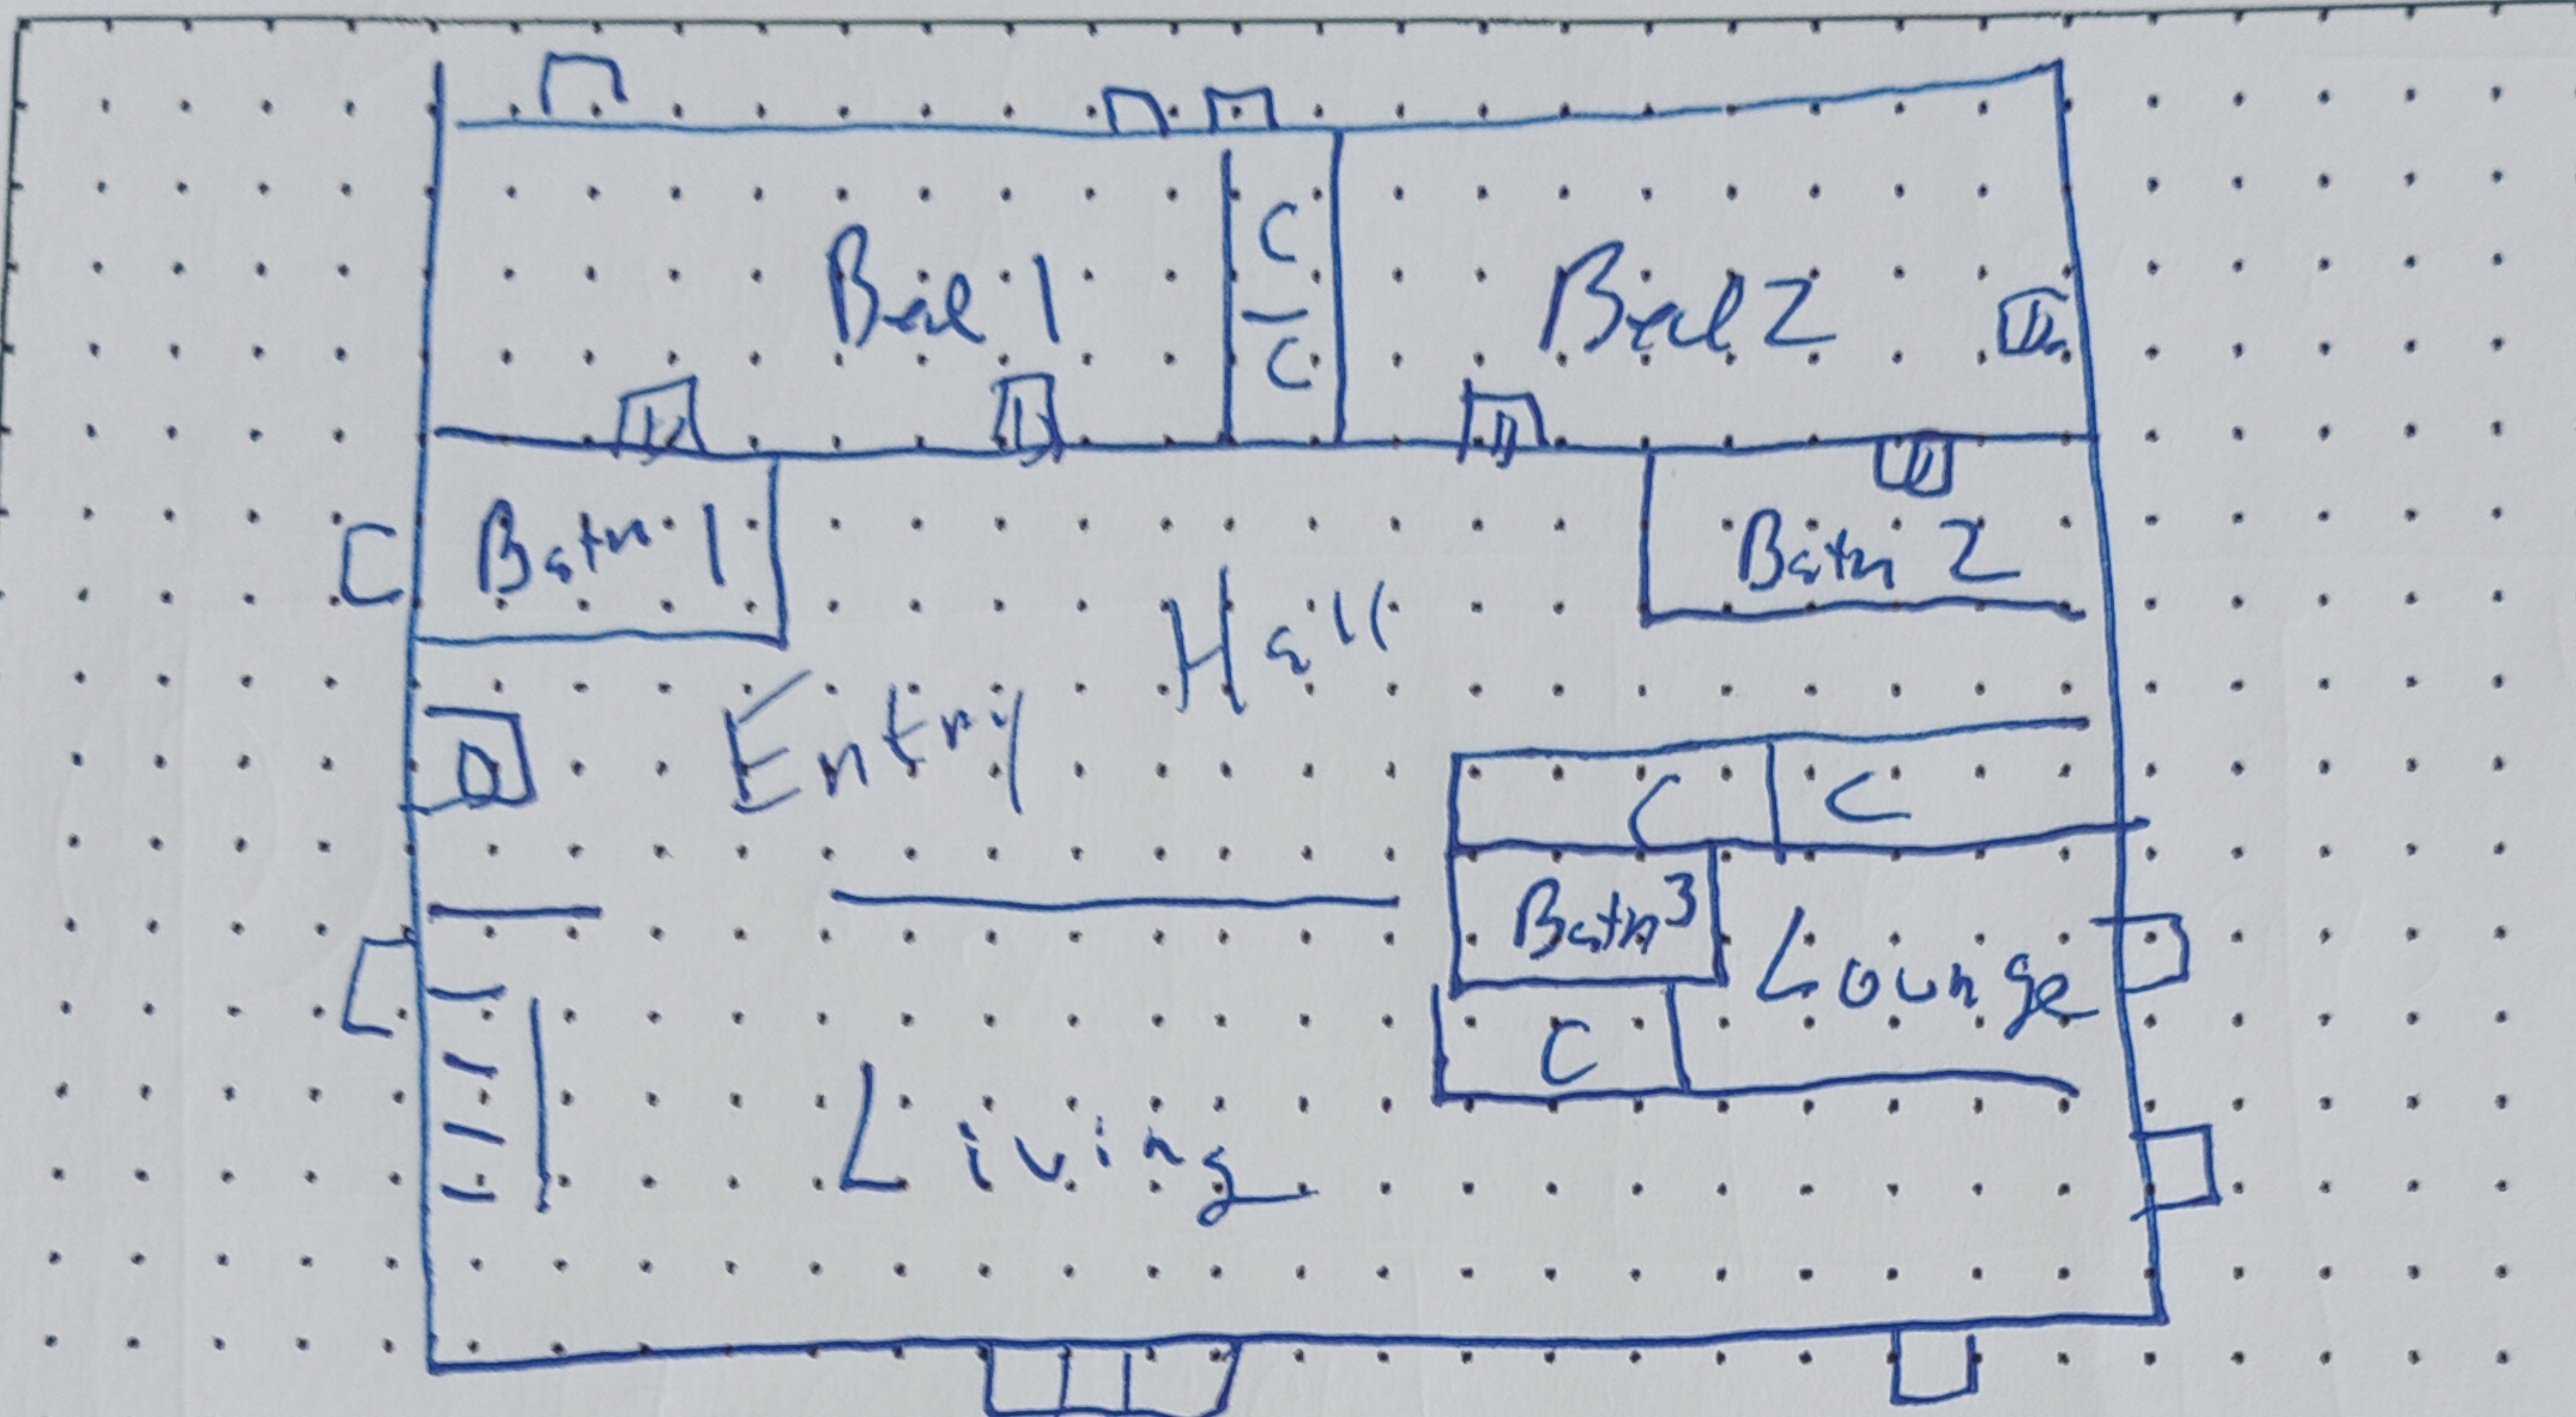
1st
Floor

C wall

B wall

D wall

APPENDIX A	FLOOR PLAN
APPENDIX B	LEAD-BASED PAINT EVALUATION REPORT
APPENDIX C	PHOTOGRAPHS
APPENDIX D	LAB SUPPORT DOCUMENTS (IF APPLICABLE)

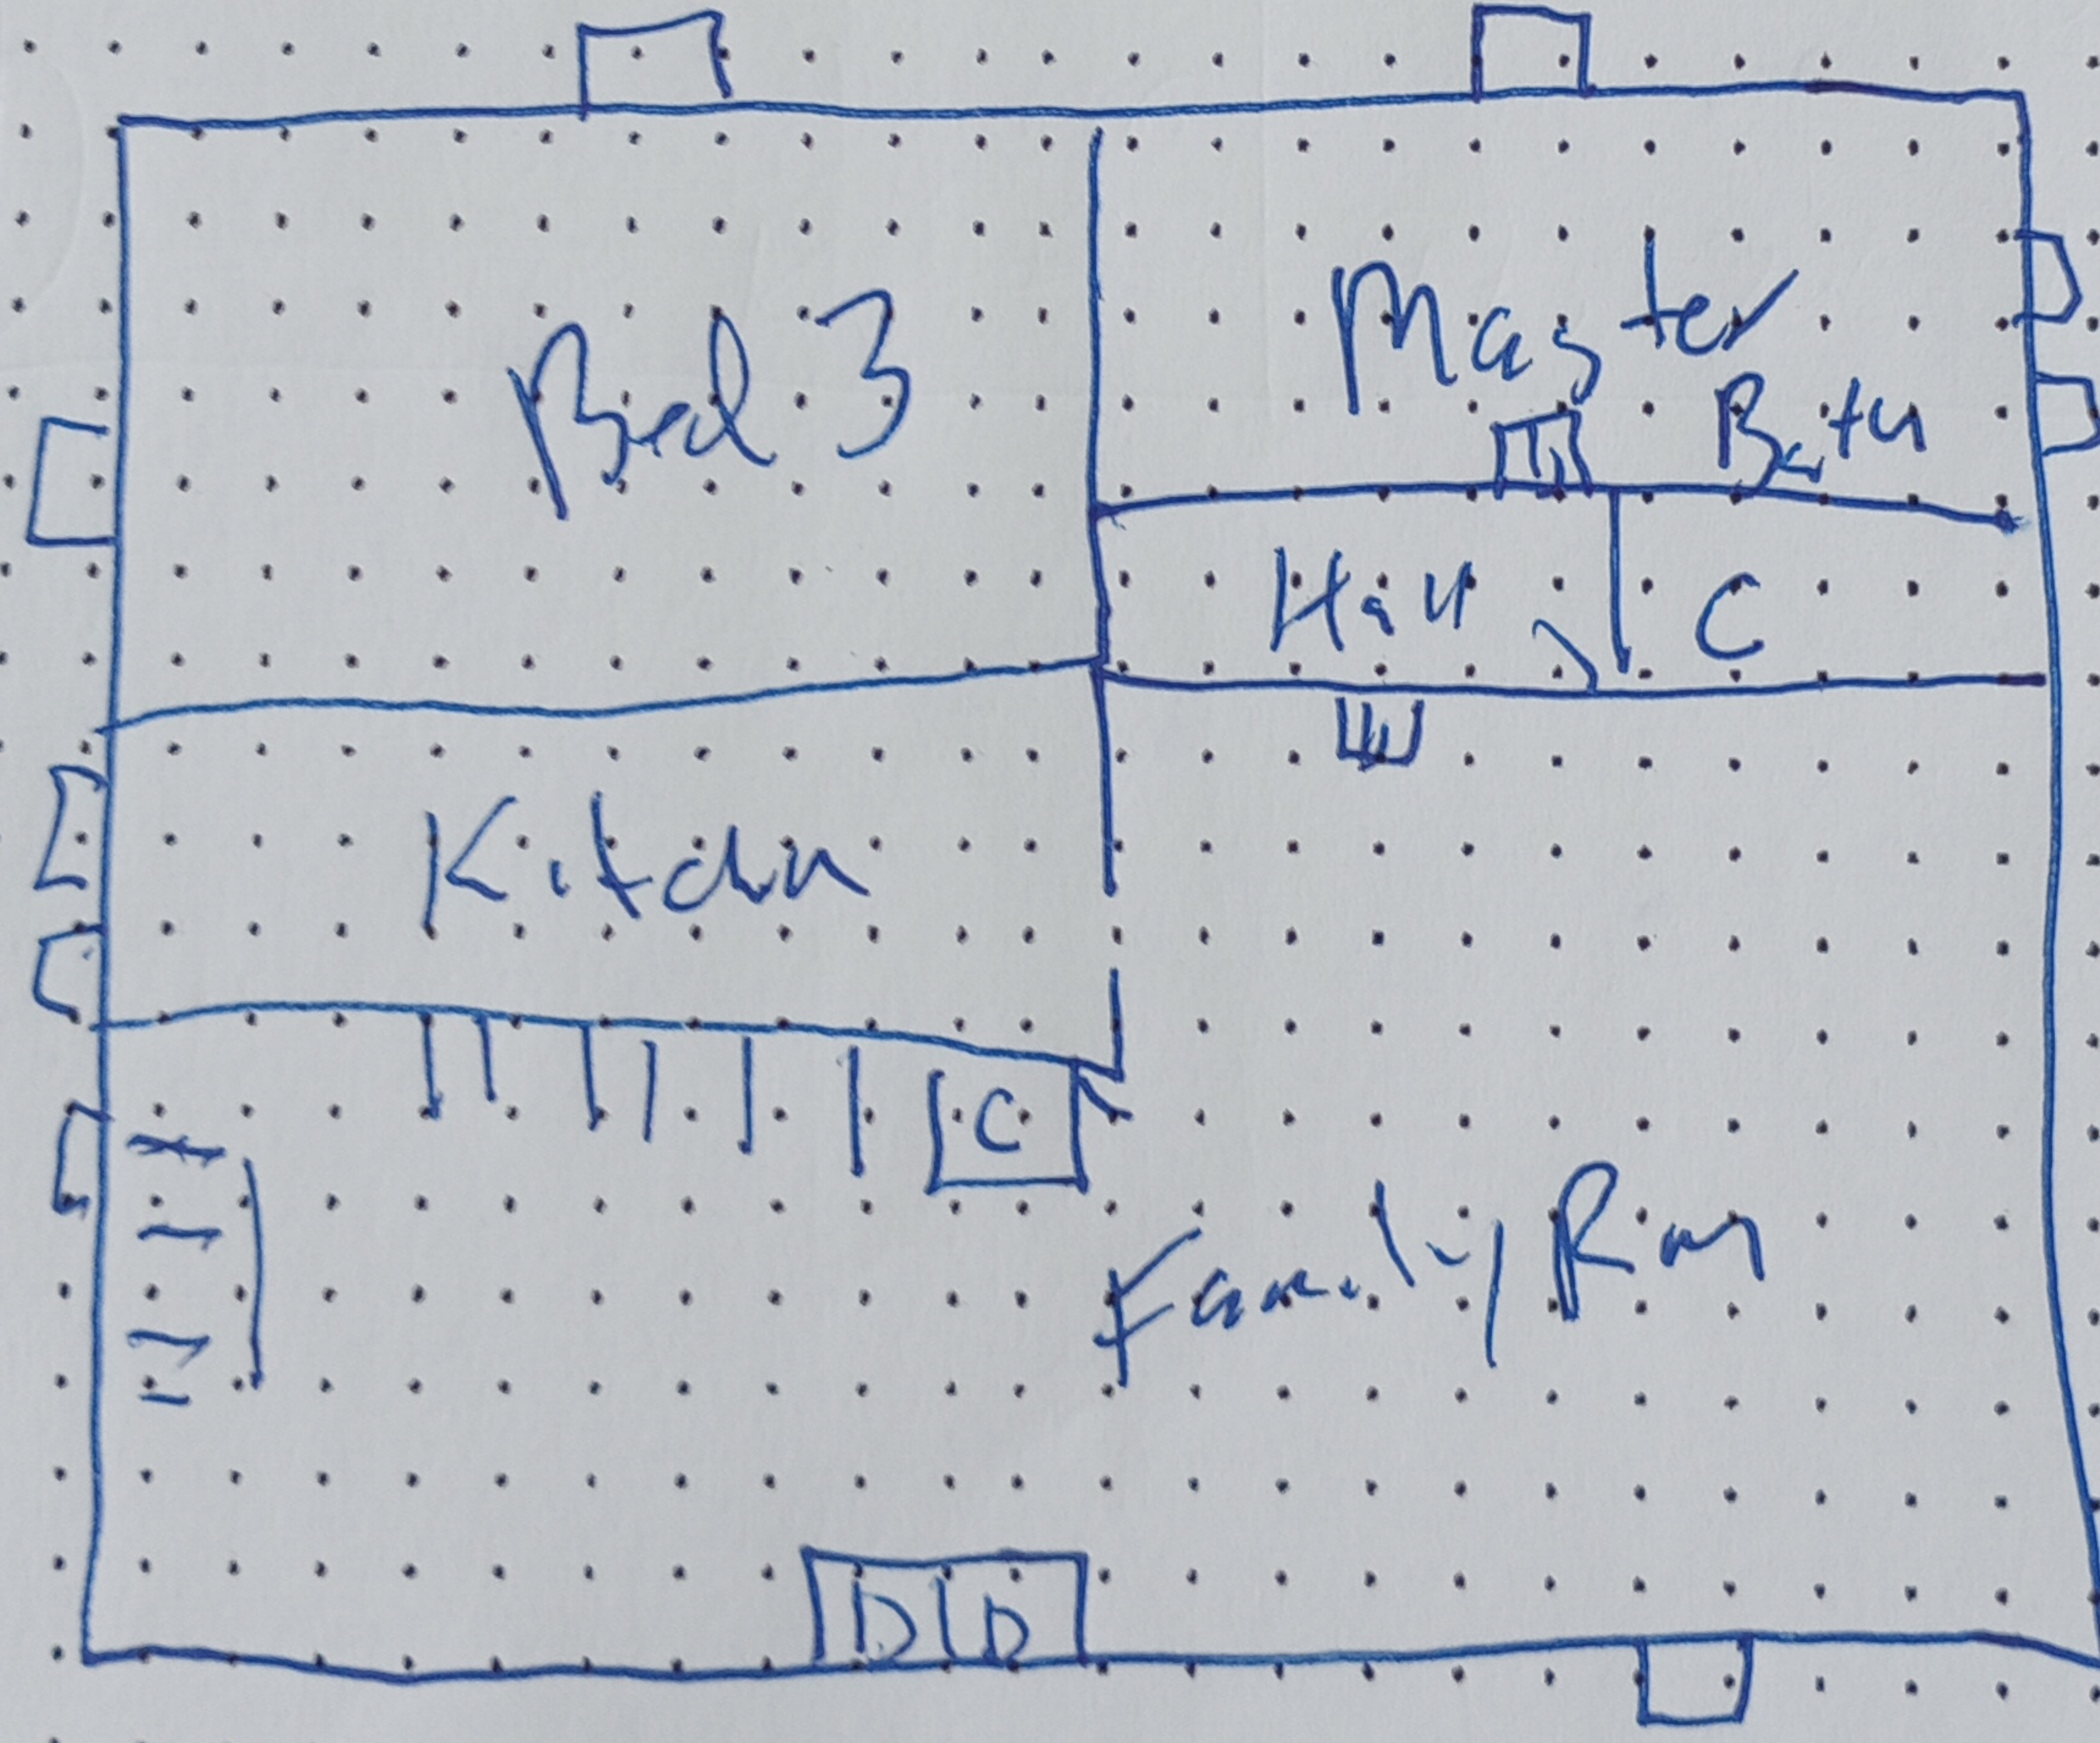
2nd Floor

Street

A wall
