LEAD-BASED PAINT EVALUATION REPORT DWELLING UNIT(S) INSPECTION

36 Knickerbocker Ave, Dover, NJ, 07801

Inspection Date: 02/14/2024
Project Number: 1117

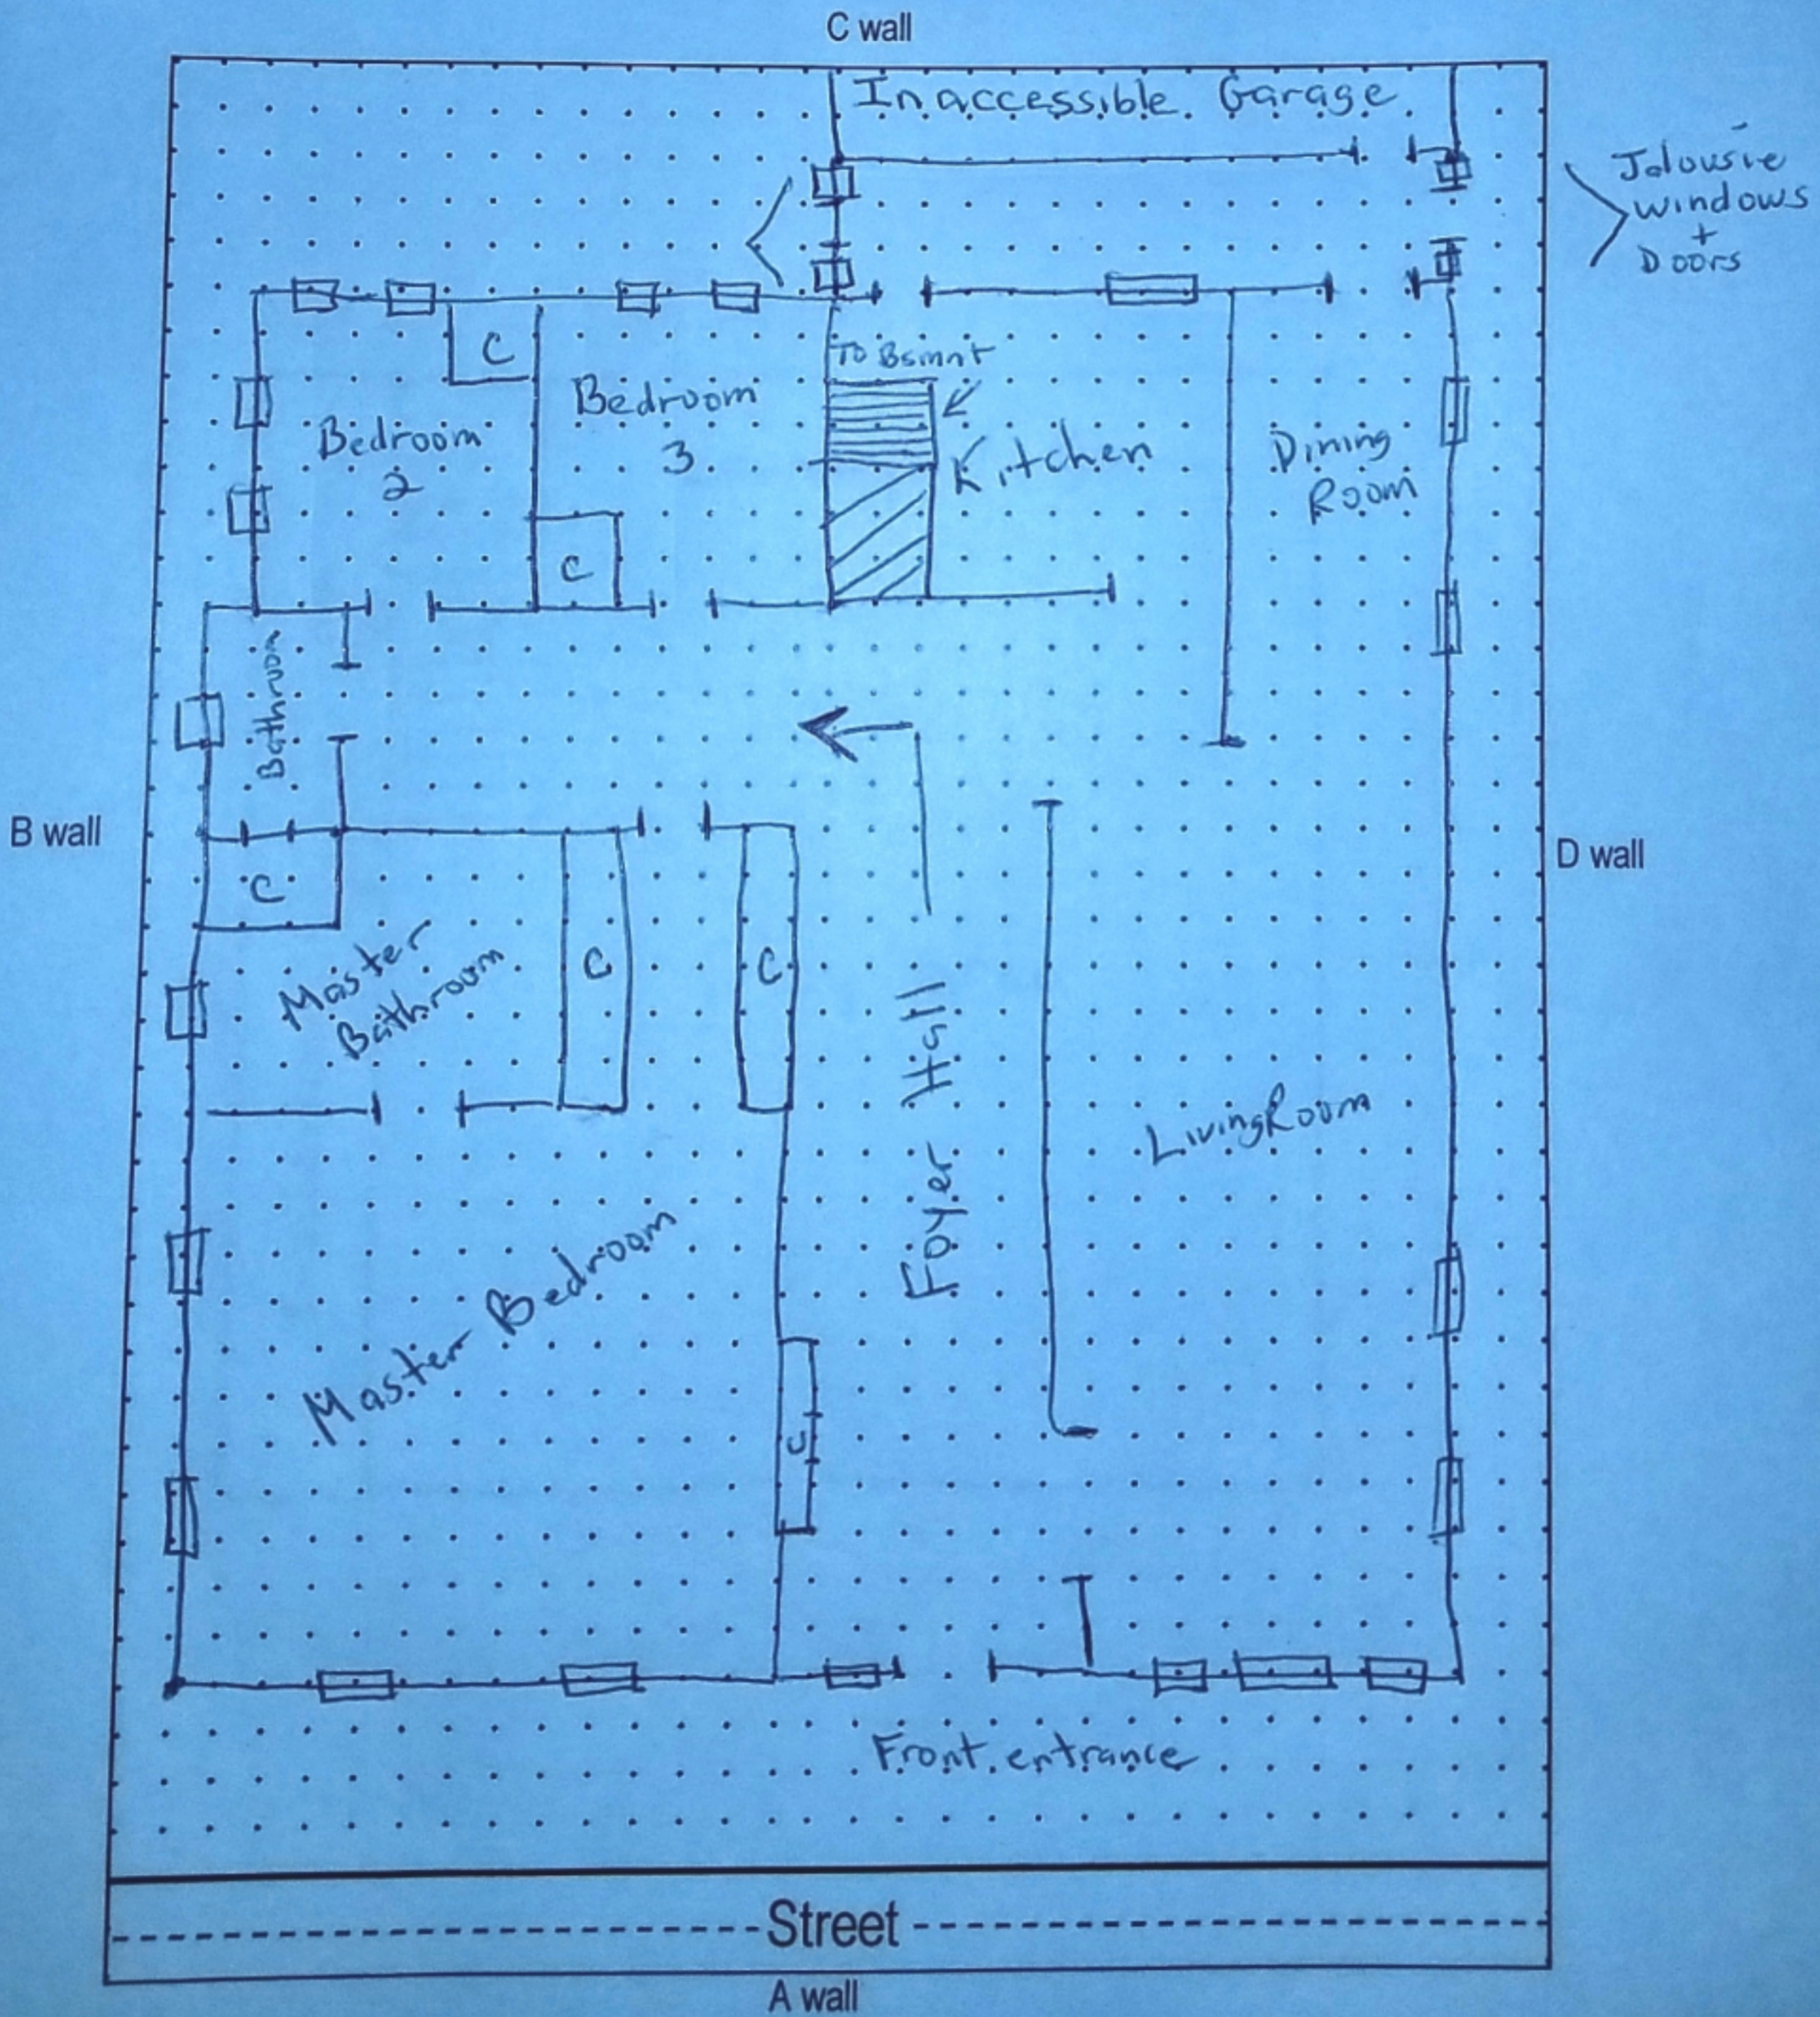
Main floor

Site: 36 Knickerbocker ave - Dover

Floor Plan

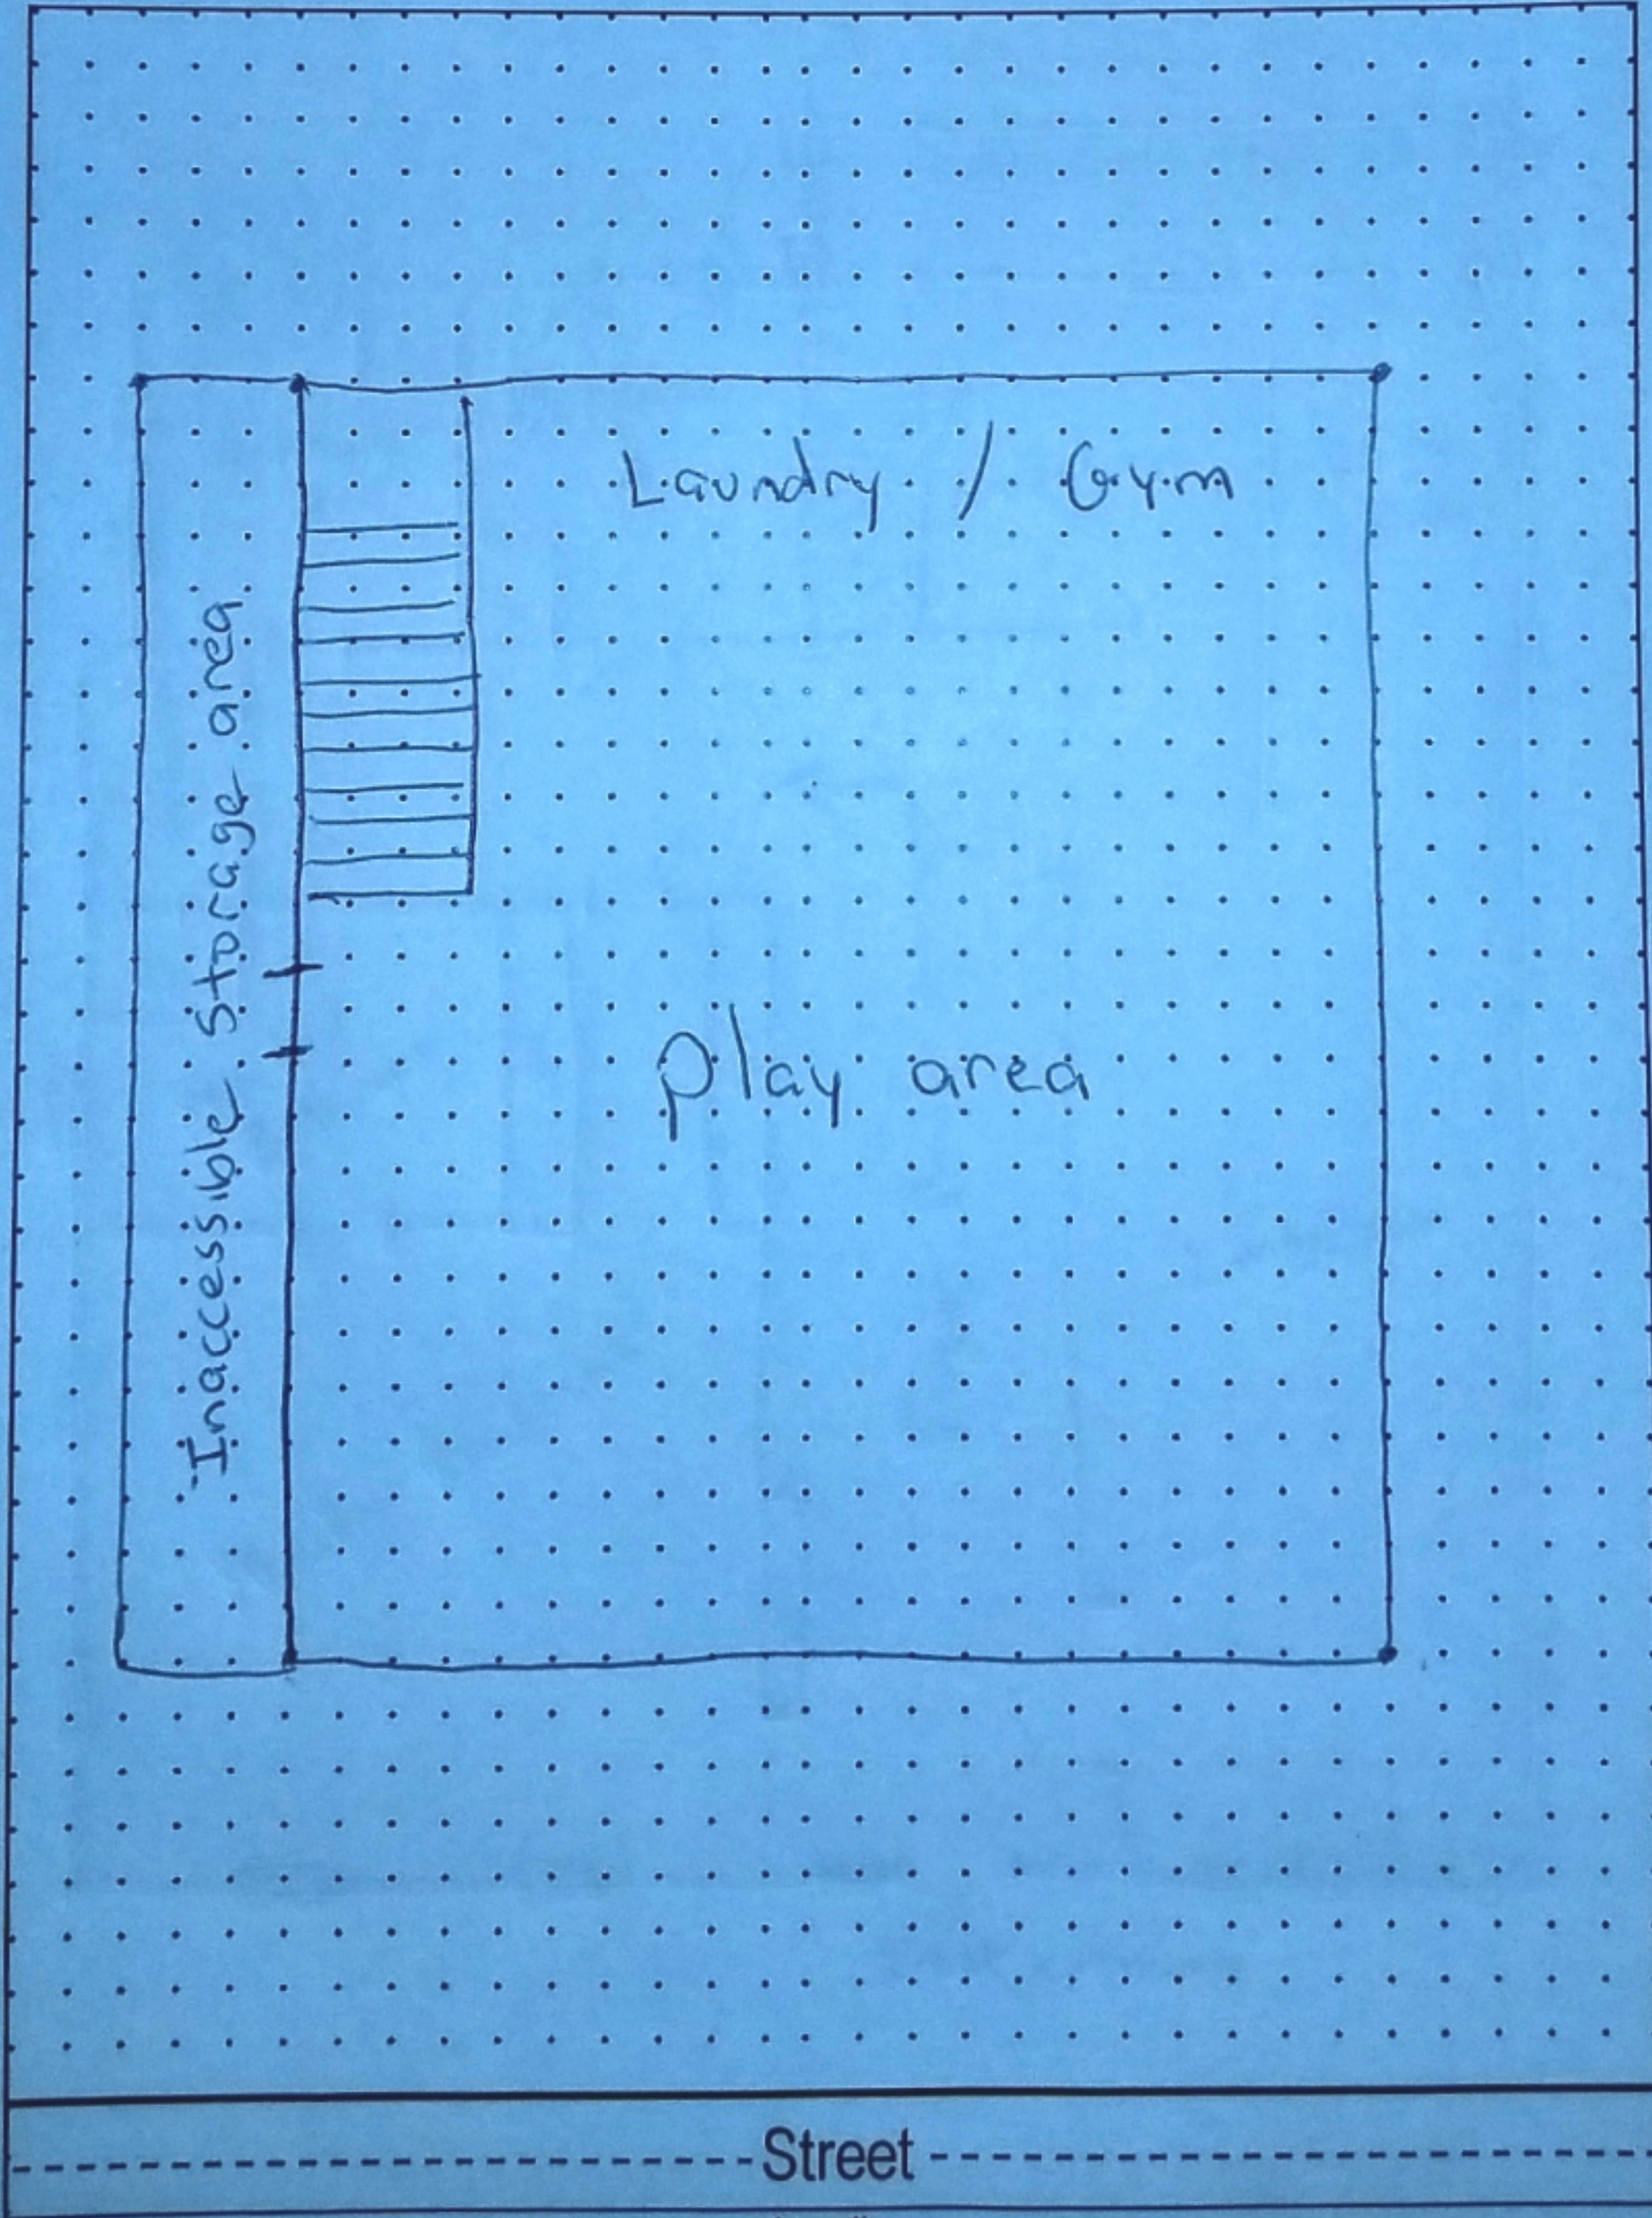
Lower floor

Site: 3b Knickerbocker ave - Dover

C wall

B wall

D wall

Street

A wall
