## **Visual Paint Assesment Report**

For 3001 cromwell ct Hillsborough Township, NJ 08844 01/24/2024

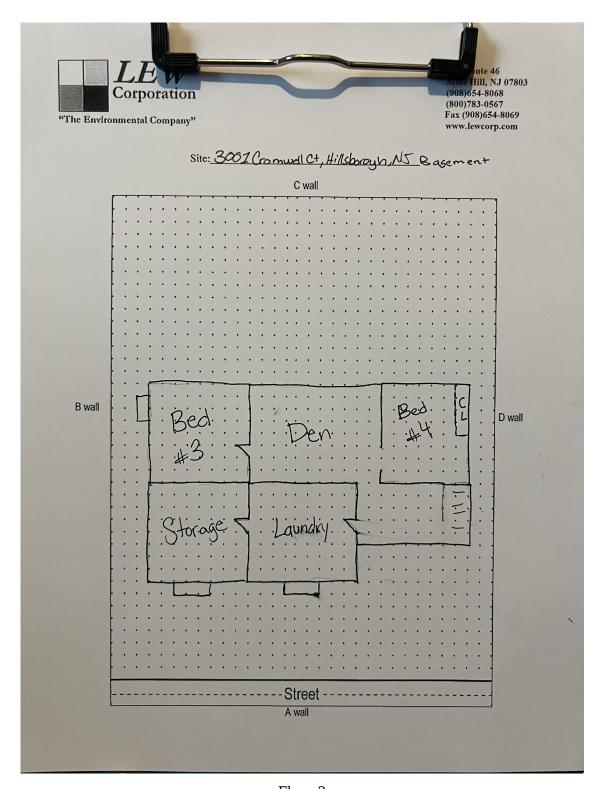
Floor 2

Lew Environmental Services - 3001 cromwell ct -Visual Inspection Prepared By: LEW Environmental Services, LLC 01/24/2024
