## **Lead Dust Wipe Report**

For 753-755 Jackson Ave Unit:2 Elizabeth City, NJ 07067 11/26/2024

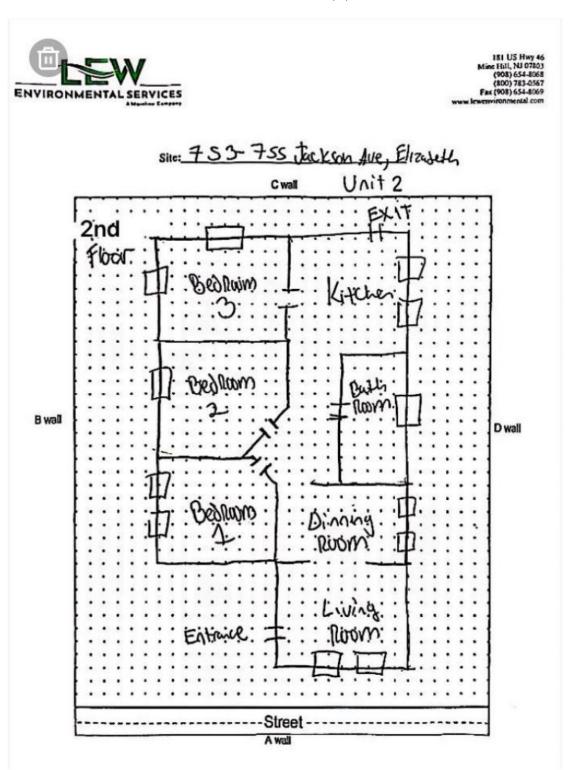
Floor 1

## Floor Plan(s)

Lew Environmental Services - 753-755 Jackson Ave Unit:2 -Visual Inspection Prepared By: LEW Environmental Services, LLC 11/26/2024
