## **Lead Dust Wipe Report**

For 11 Musconetcong St Unit:1 Pohatcong Township, NJ 08865 06/10/2024

## Lead Dust Wipe Analysis Report

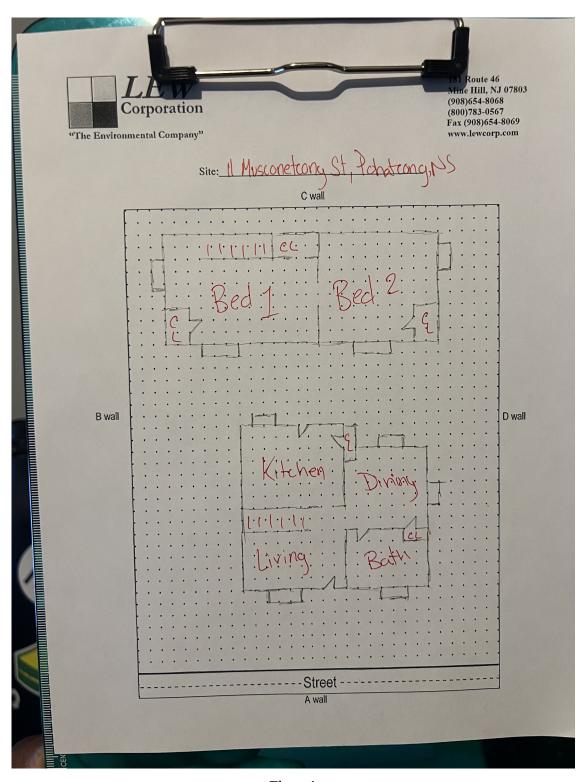
Floor 1

Lew Environmental Services - 11 Musconetcong St Unit:1 -Visual Inspection Prepared By: LEW Environmental Services, LLC 06/10/2024
