Lead Dust Wipe Report

For 15 General Karge Ct Unit:2 Elizabeth City, NJ 07202
11/26/2024

Site: 15 General Karge Ct, Elizabeth
Unit 2

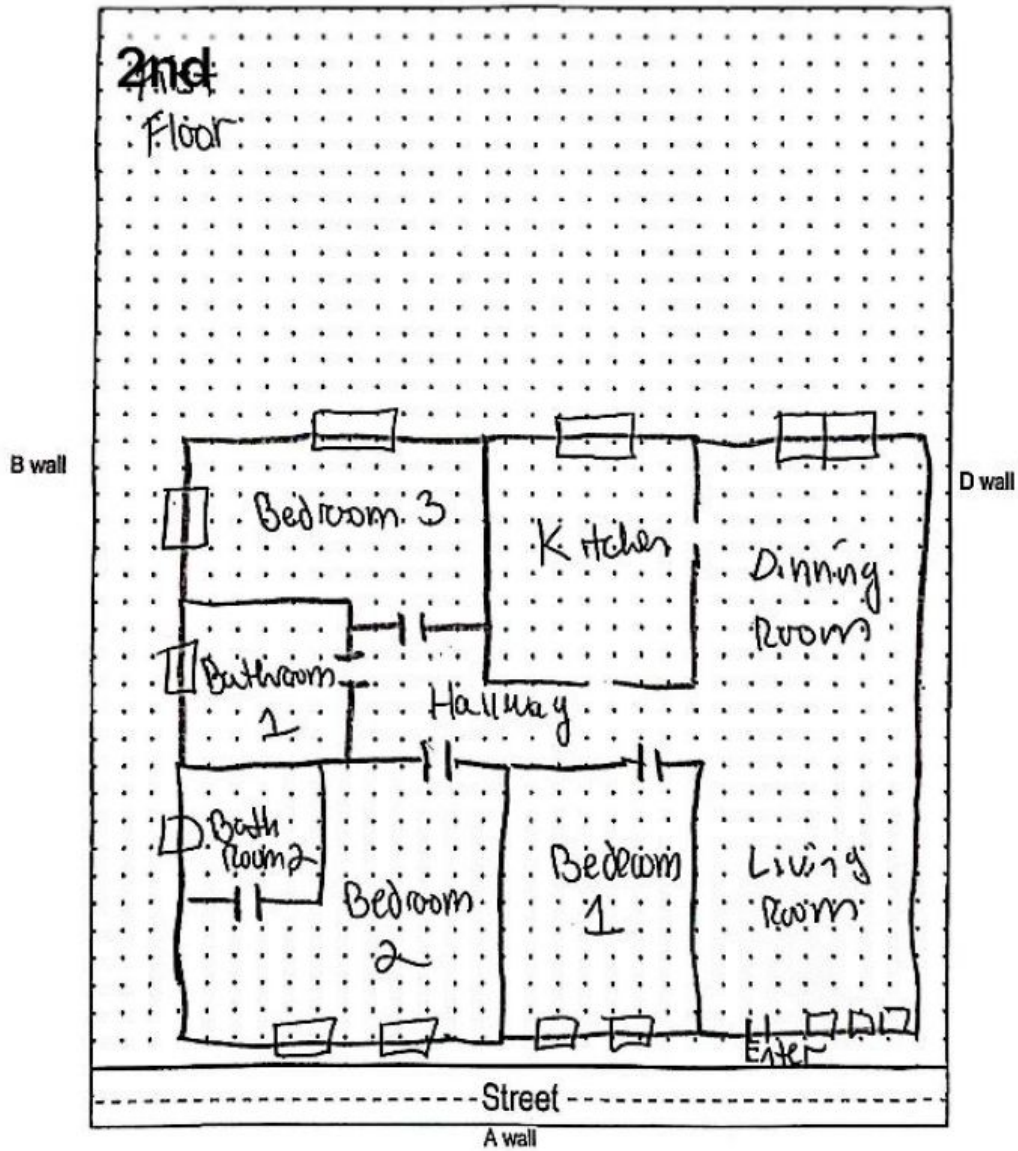
Floor 1

Lew Environmental Services - 15 General Karge Ct Unit:2 -Visual Inspection
Prepared By: LEW Environmental Services, LLC
11/26/2024
