Lead Dust Wipe Report

For 214 E. 6th St Unit:1 Plainfield City, NJ
11/26/2024

Lead Dust Wipe Analysis Report

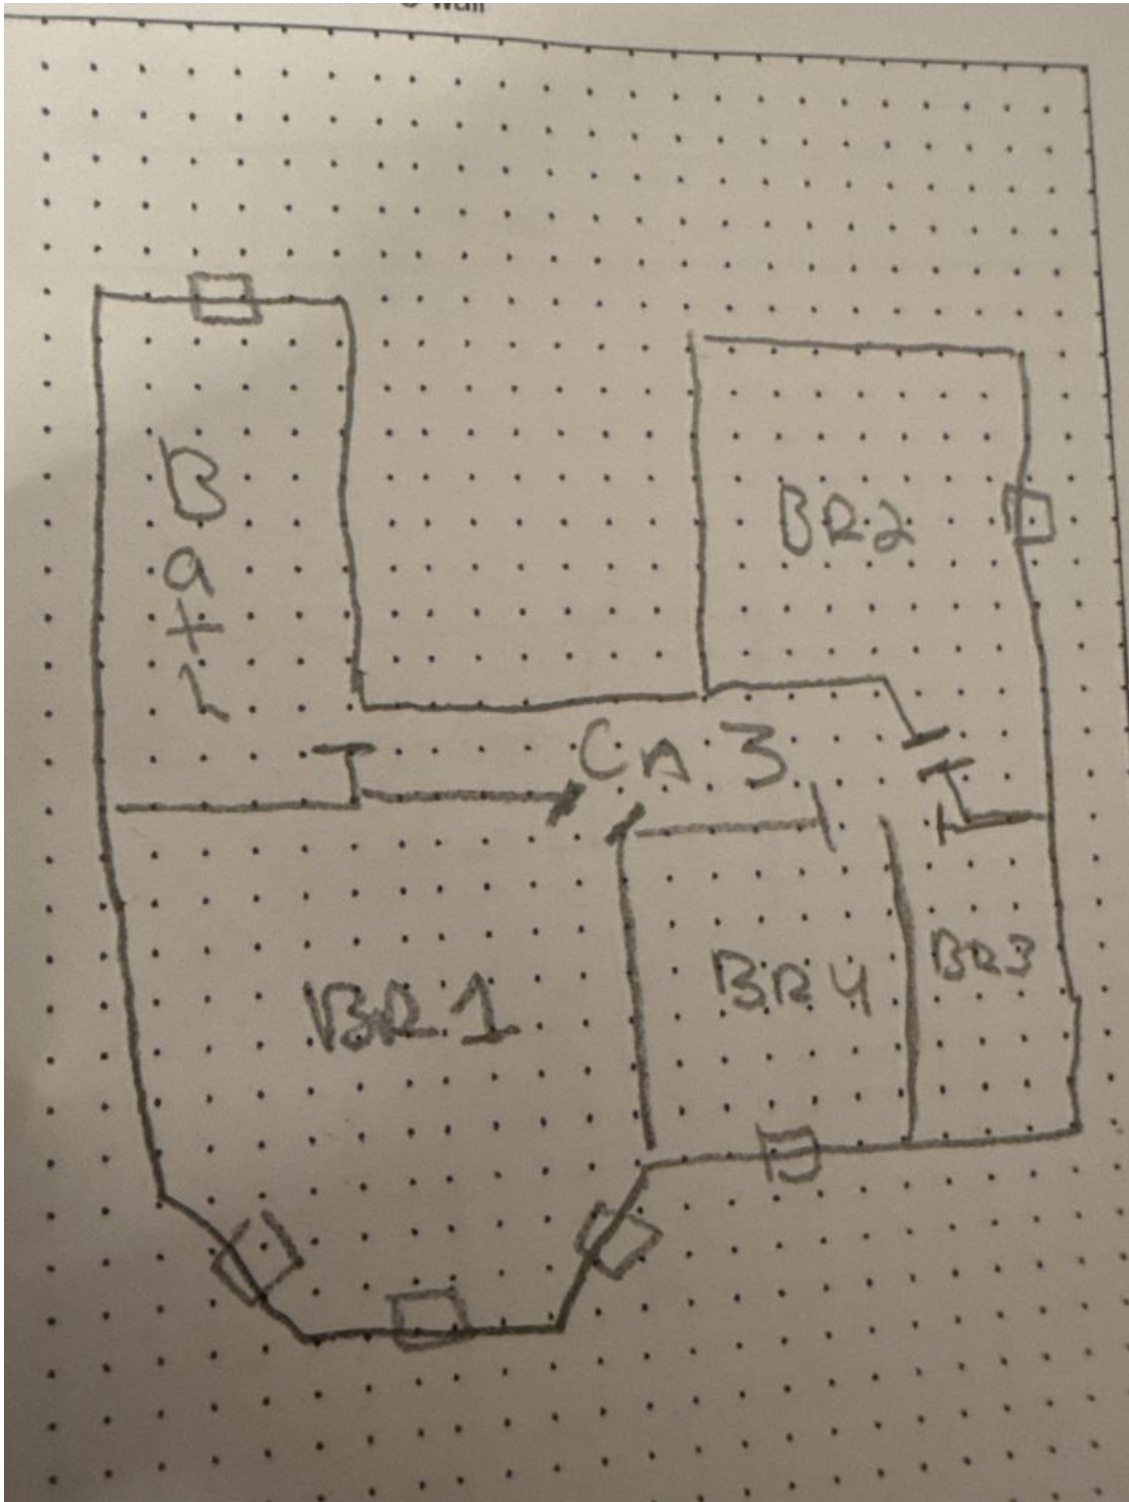
Floor 1

Lew Environmental Services - 214 E. 6th St Unit:1 -Visual Inspection
Prepared By: LEW Environmental Services, LLC
11/26/2024

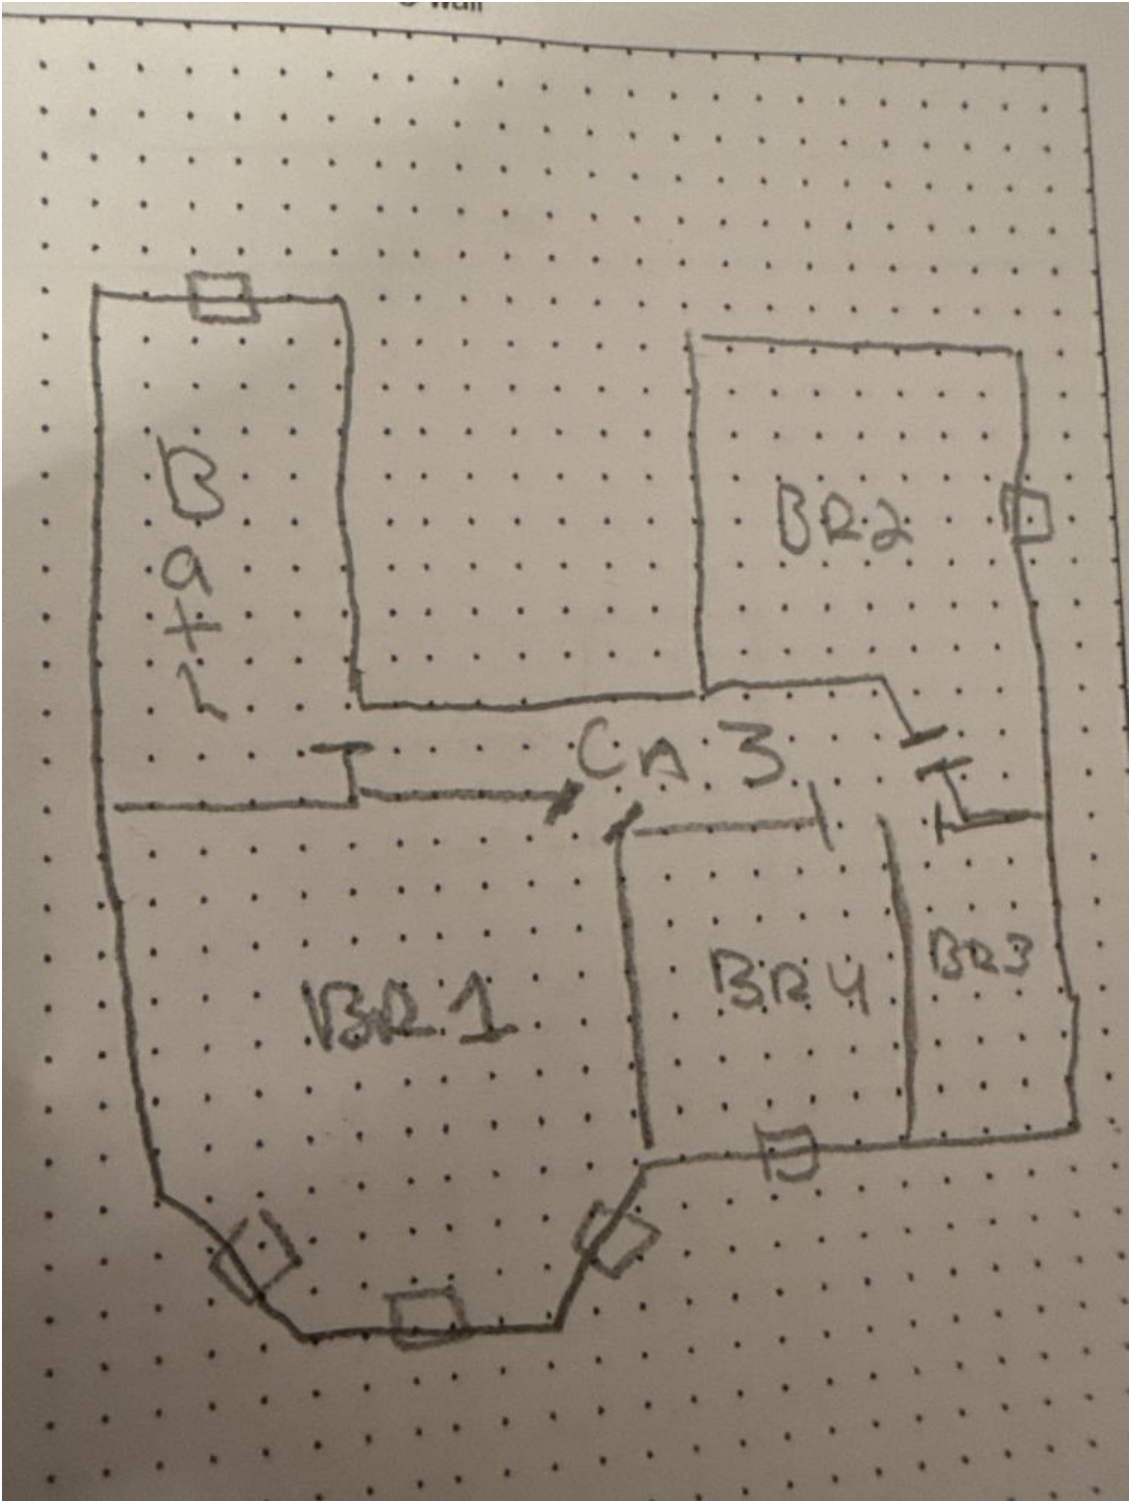
Floor 2

Lew Environmental Services - 214 E. 6th St Unit:1 -Visual Inspection
